**Report Card:**  
2005 BMW 730i (Silver)

## 1.0 Enrolment:

For the second time in as many weeks, we were engaged to undertake 'Major Paint Correction' services on a newly purchased BMW. In a similar vein to our recent work on the 525i M-Sport, the owner of this sleek executive sedan was disappointed with the condition of the vehicle upon delivery from the dealer - and keen to achieve a showroom-perfect finish.

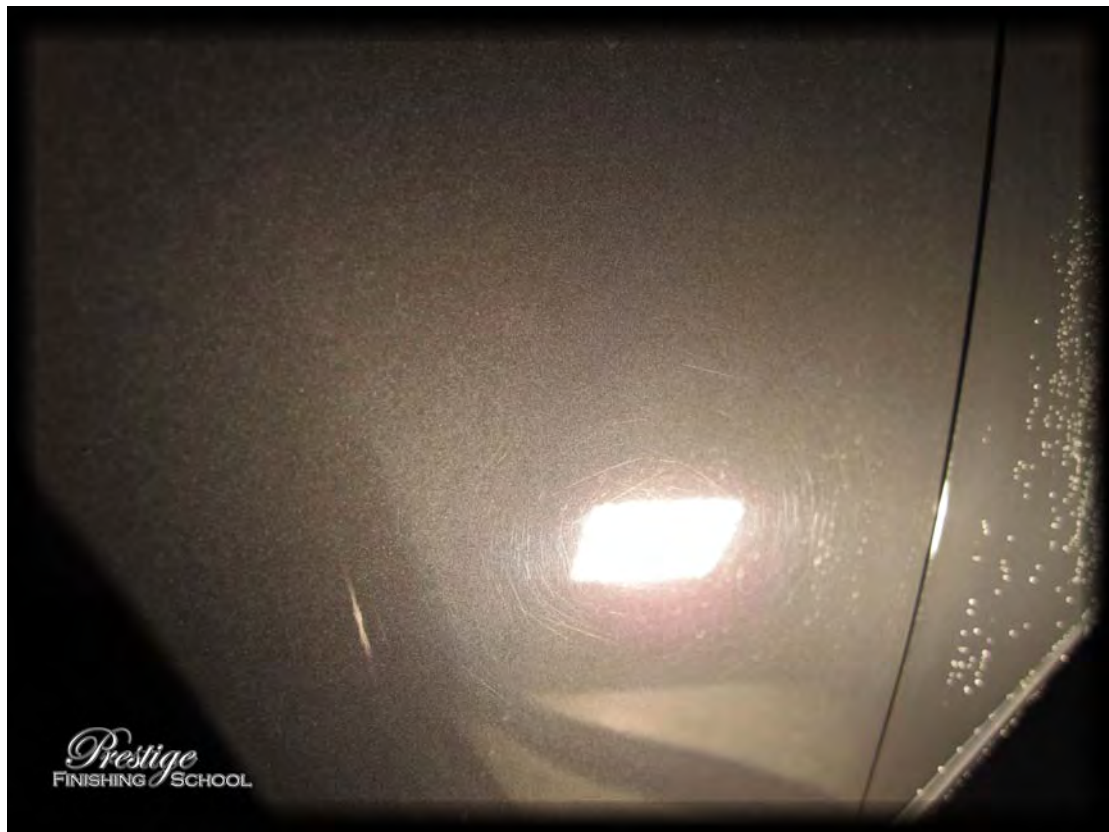
Despite appearing remarkably clean and defect free, direct lighting shows evidence of swirling and random, deeper scratches - both under 500W Halogens...

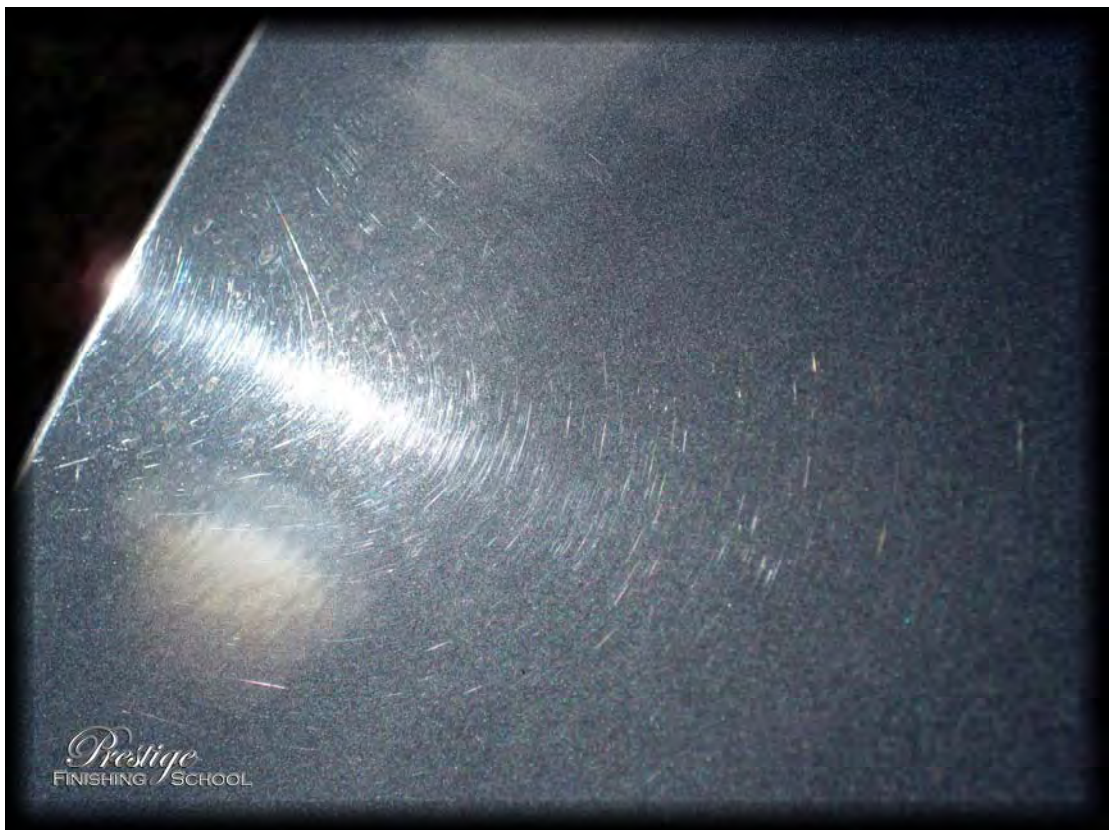
...and direct sunlight.

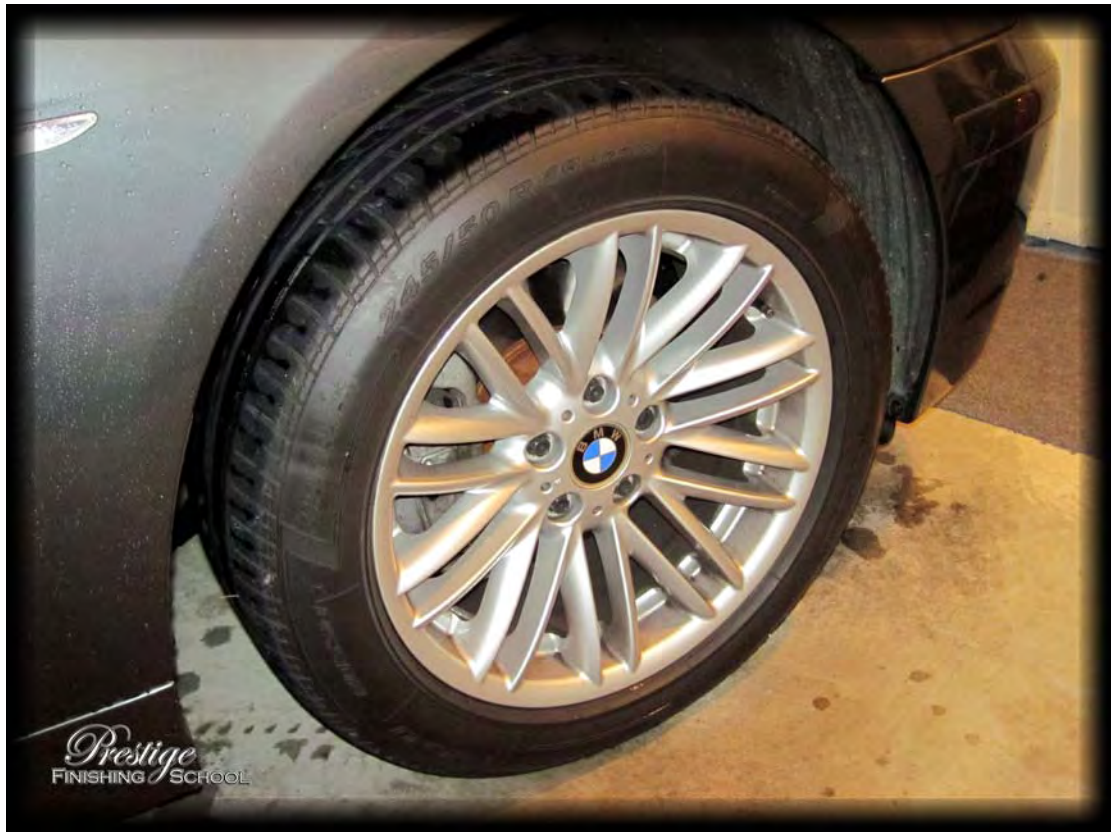
The wheel arches also have a small amount of grime which detracts from the vehicle's overall appearance.

The arches are initially rinsed with high-pressure spray, then a strong solution (4:1 dilution ratio) of “Meguiar’s Super Degreaser” was applied and the arches are scrubbed vigorously with a stiff bristled brush.

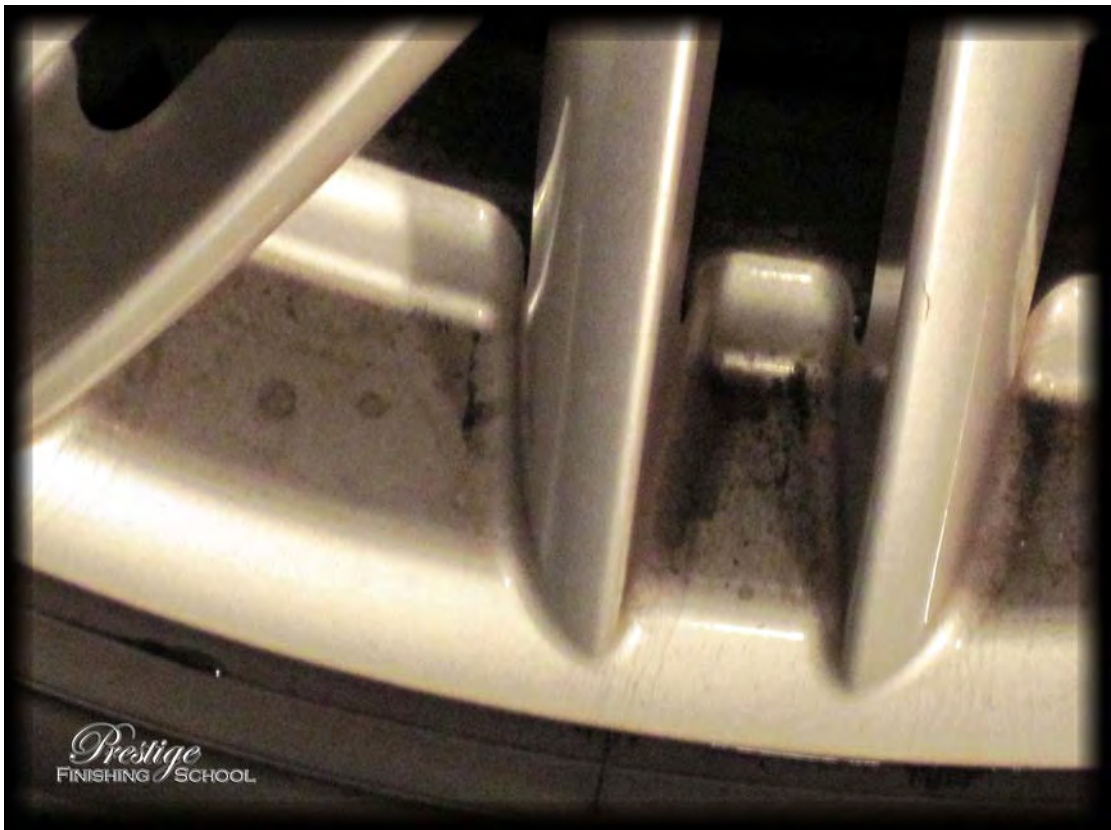
And the rims showed evidence of accumulated brake dust having bonded/etched into the wheel surface.

P21S Wheel Gel was employed to remedy the problem, combined with another full hour spent meticulously cleaning each of the rim's 20 alloy spokes. This was followed with an application of Poorboy's Wheel Sealant to protect the rim.

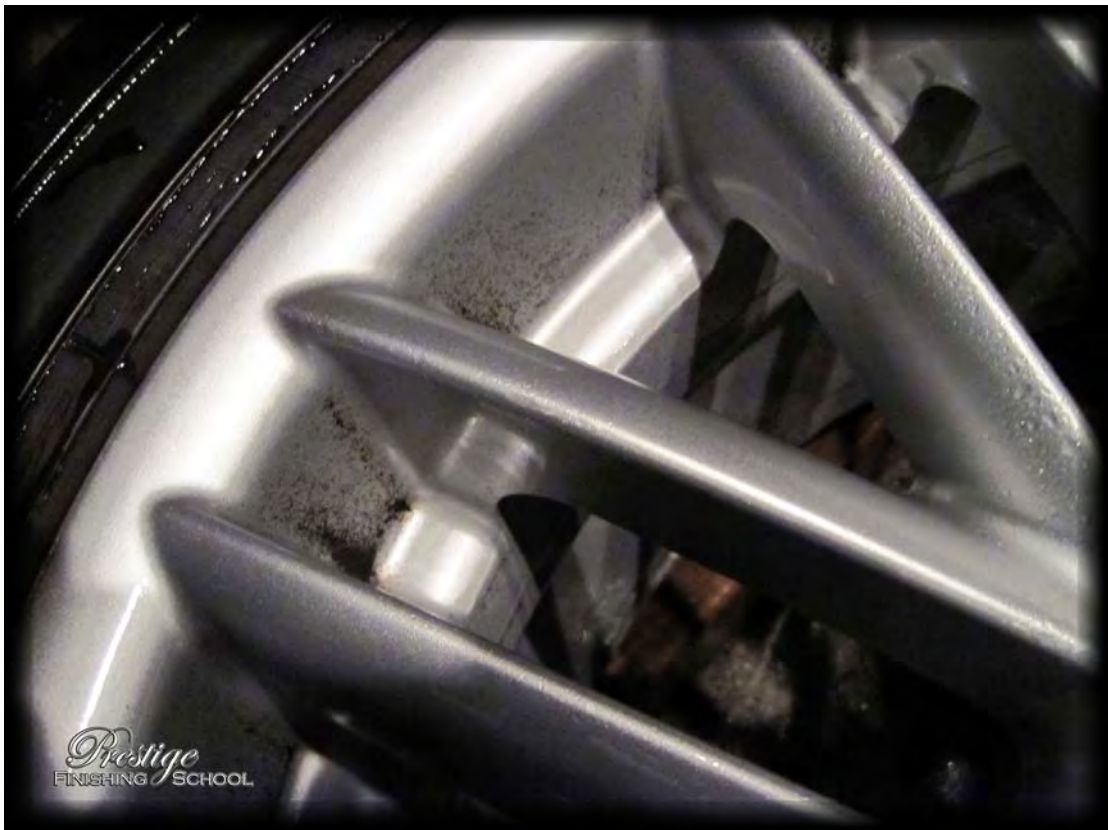
This left us with the etching and bonded particles of brake dust to attend to:

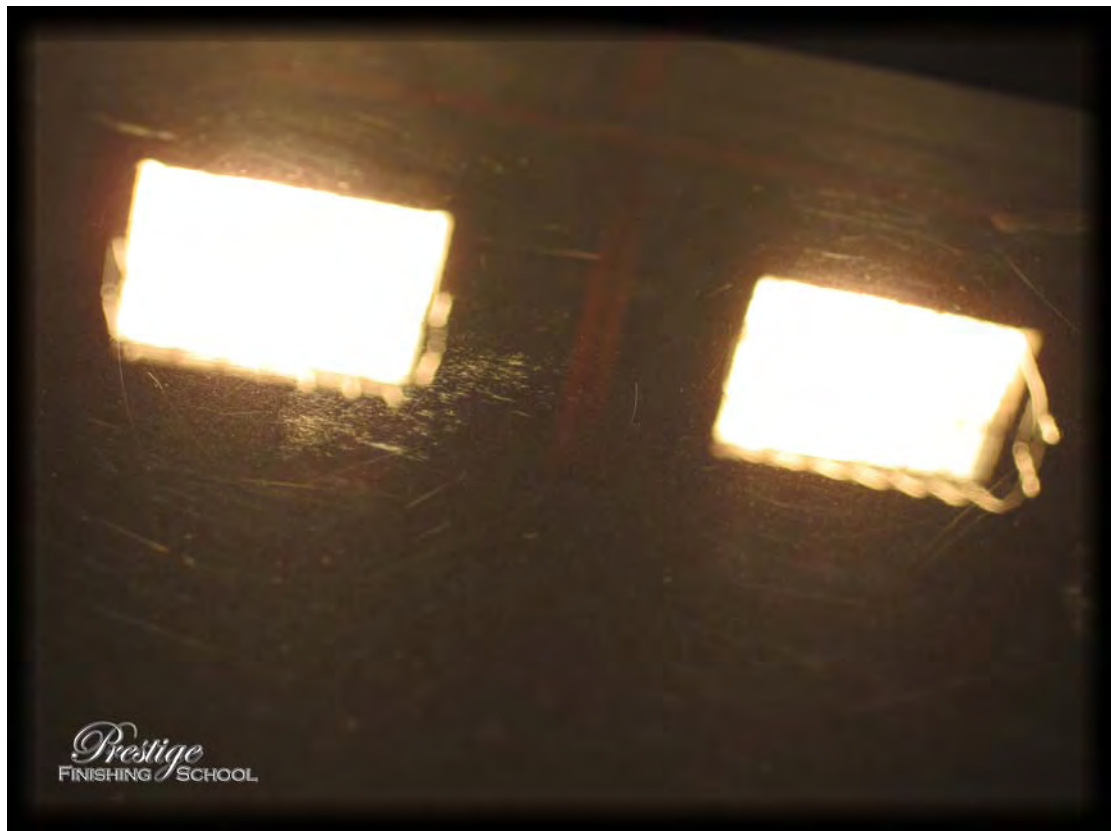
This was the condition of our 'test' area prior to starting.

To begin, we need to establish the correct polishing compound, pad and technique combination required to achieve the desired level of correction for this vehicle's paint. It is important in all cases to approach this exercise from the 'least aggressive' option, and step up the cutting level, machine speed, and pad type as required. This ensures that the paint defects are corrected with the smallest possible amount of paint being removed from the vehicle.

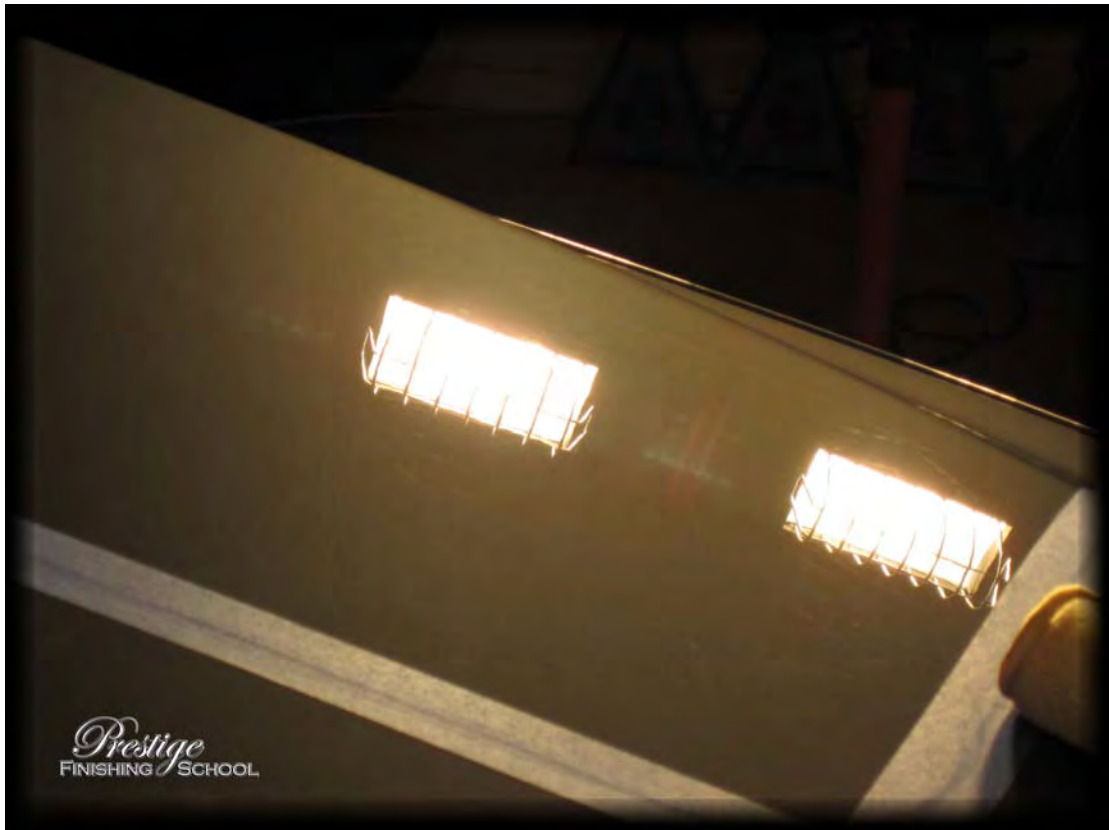
This is the level of correction after a single pass of the Extra Fine Compound. Much improved, but some defects are still evident in the paint.

Once again, we reached for Menzerna “Power Finish” PO85 RD 3.02 on a 3M compounding pad.

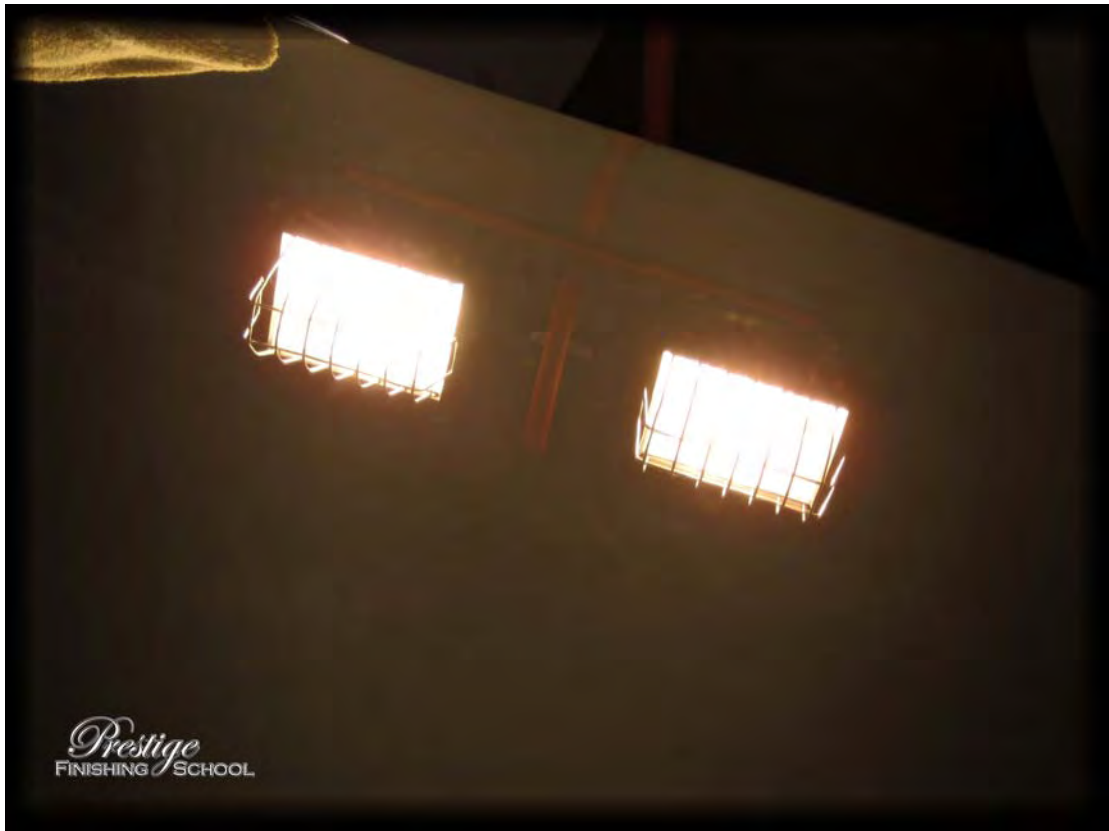
Only a very slight hazing remained in the finish...

...which was subsequently refined with Menzerna RD85 on a 3M finishing pad.

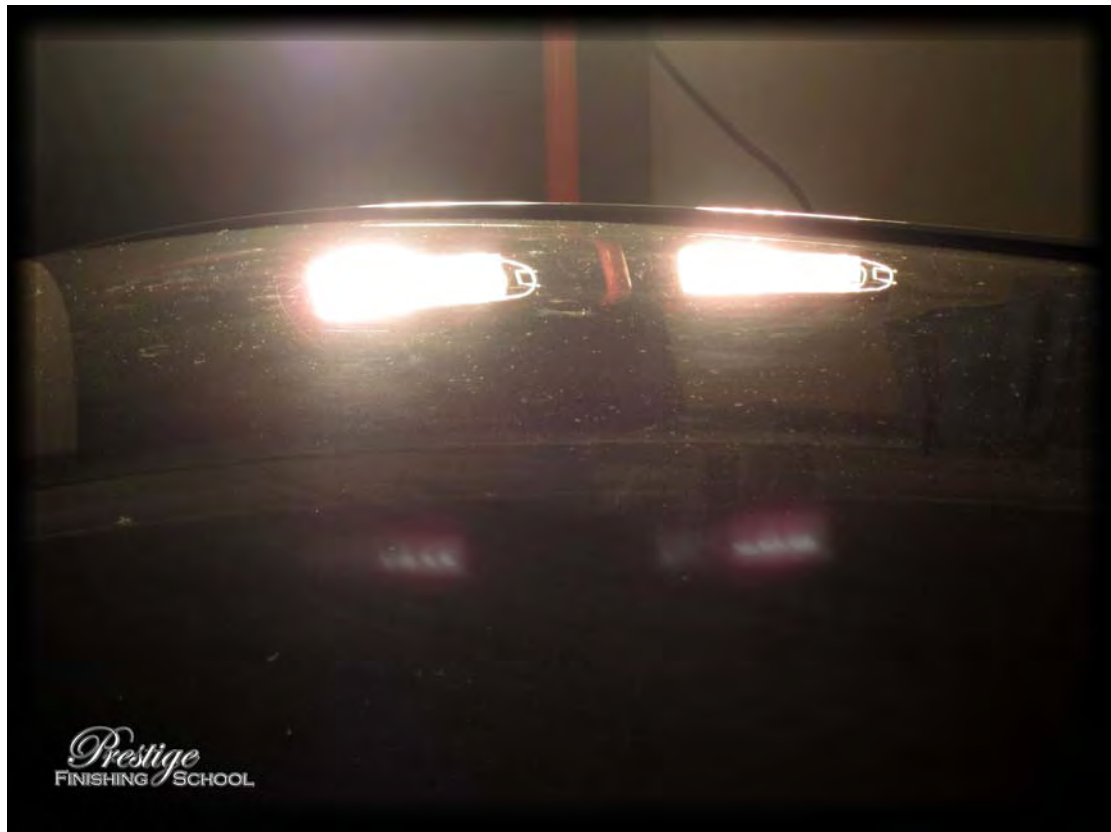
...with slight marring on the surface of the panel.

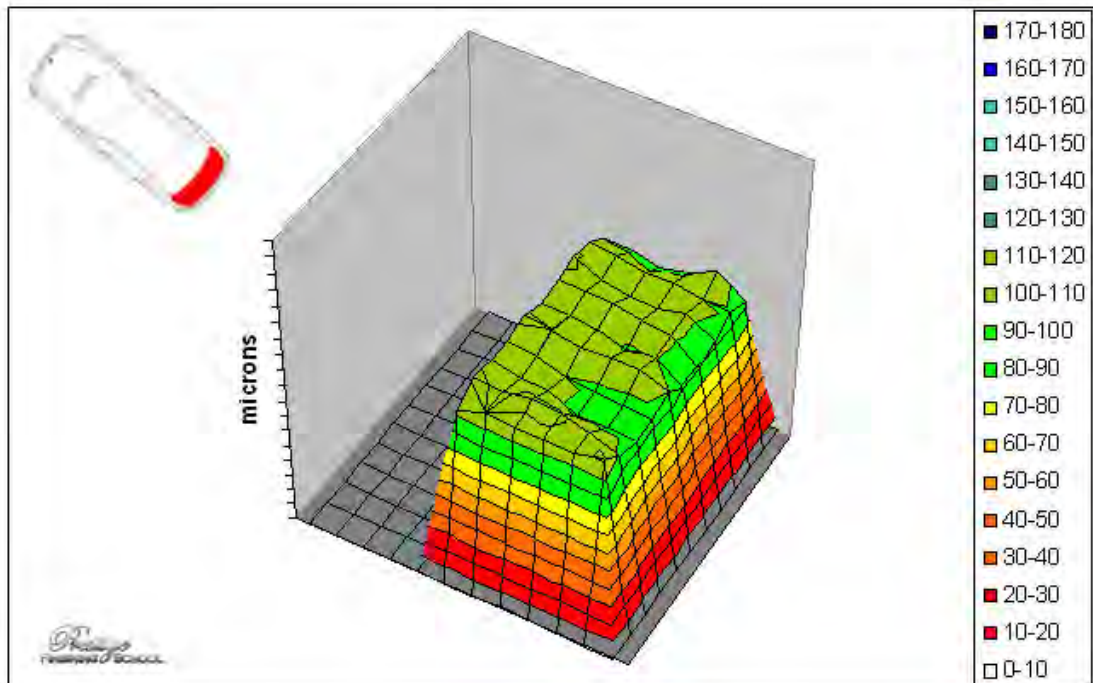
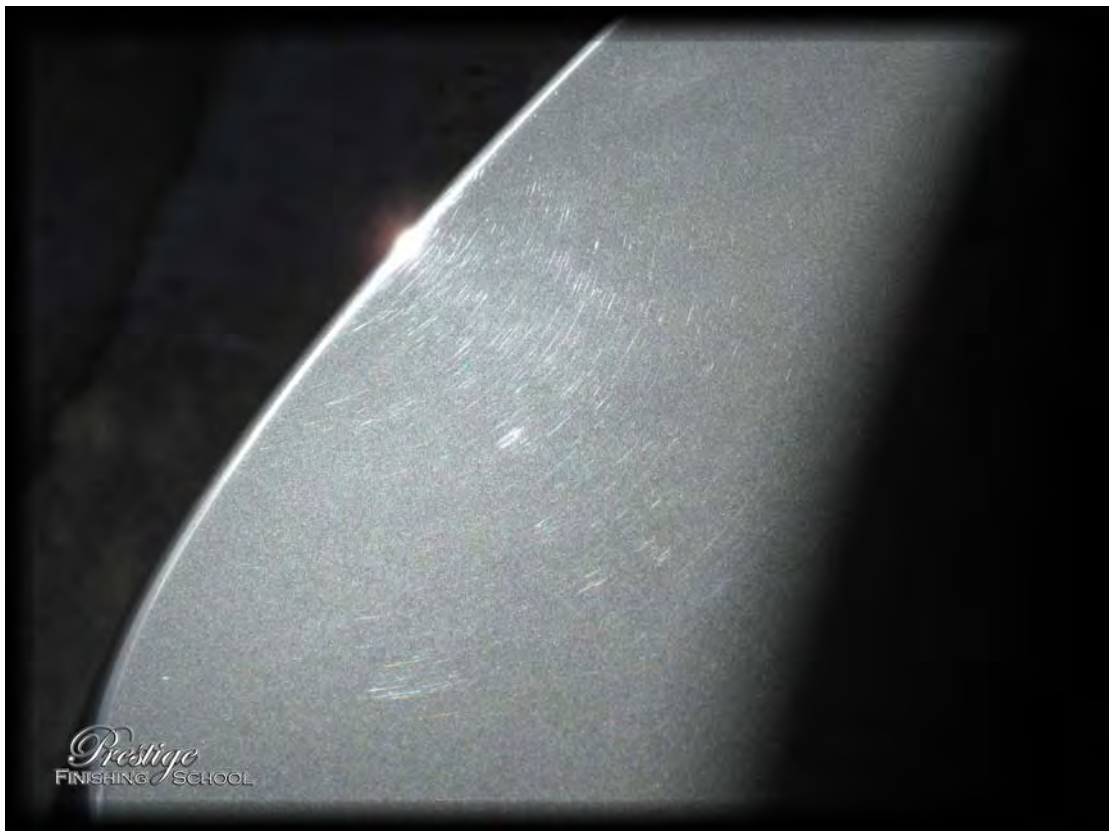
## Boot

The bootlid was a location that was showing signs of swirl marks under sunlight. The paint thickness on this panel was the lowest on the vehicle, but still well within 'safe' working range.

The same corrective process was followed...

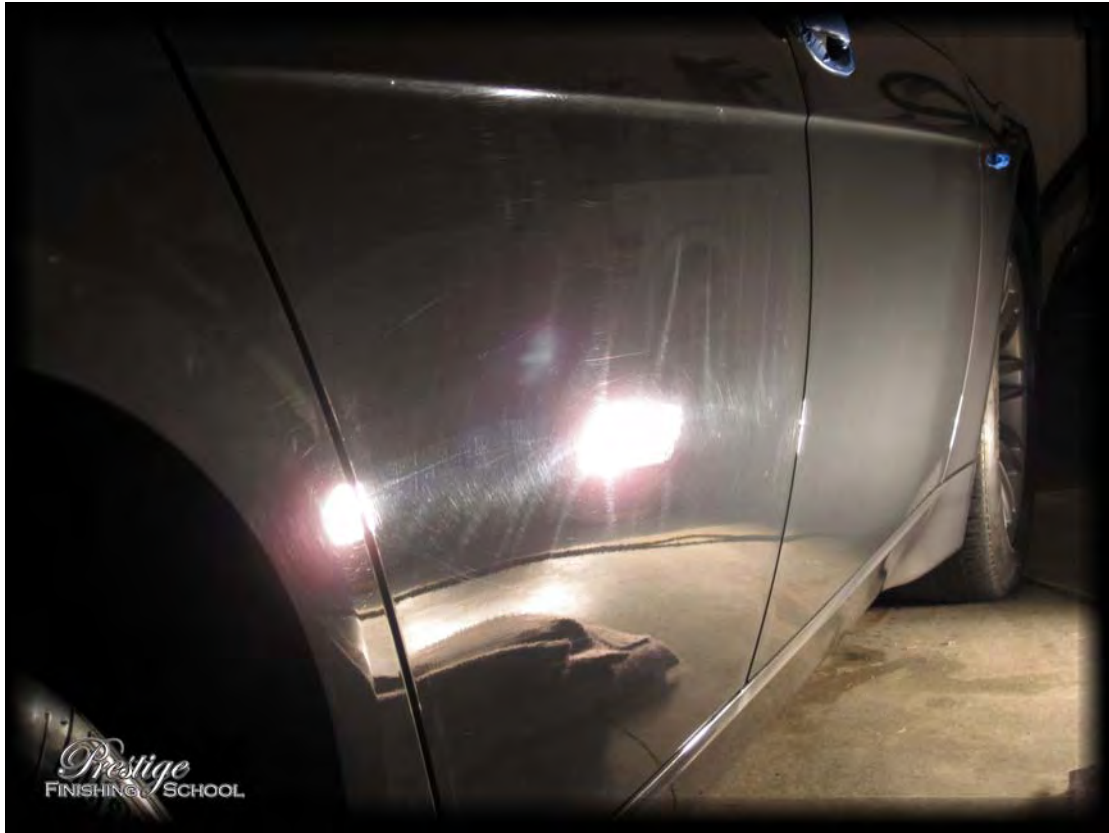
This shot shows the difference between the two right hand doors. The front has been corrected, with the rear showing holograms & buffer trails (likely from previous attempts at machine polishing with poor technique) ...as well as the expected swirls & scratches.

Now with both panels fully corrected:

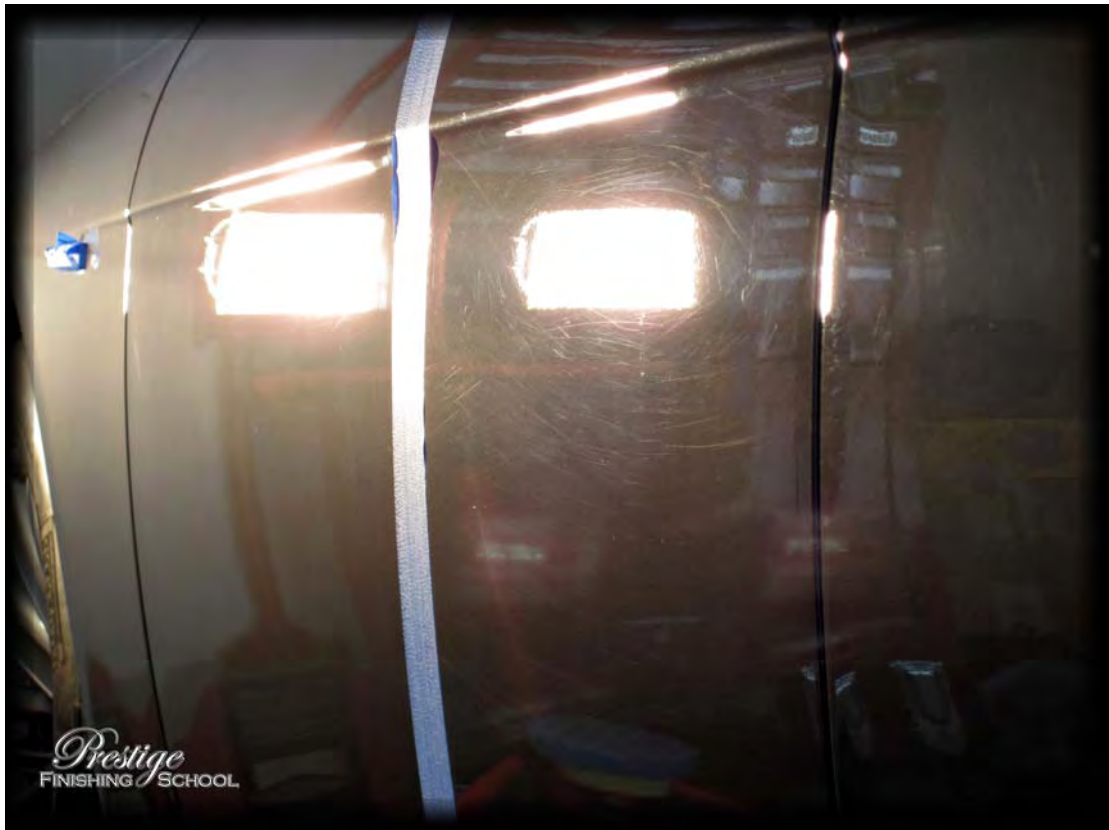
This is a 50:50 shot of the left front door, clearly showing the before and after state of the paint finish on the panel.

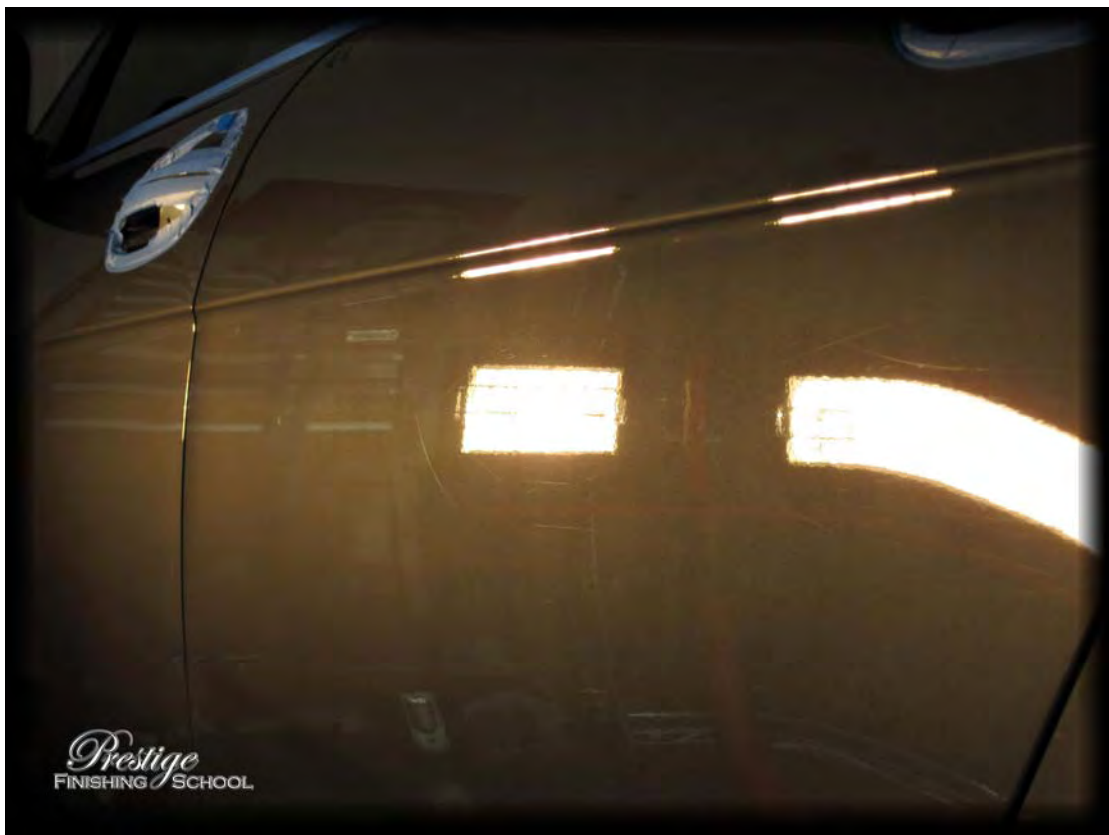
Minor swirl marks clustered around the twin light sources...

Gone!
