**Report Card:**

2008 Porsche Cayenne S (Silver)

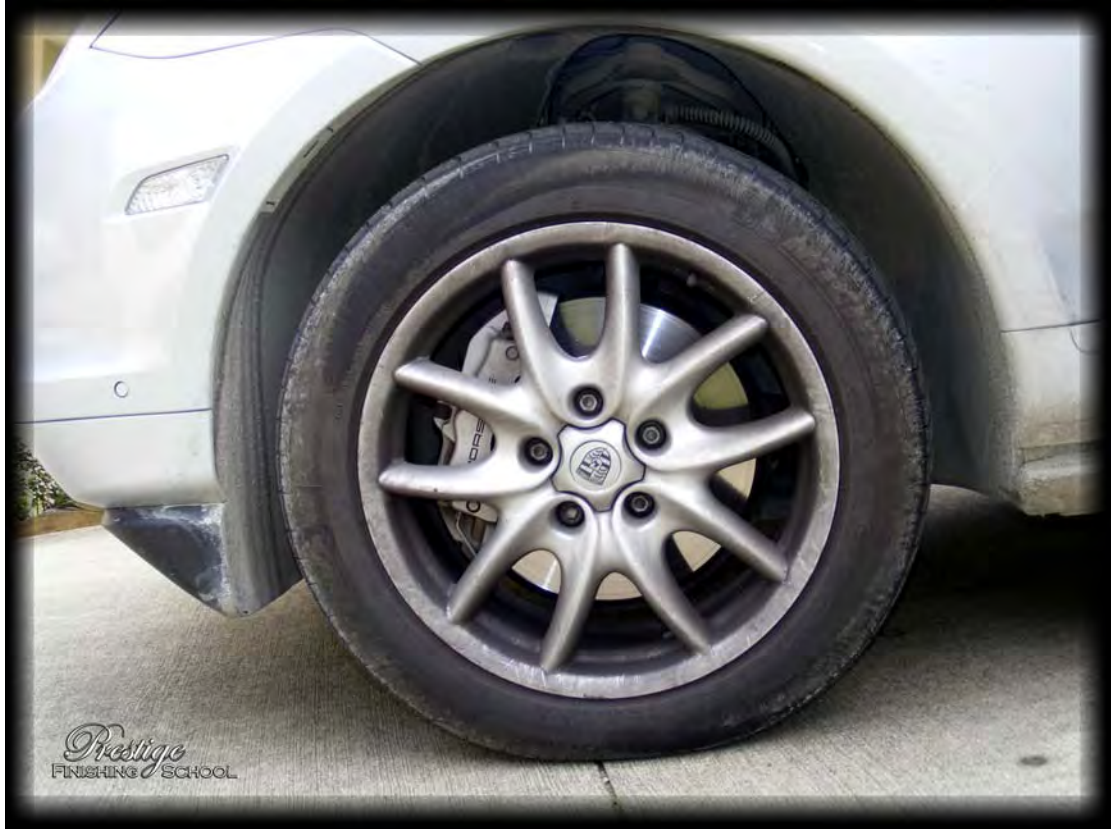
However, it was evident that the miles covered on gravel had resulted in the accumulation of a fair amount of grit in the wheel wells...

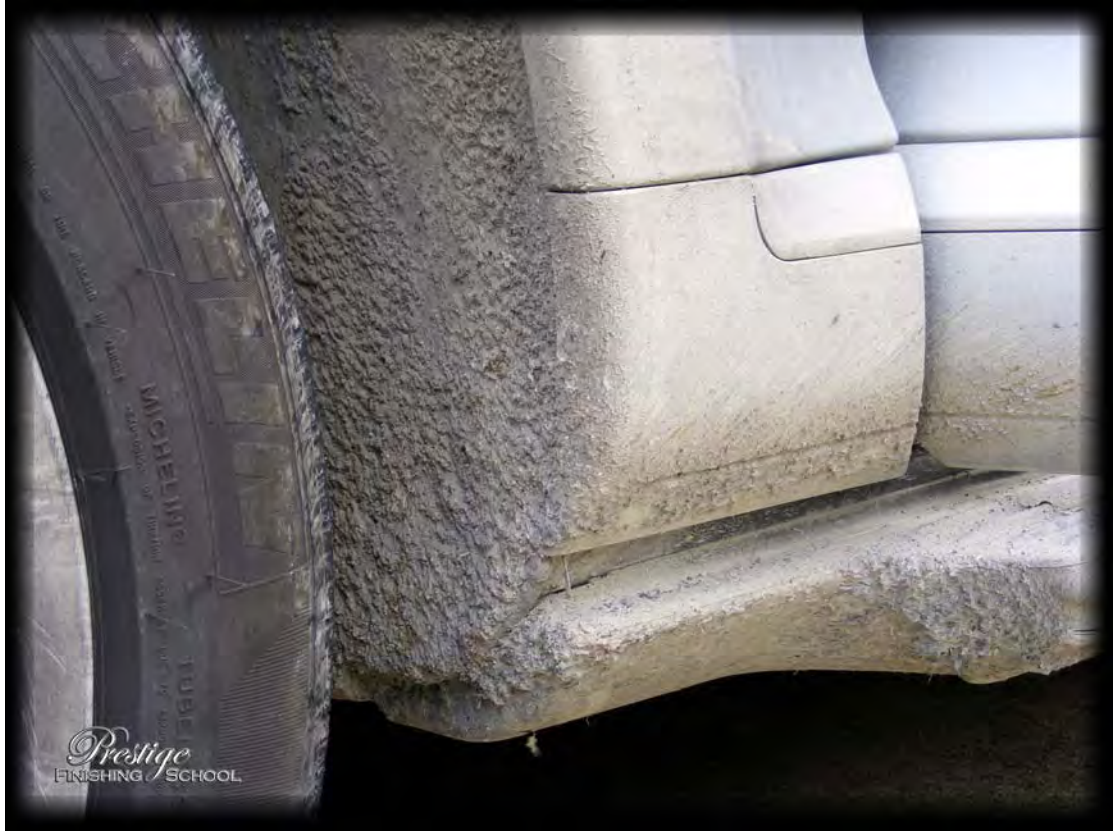
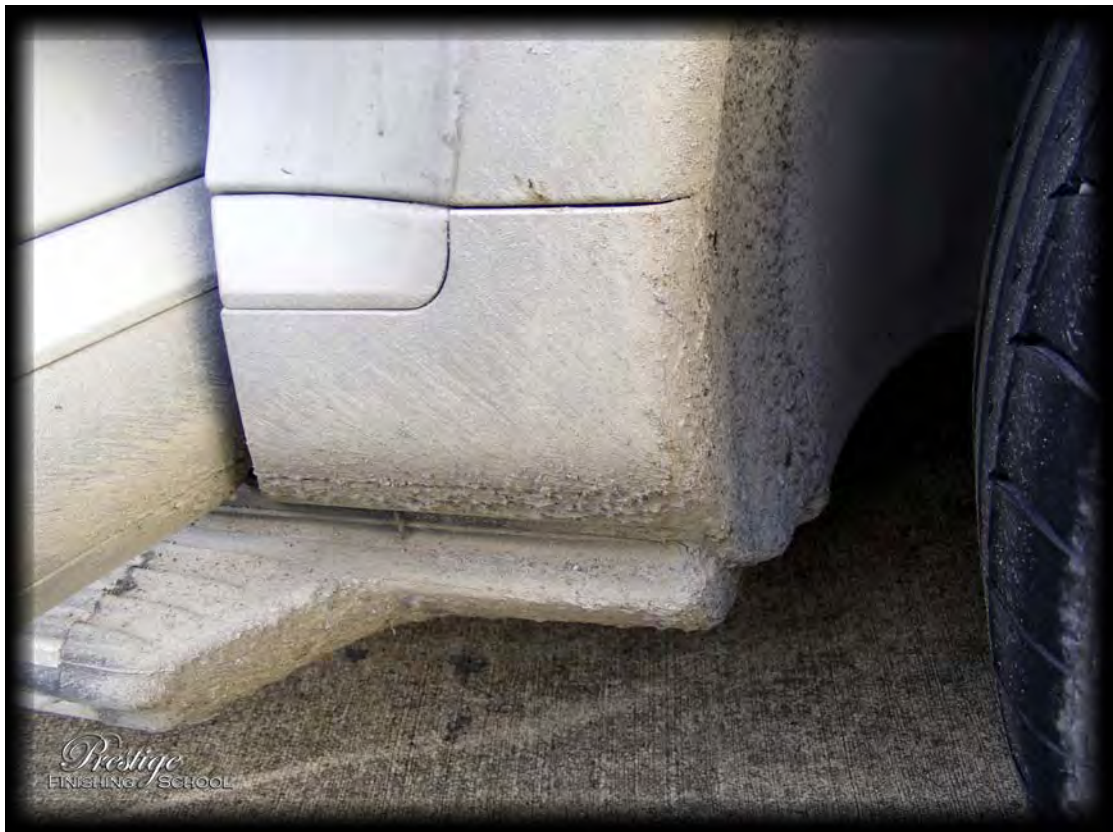
These two shots reveal just how big the job was going to be!

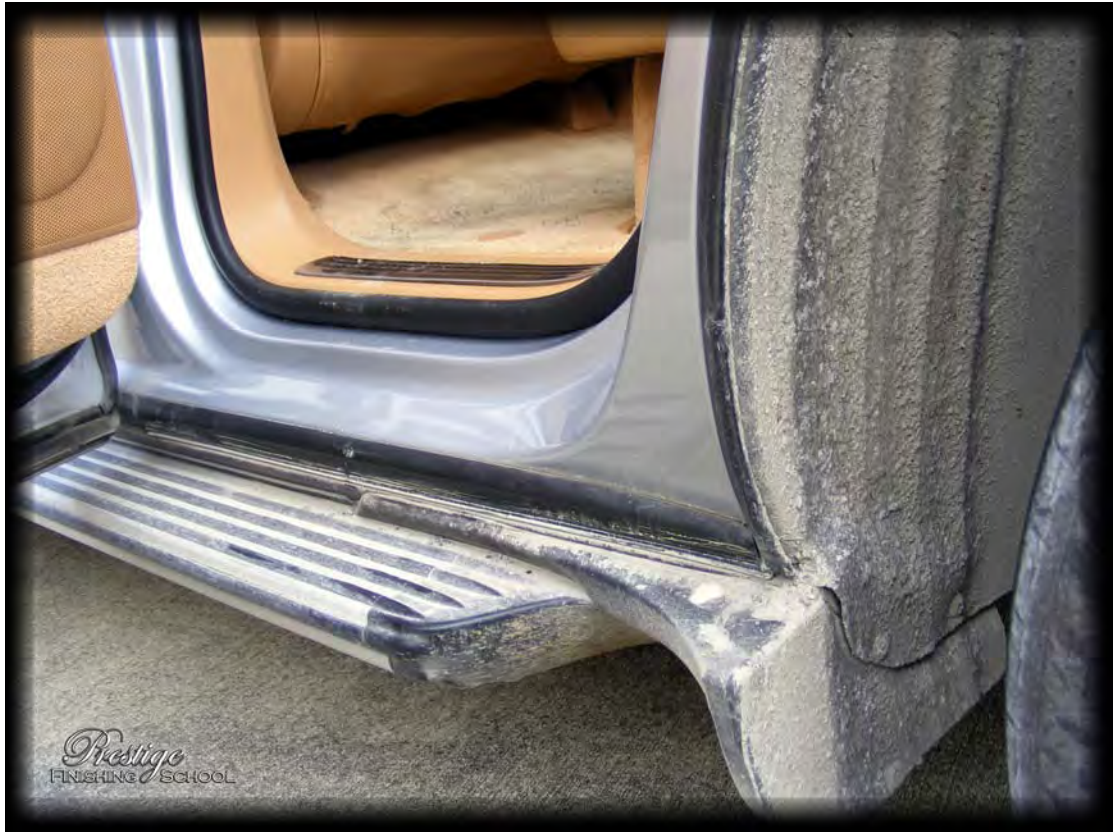
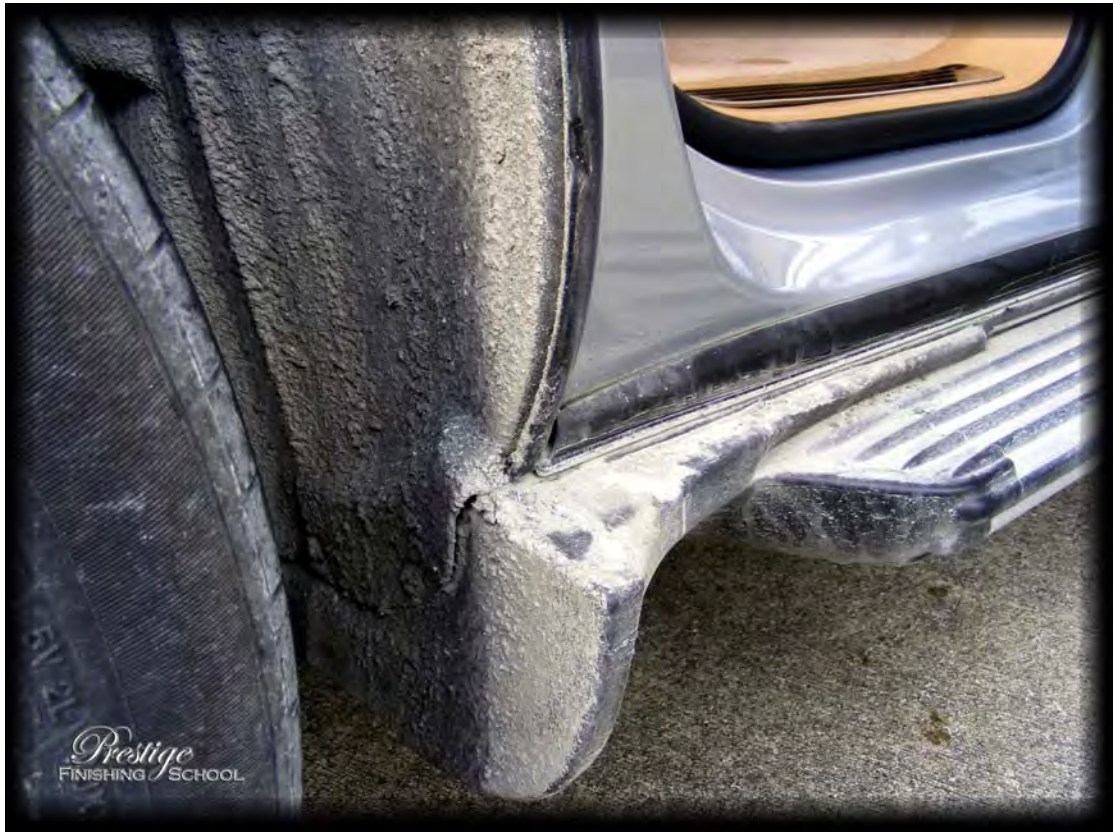
These two pics of the rear arches show the stark contrast between new/clean paint, and the exposure to some of our local 'goat tracks'.

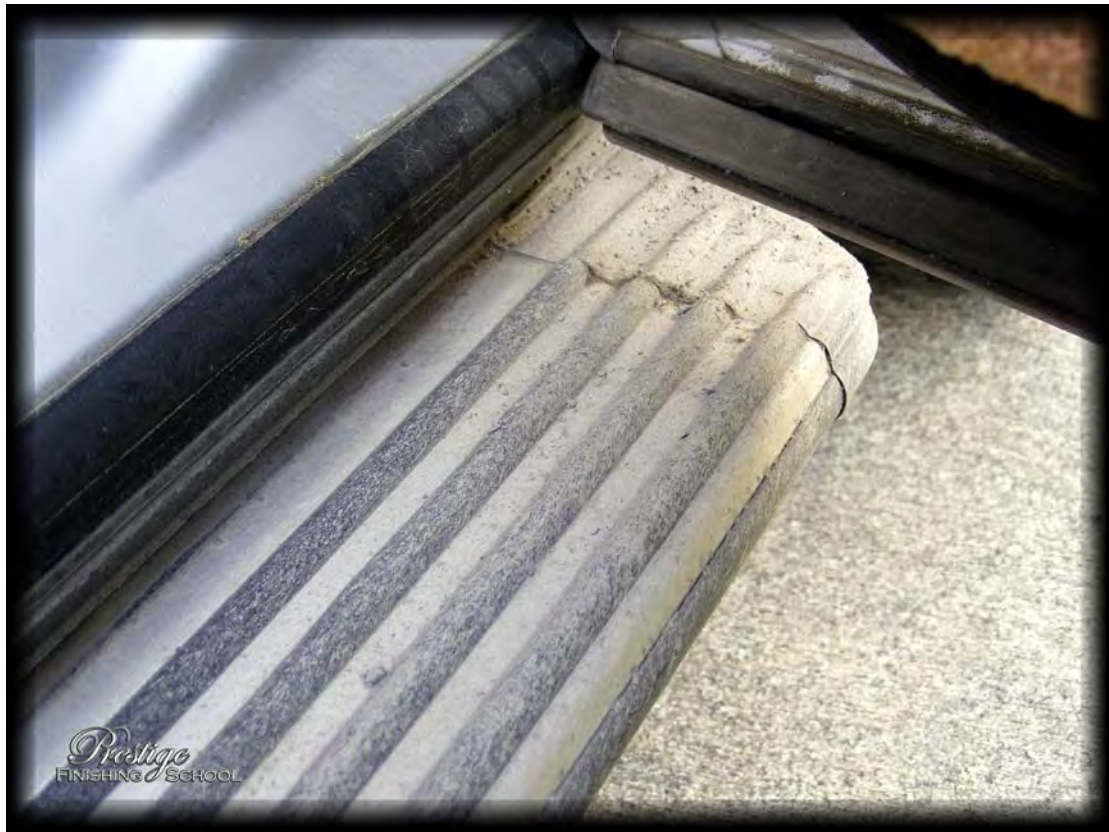
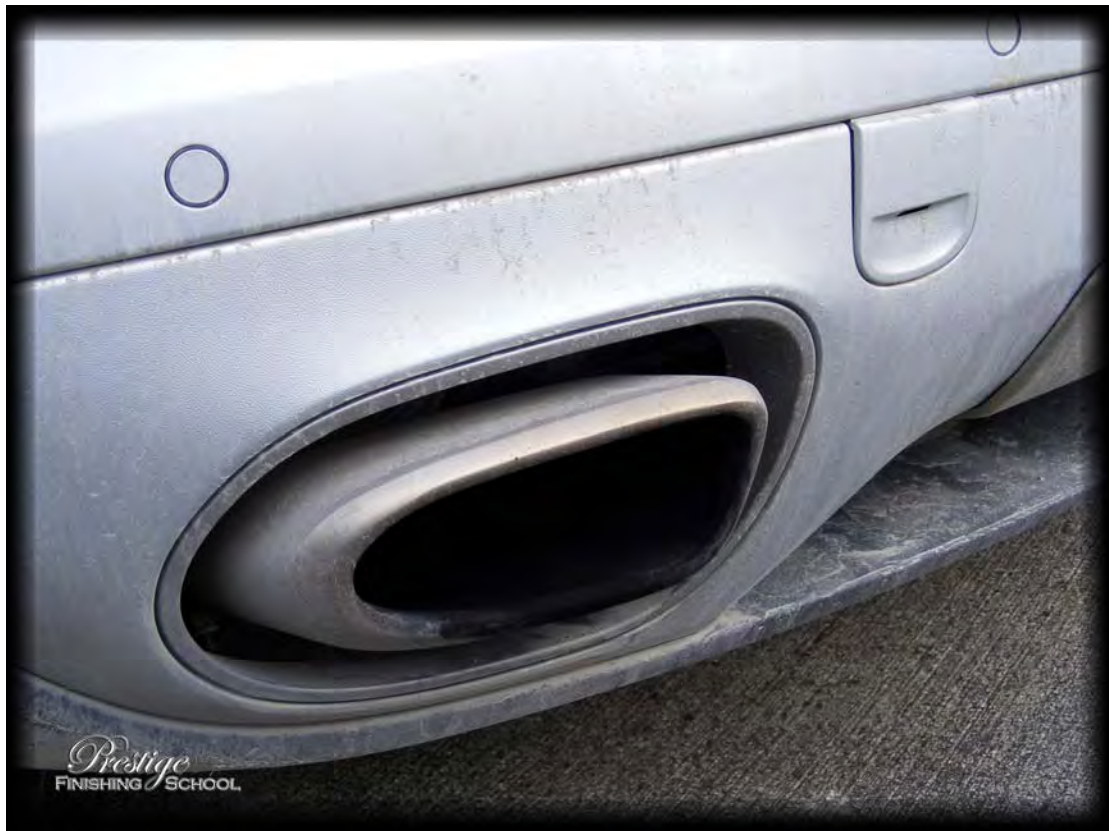
The lower panels and features of the vehicle also showed a decent amount of mud and general grime.

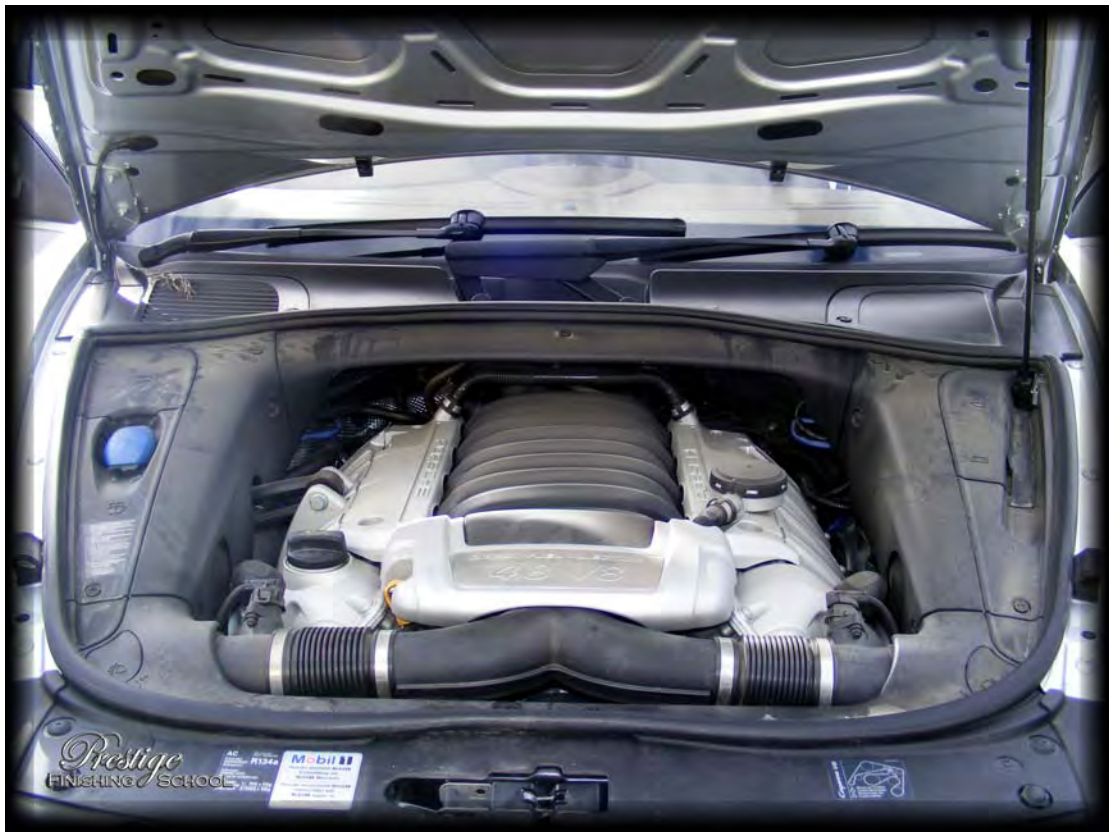
The German powerplant was certainly showing evidence of having powered the vehicle along many miles of very dusty roads:

...and the entire engine bay given a thorough going over with Meguiars All Purpose Cleanser, and "Slide-Lock Detailing Brush".

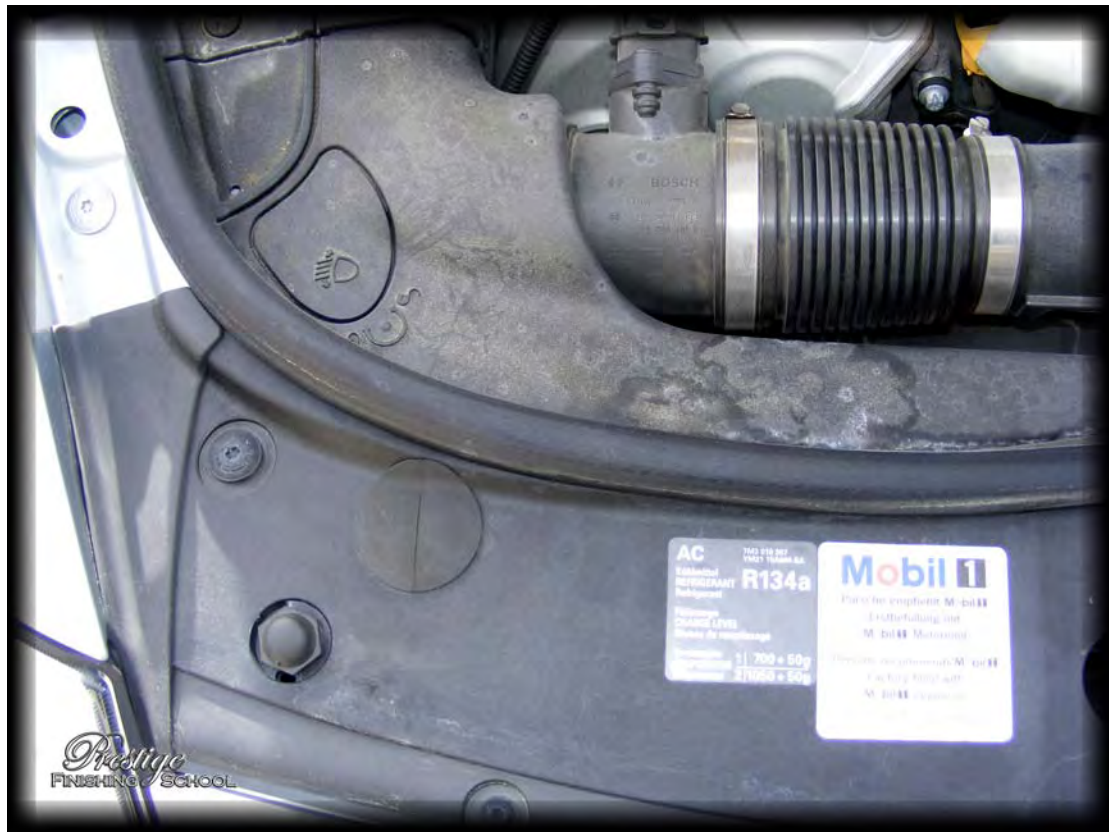
With some evidence of chemical spills staining the plastics:

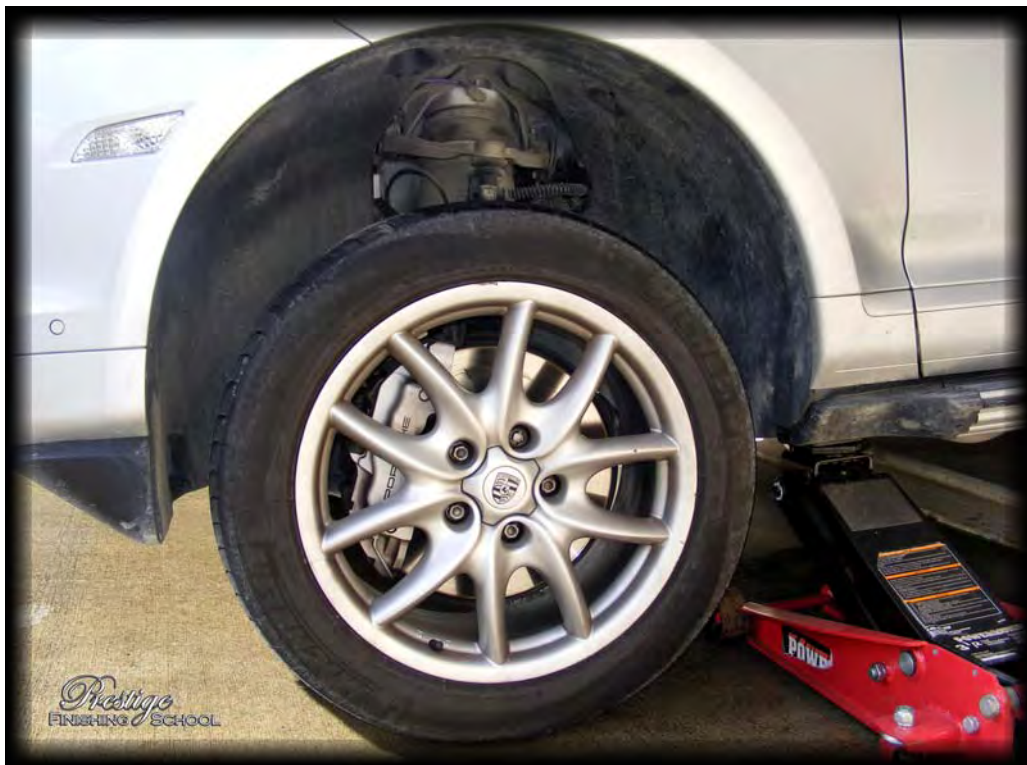
...and left us with this to take care of:

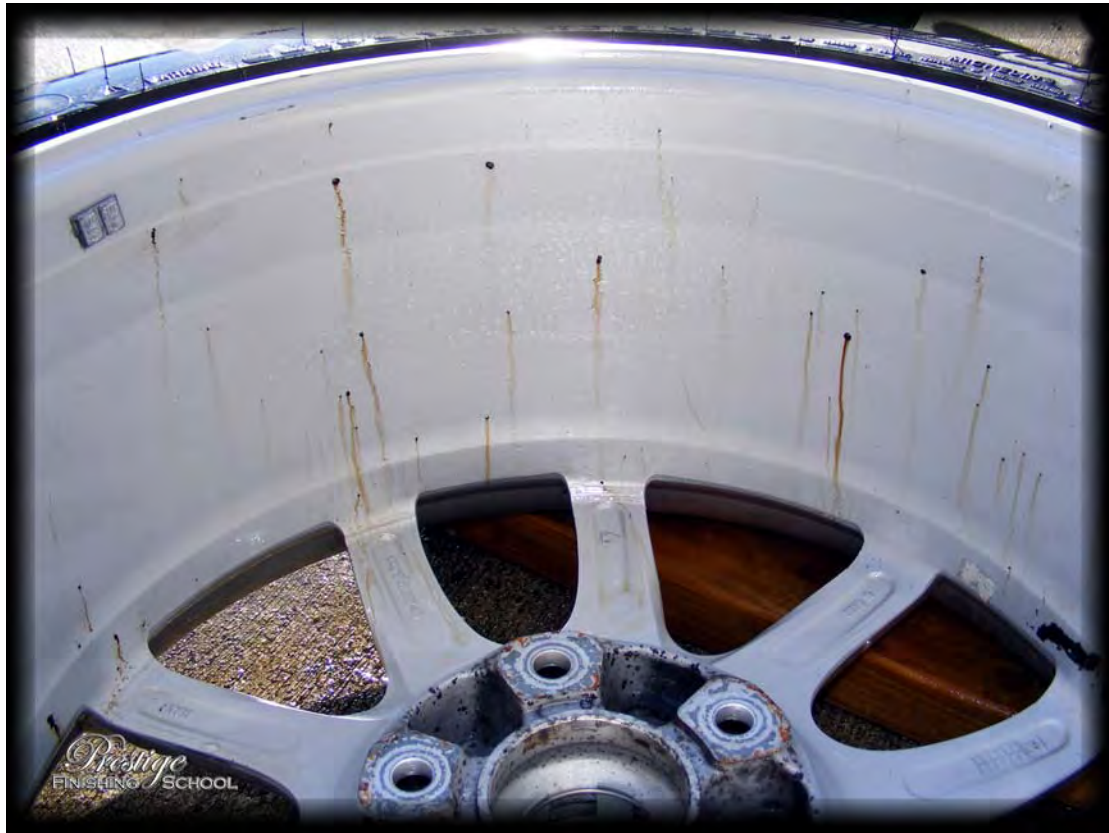
The wheels were left with some spots of tar, as well as glue residue from earlier wheel balancing weights. They were sprayed with our trusty tar removal solution and left for 30seconds. This lets the product completely dissolve the tar and glue...

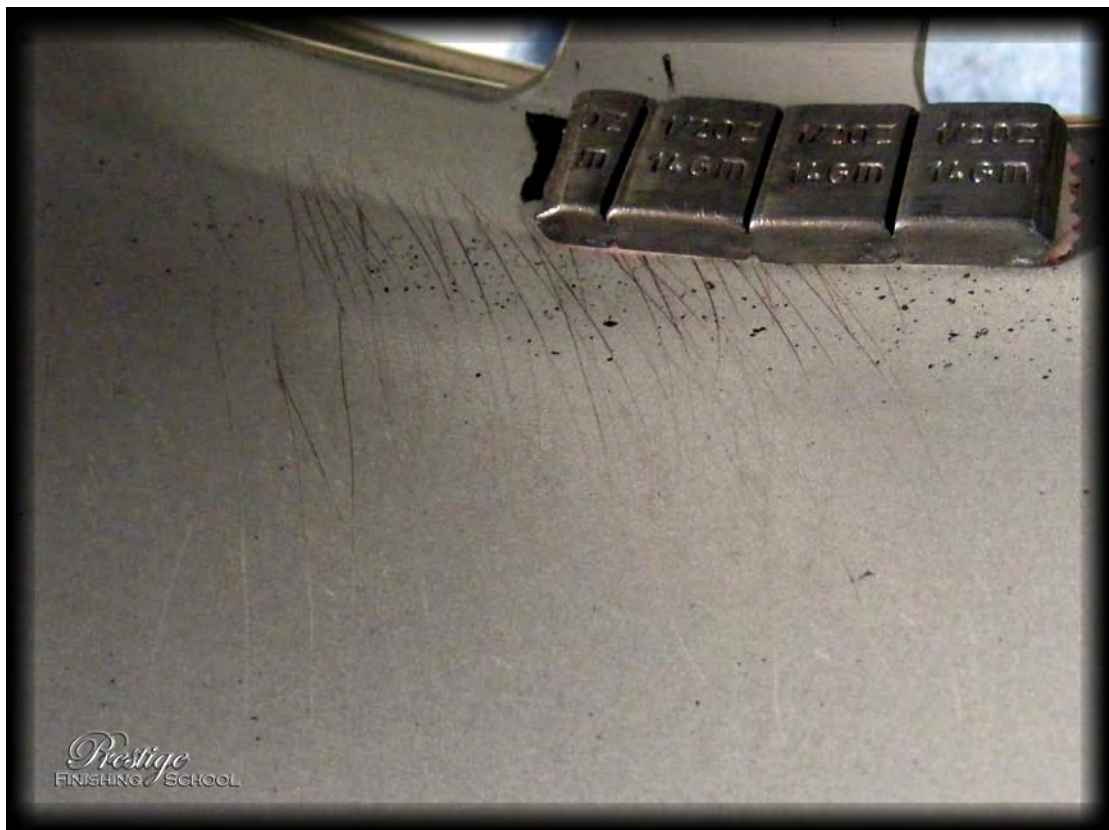
Though, it is hugely disappointing to see this kind of damage that must have been inflicted during the vehicle's first ever tyre change...

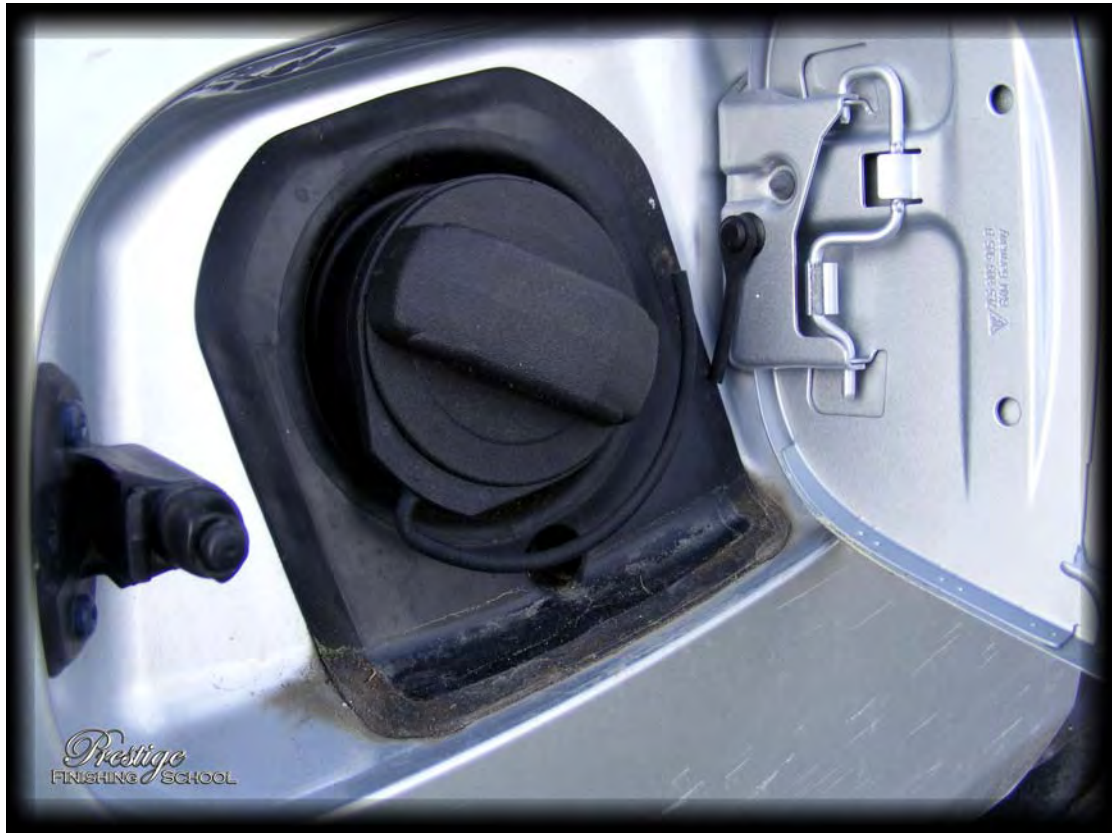
The petrol filler cap had a small buildup of dirt:

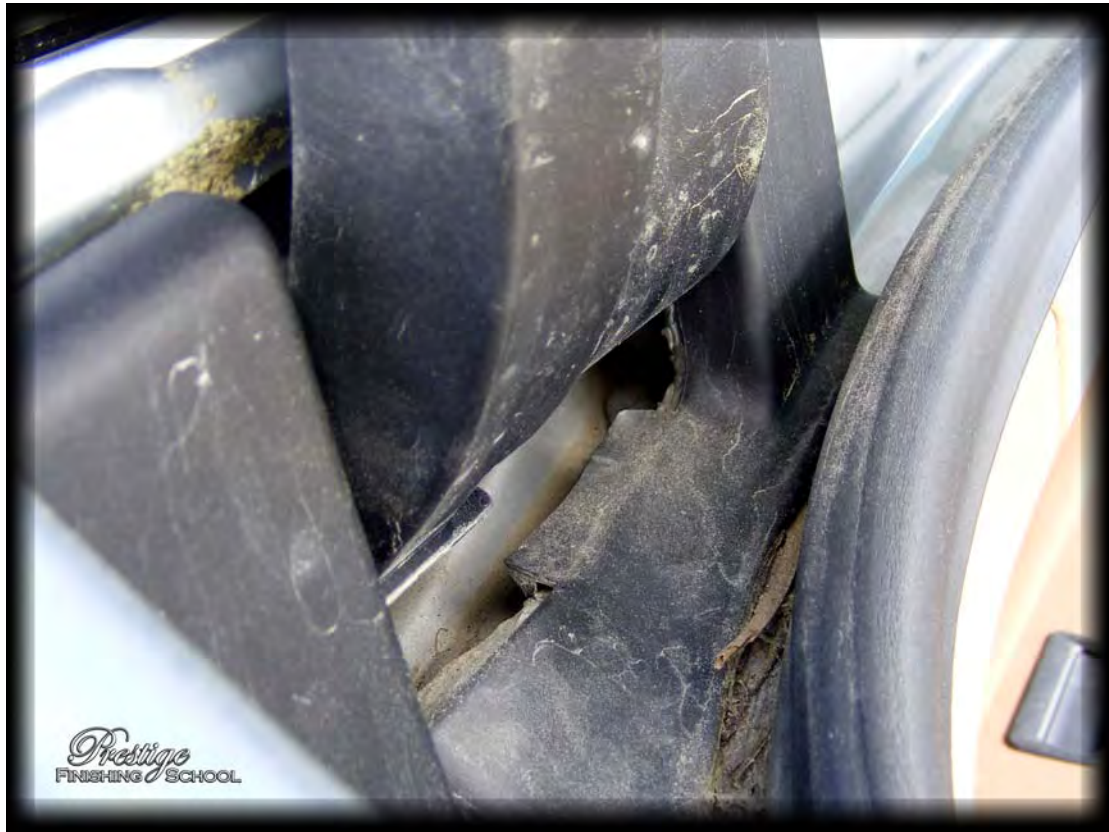
The hinges on the tailgate were also showing signs of neglect.

Nooks and crannies such as these are often missed in 'regular' washes, and can end up with years of dirt building up.

Again, these spots were addressed with Meguiars APC and a soft brush...

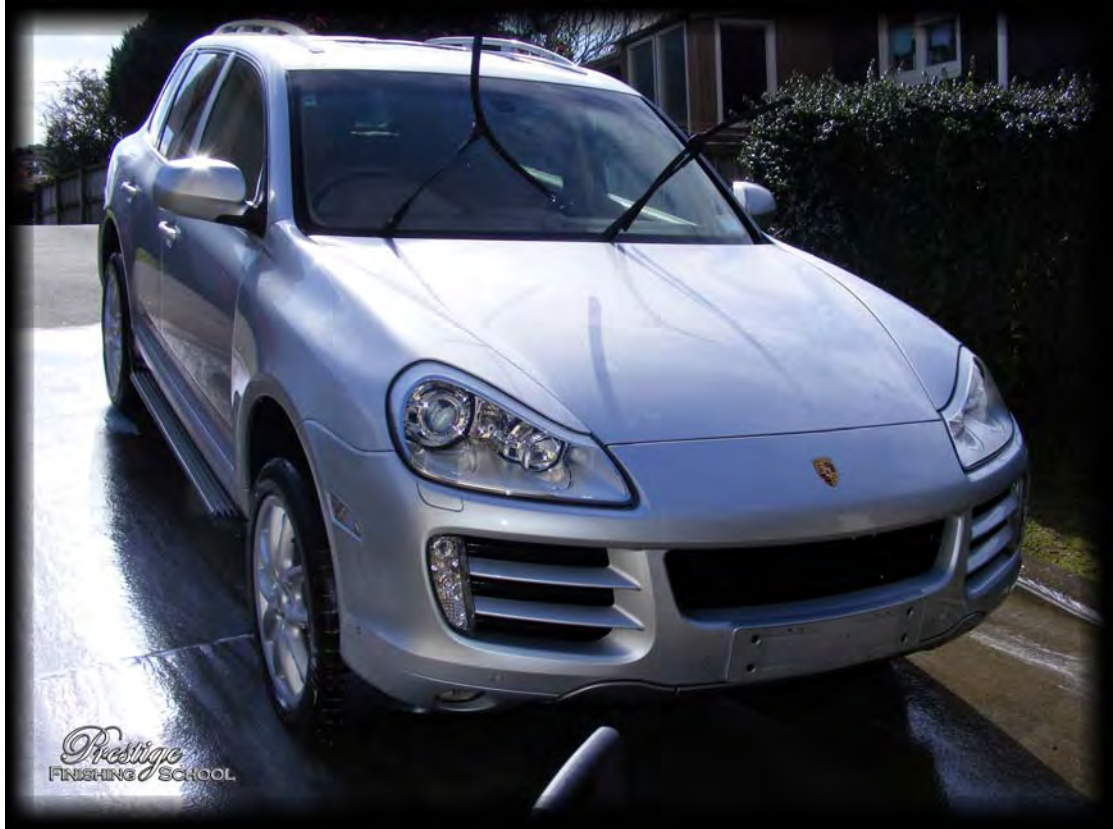
...and then rinsed off.

This was followed up with a second treatment, this time comprising Meguiars Hyperwash Shampoo.

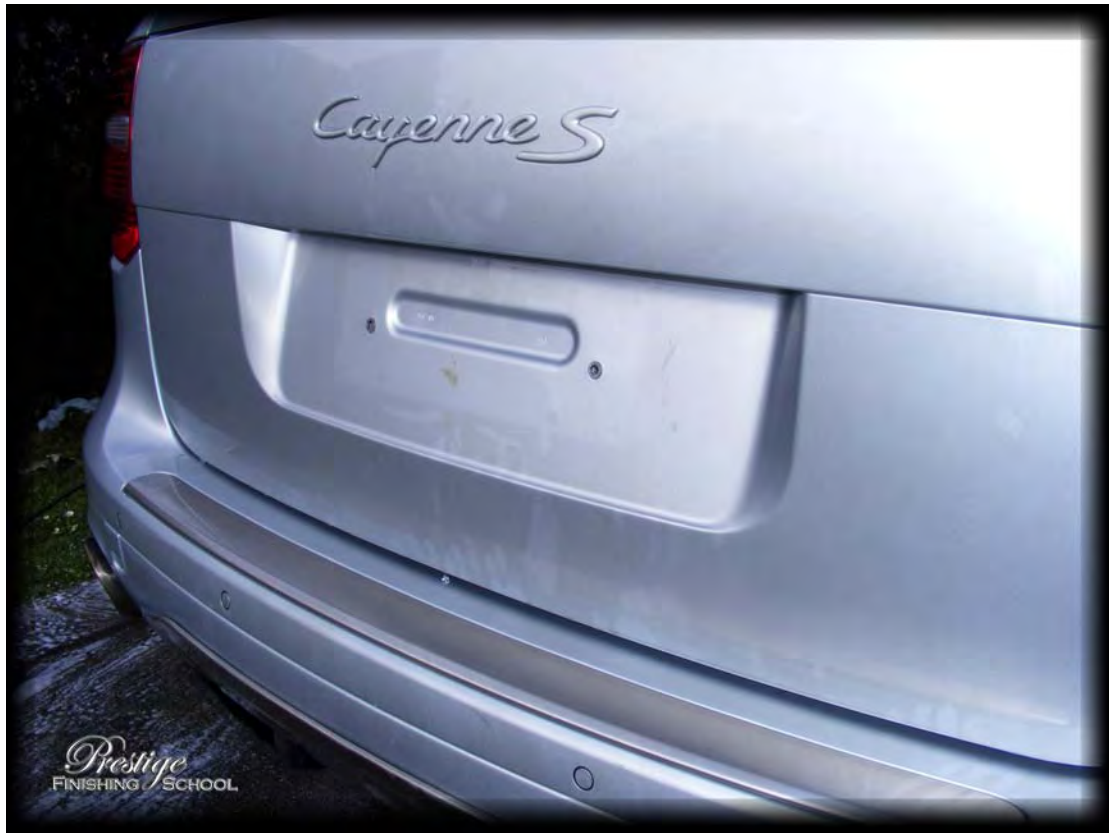
The vehicle was again rinsed clean of the foam with a pressure washer, and was already looking much more respectable. Only the finest film of dirt remained on the painted surfaces, thus greatly reducing the risk of marring the paint during the contact wash process.

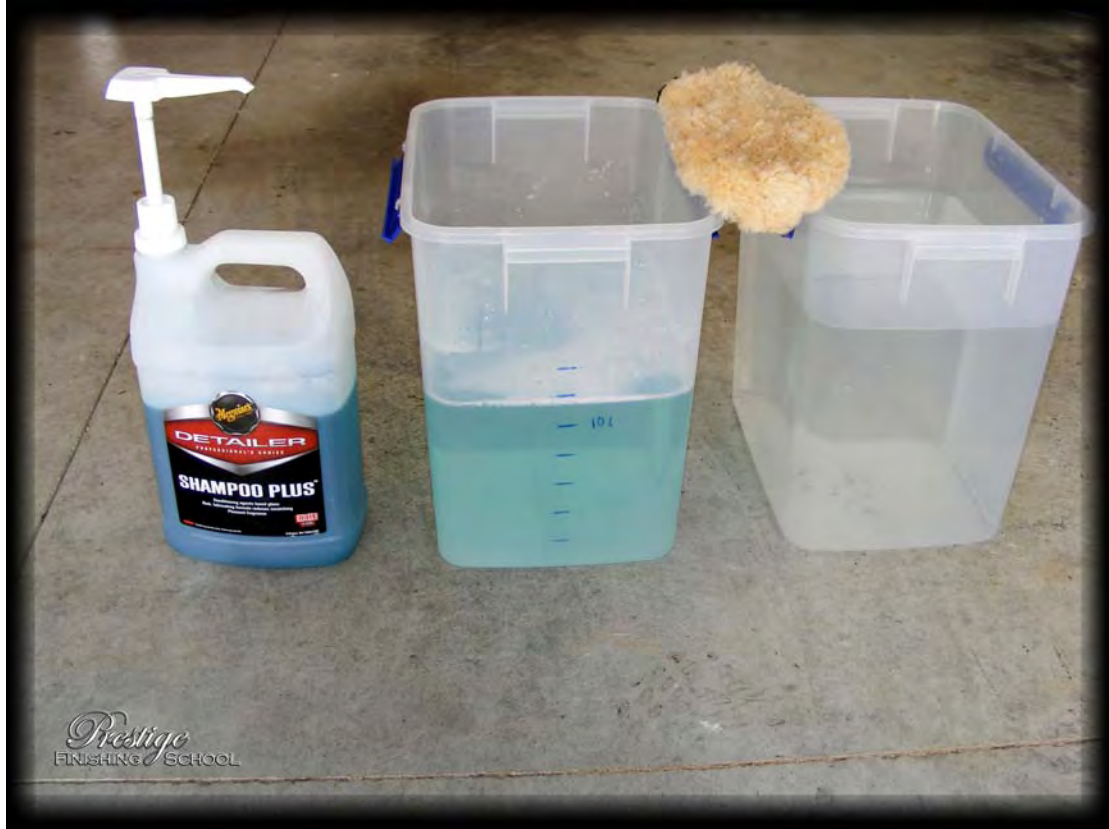
With as much dirt as possible removed from the vehicle without direct contact, it was time to complete the wash process with a hand wash via a Lambswool Mitt and Meguiars Shampoo Plus.

A lambswool (or microfibre) mitt should always be used for ‘contact’ washing of a vehicle’s painted surfaces. Particles of grit and dirt on the paint are the **primary** cause of swirls on modern vehicles with clear ‘coat paint’. Regular sponges cause the grit to be trapped against the surface of the paint and dragged across it. (Even worse still are the brushes at self-service or automatic carwashes.) The plush mitt however will draw the dirt away from the paint surface, deep into the fibers of the wool, thus preventing it from inflicting further damage.

Also notice the separate buckets for ‘wash’ and ‘rinse’ action. This is the safest and most effective way to clean a vehicle’s paint. The Mitt is soaked in the 60° C Shampoo Plus solution which has a “*Low-Suds / High-Lubricity*” formula and then worked over the vehicle. After each panel, the Mitt is cleaned off in the ‘rinse’ bucket, dislodging any dirt picked up off the car, before being re-soaked in the shampoo.

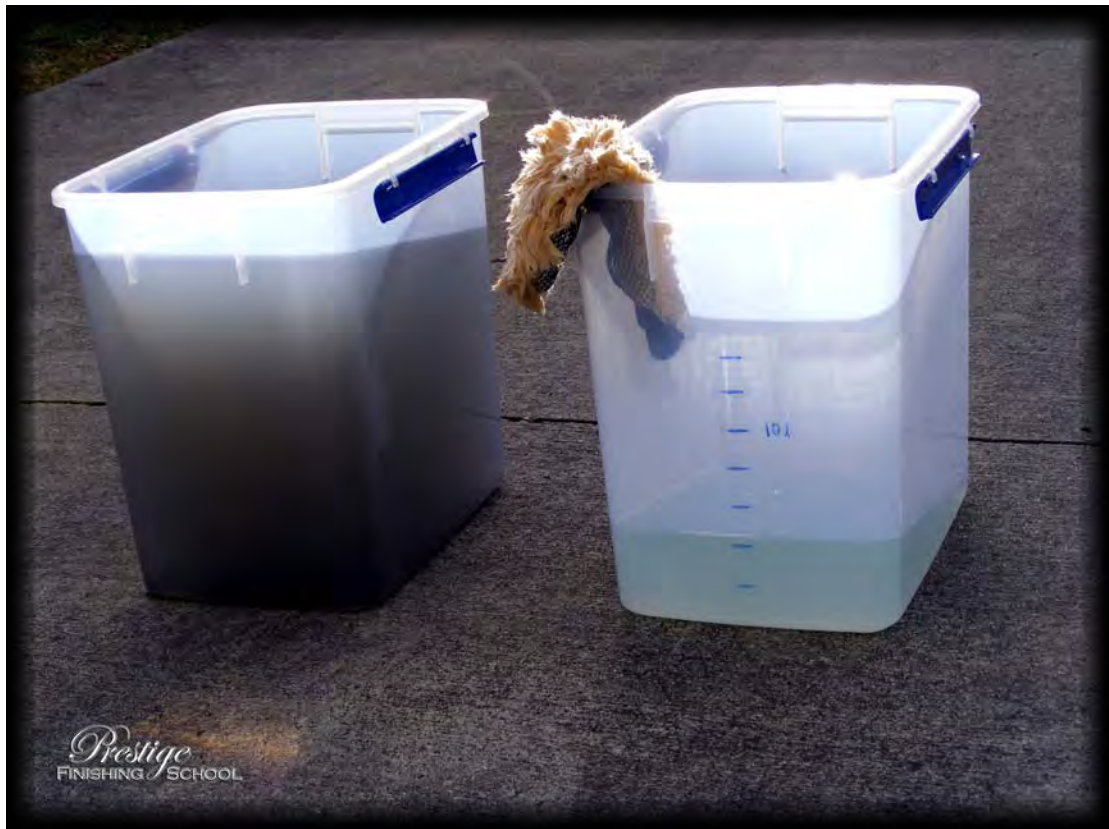
If you consider the use of two buckets 'overkill', consider the state of the rinse bucket after completing the wash:

Would you consider wiping your car with anything soaked in the left bucket?

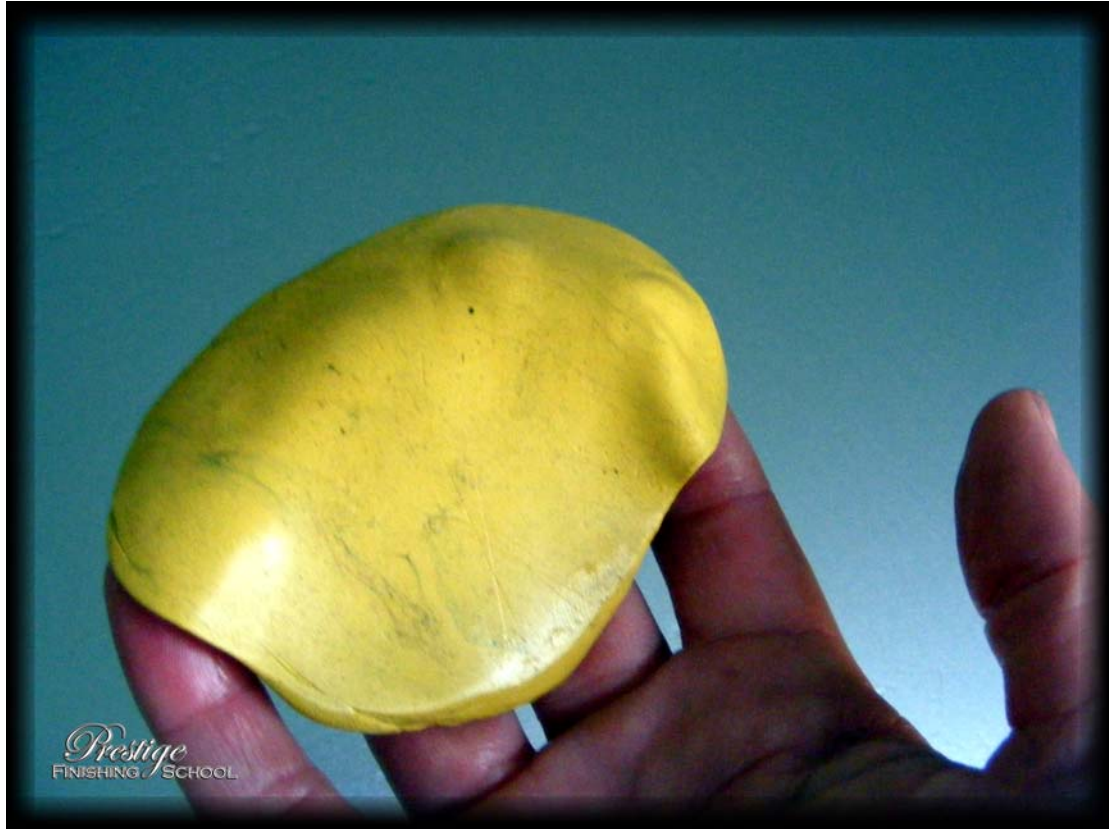
The final step in ensuring a perfectly clean paint surface is the removal of bonded contaminants with a detailing clay bar. This can include tar spots, tree sap or industrial fallout, all of which contribute to making the paint surface rough to the touch and dull to look at. In this instance, a Meguiars 'Mild Professional Detailing Clay' bar was used with Meguiars Last Touch (diluted 1:1) as lubrication.

Very little contamination was removed from the vehicle, with the above picture being representative of the amount of bonded material on each panel.

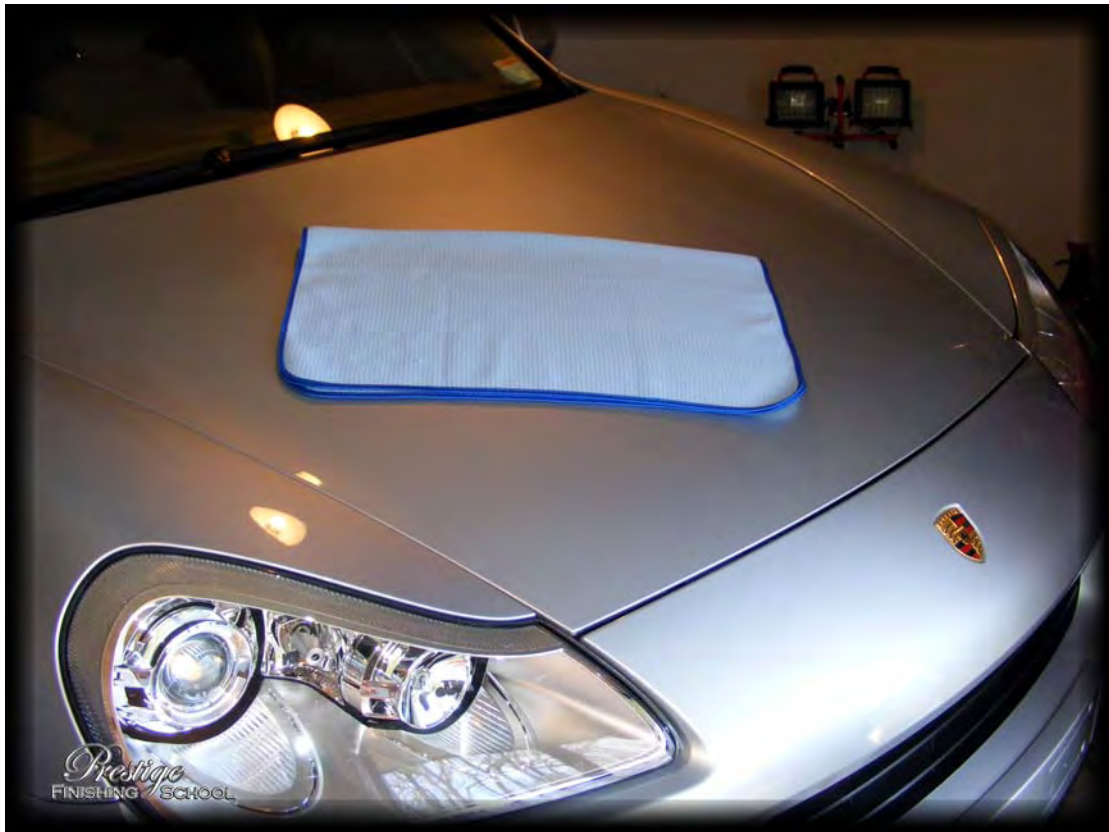
The vehicle was then given a final rinse off with the pressure washer and then patted dry with a Sonus Der Wonder Microfibre Drying Towel.

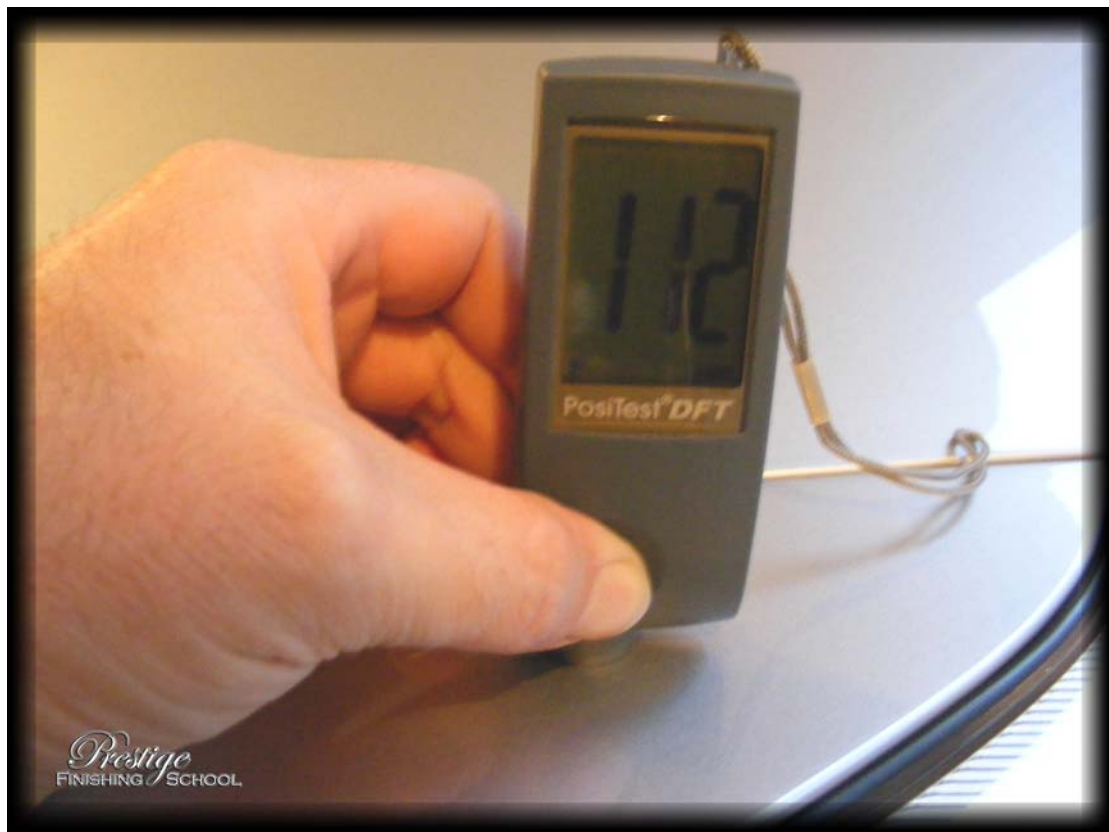
Across the majority of the Cayenne, paint levels were showing consistently healthy readings:

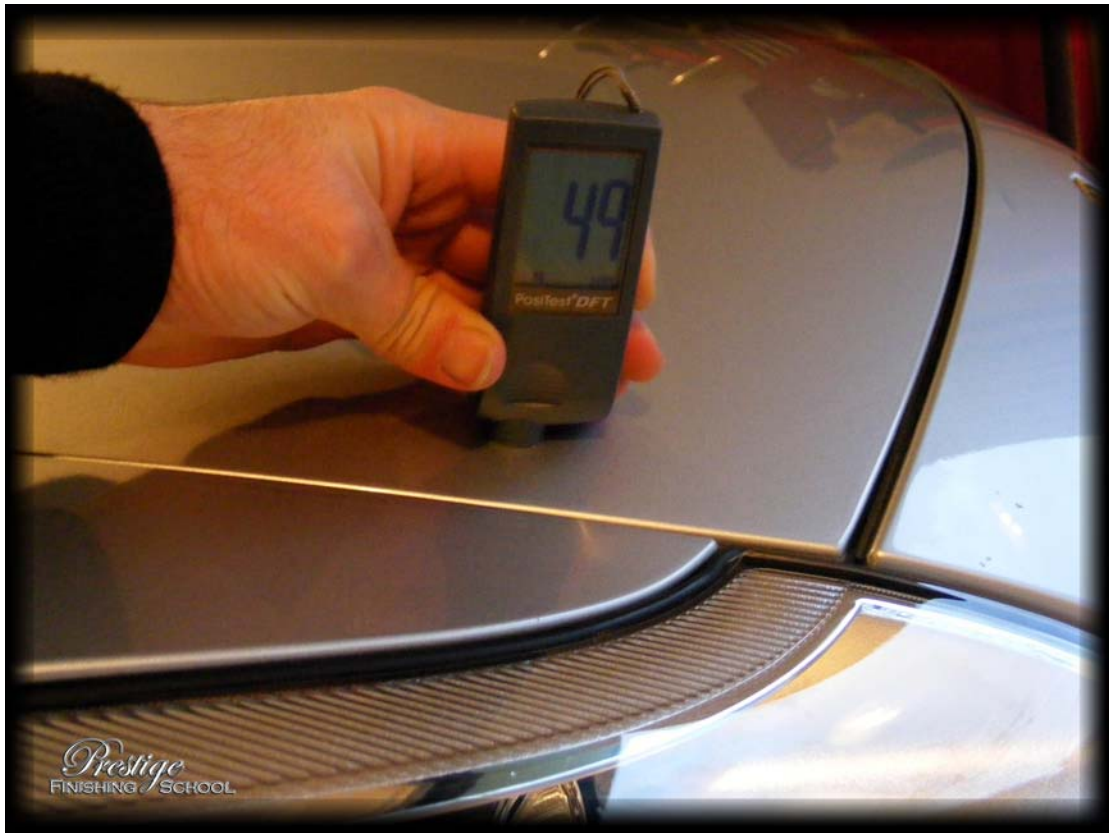
However, on the aluminium bonnet, there was a significantly thinner application of paint, with some areas reading as low as  $45\mu\text{m}$ . That's roughly the thickness of a very thin human hair! (And bear in mind, that reading comprises a layer of primer and a layer of colour, as well as the clear.)

Undertaking any corrective action on this level of paint with aggressive compounds or polishes would run a significant risk of “striking through” the protective clear coat altogether. Such a misstep would necessitate a complete re-spray of the panel, so we always check every panel before, during and after any of our details.
