**Report Card:**

2008 Porsche Cayenne S (Silver)

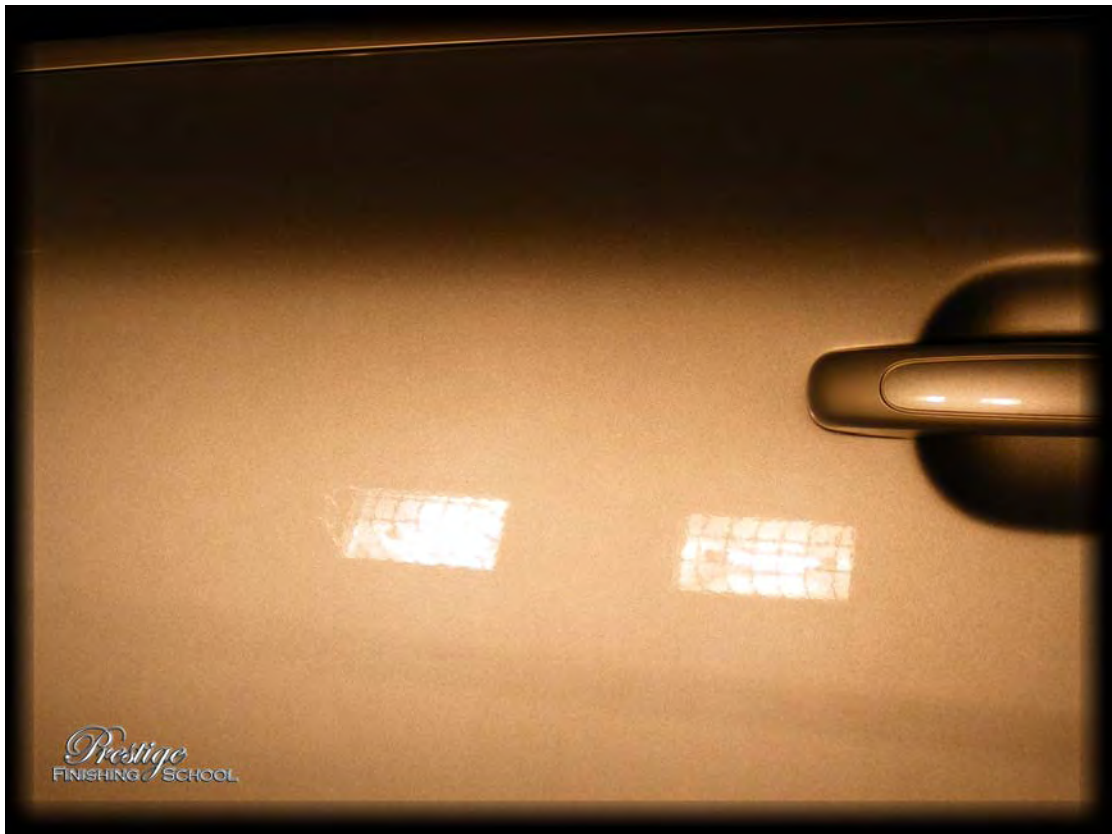
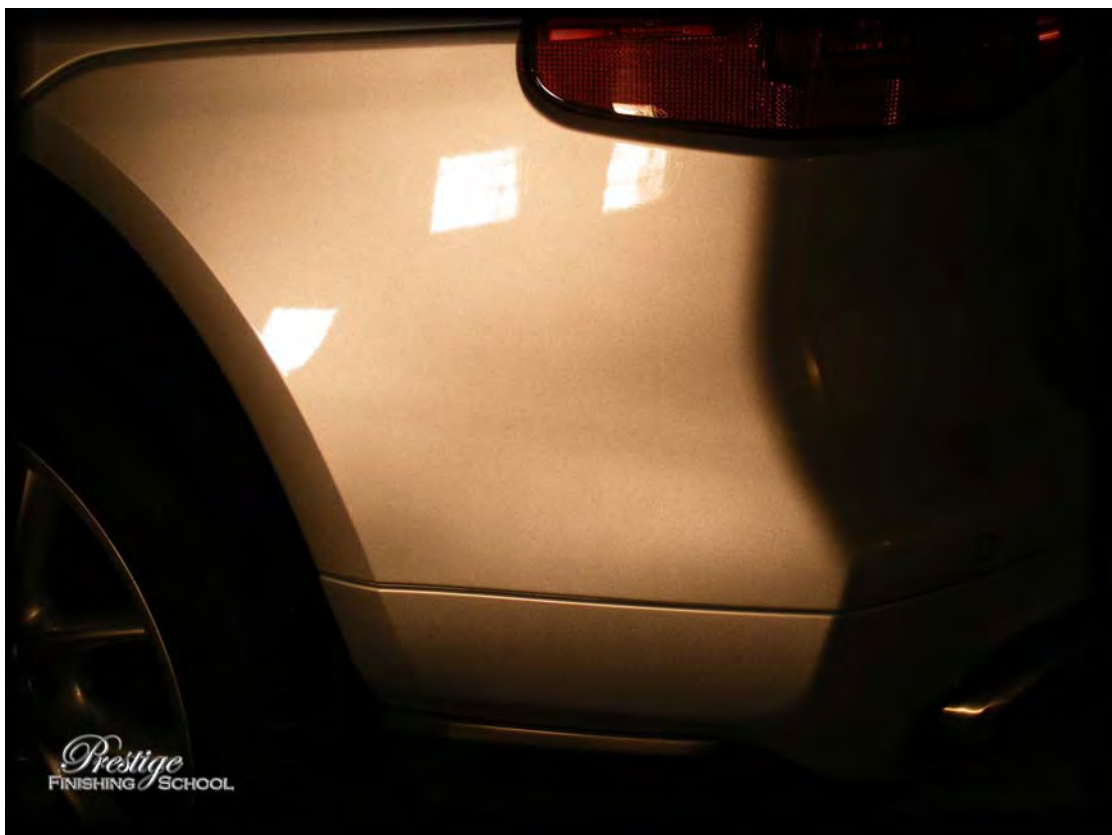
And, the paint was in great shape, with no evidence of swirling or scratches

Only a very small amount of mico-marring could be seen on close inspection.

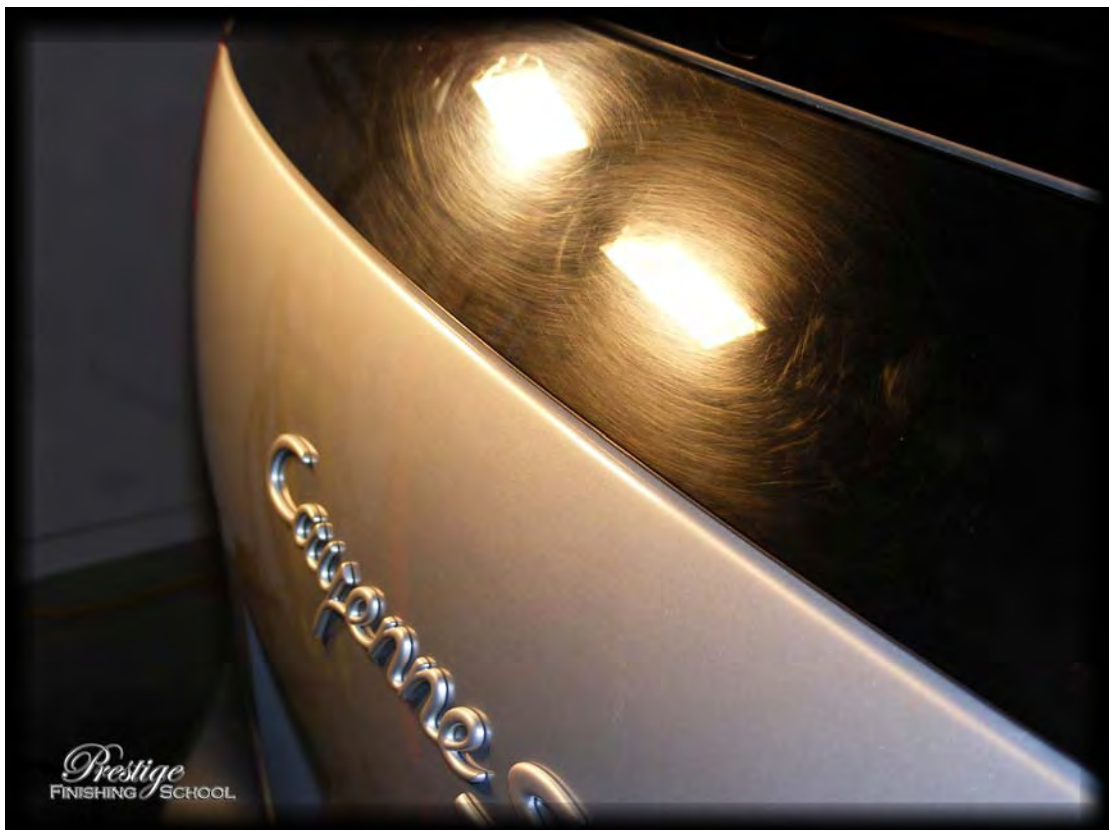
There were two areas of concern, both on the vehicle's boot. Here, severe swirling of the trim just below the rear window:

The machine is fitted out with a 3M rotary backing plate and 3M polishing pad. Given the German subject, we opted for Menzerna polishes – starting off with the least aggressive 85RD

We corrected half the section at a time – this shot shows the dramatic reduction in swirl marks and increase in clarity on the right. This was achieved with only two 'hits' with the very mild 85RD.

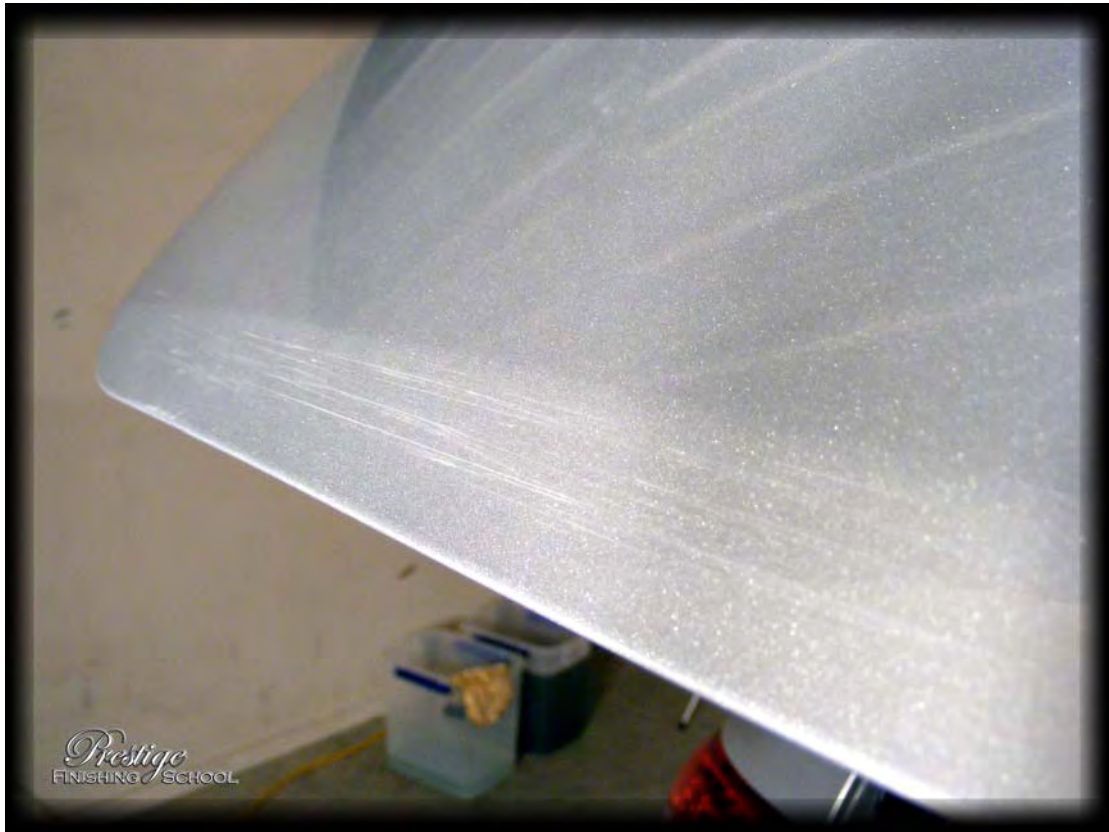
And here, some deeper scratches at the base of the boot door.

The scratches at the base of the tailgate were not so easily moved. These required a slightly more aggressive treatment, but not significant cutting or compounding. In this case, 3M's "Extra Fine Polish" on a new 3M polishing pad did the trick.

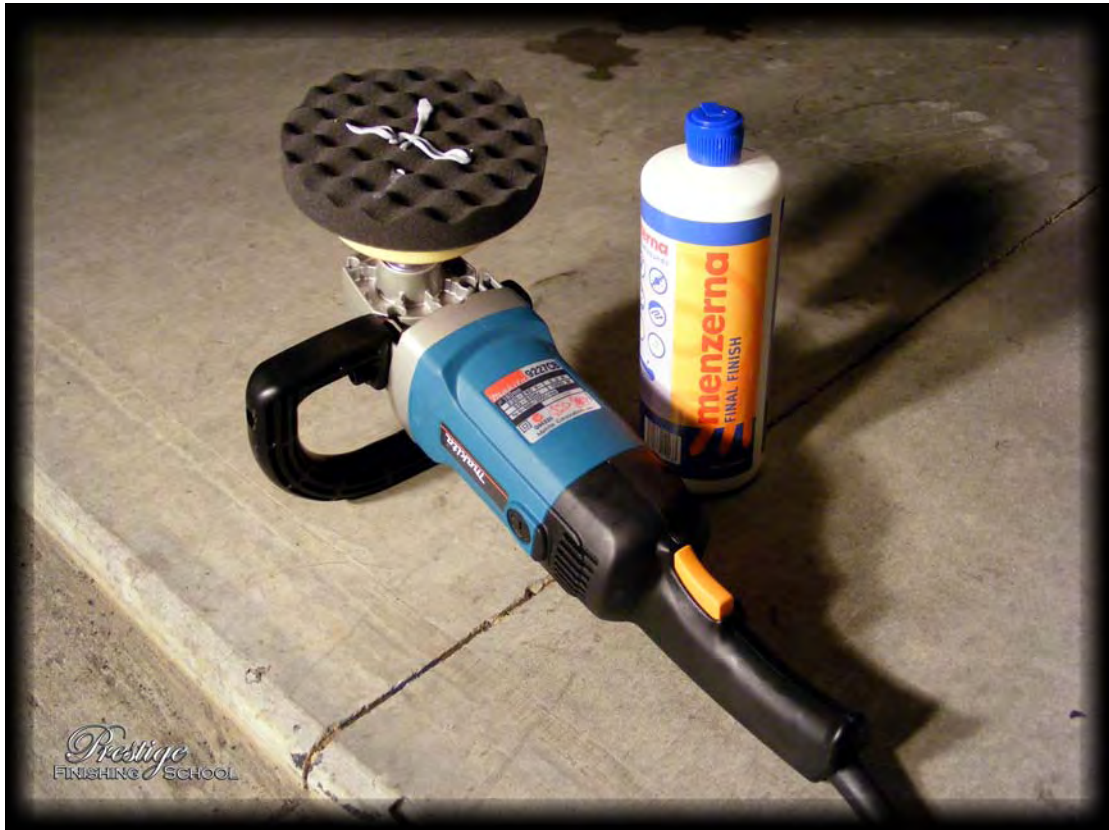
This stage of the detail would be carried out with the Makita 9227CB rotary polisher. There are a plethora of “cheap & nasty” rotaries on the market, but the Makita has several features that are practically mandatory for any quality correction. The first is a guaranteed constant rotational torque, irrespective of the amount of pressure placed on the machine head, and the second is a variable speed control, providing fine-grained control between the ranges of 500-2000RPM. These combined with the superior ergonomics and ‘nice’ features such as the ‘soft start’ mechanism make for an ideal tool.

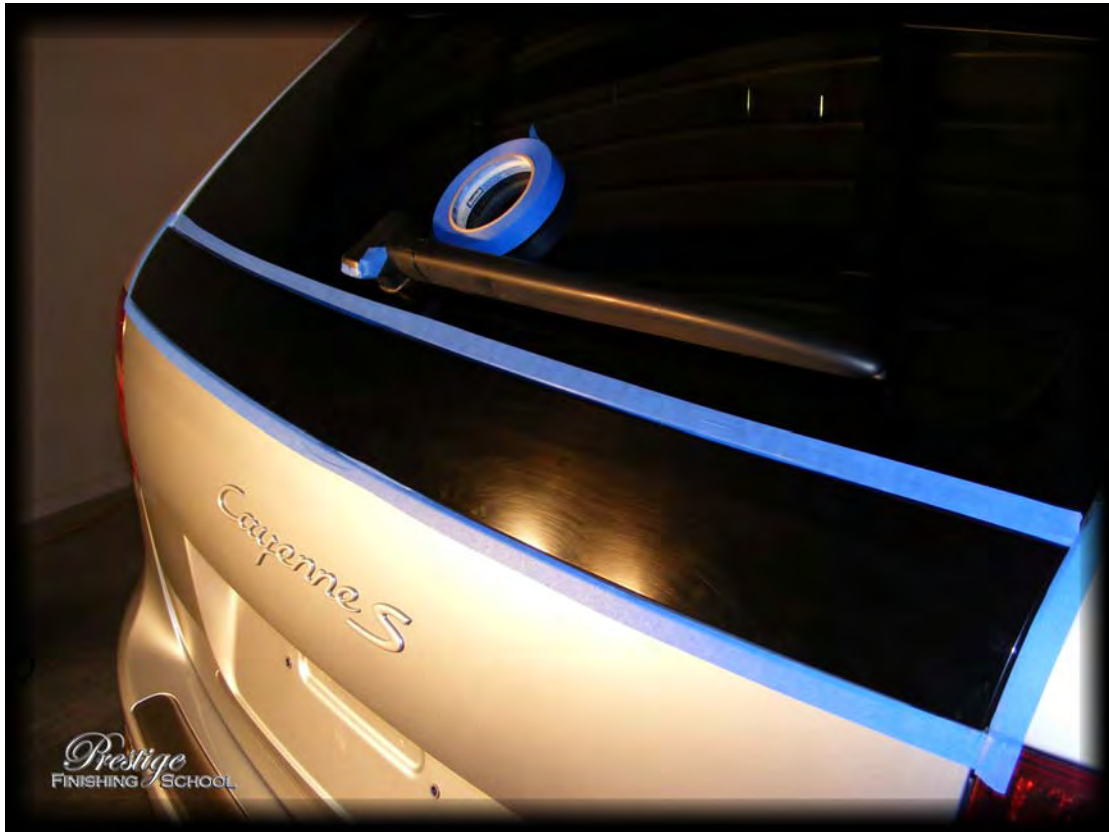
The area was taped off in preparation with 3M painters tape:

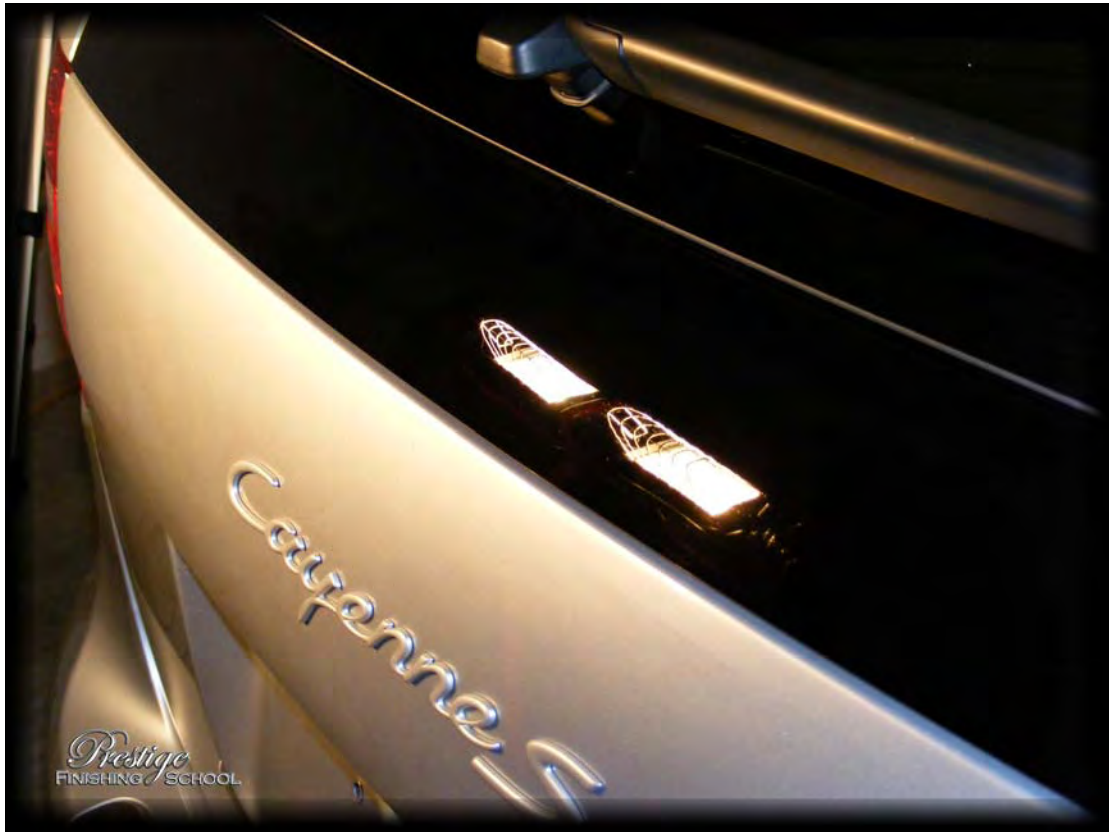
...and here is the completed panel looking brand new once again.

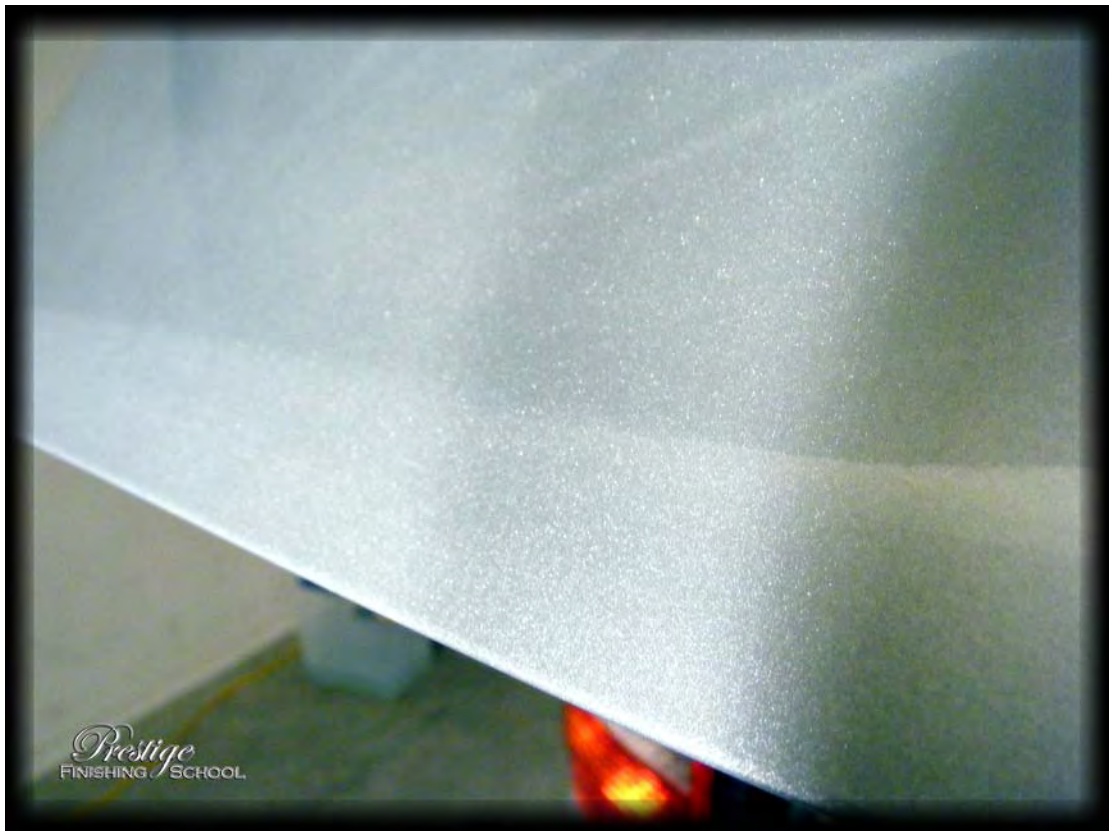
The results are a great improvement.

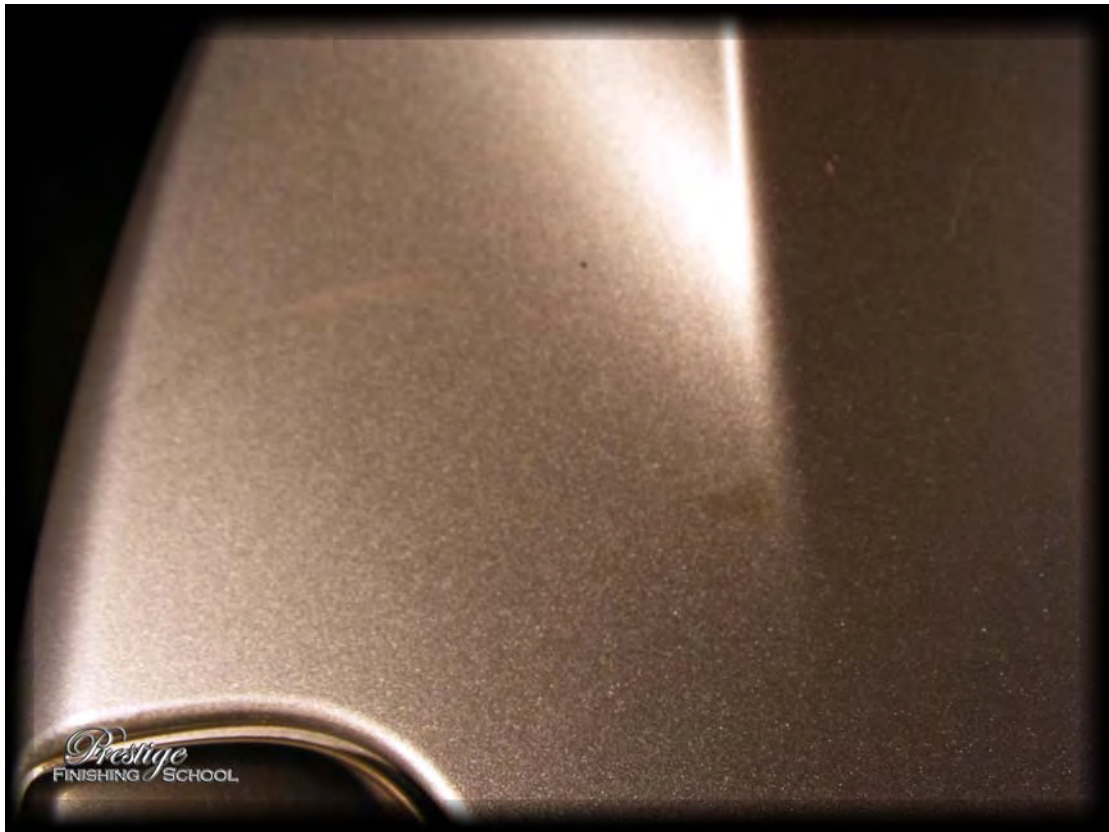
Also, on the loading 'ledge' of the boot, just above the rear bumper, there was some discoloration and etching, as well as some light scuffs.

This was cleaned up by hand with more of the 3M polish on a microfibre work cloth.

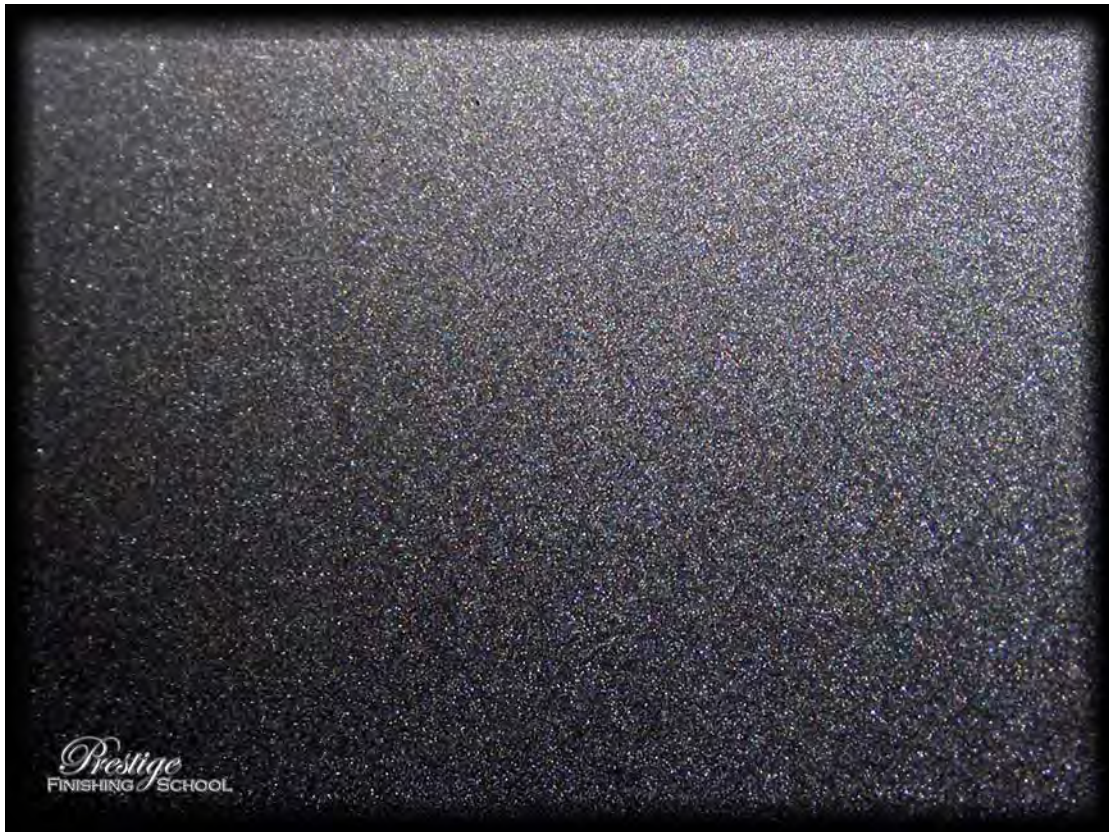
Finally, the entire vehicle was finished to a jewel-like clarity with an application of 3M's Ultrafina SE on a finishing pad.

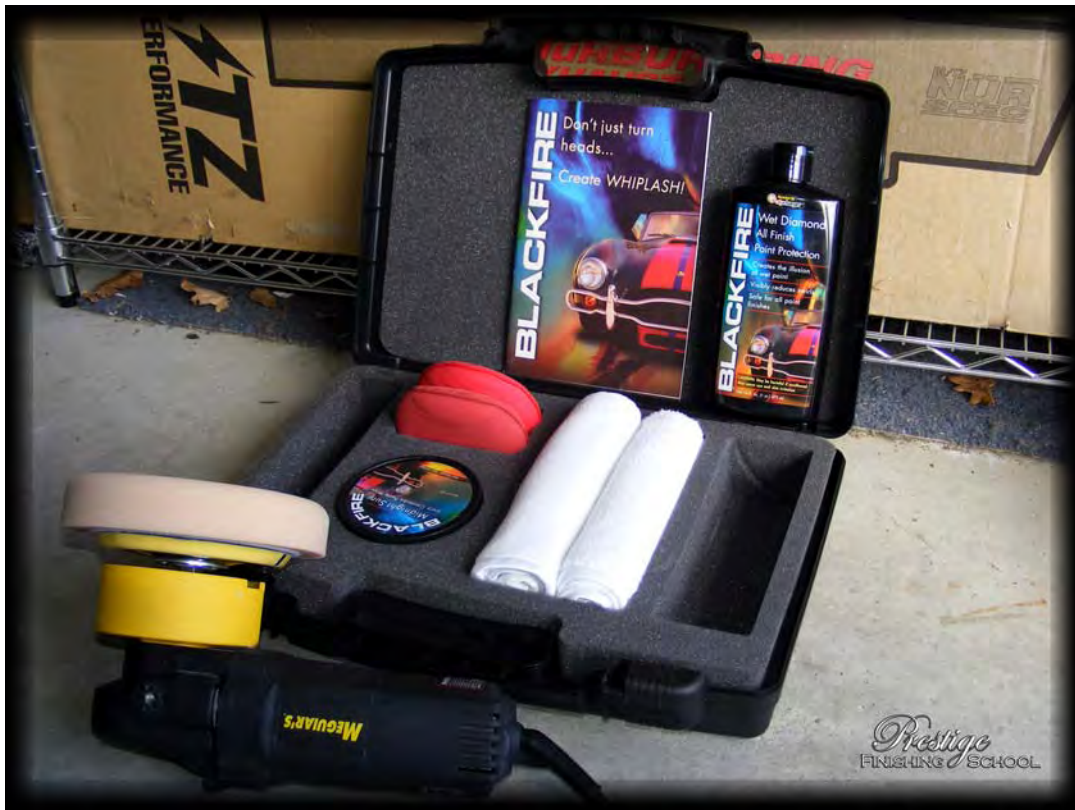
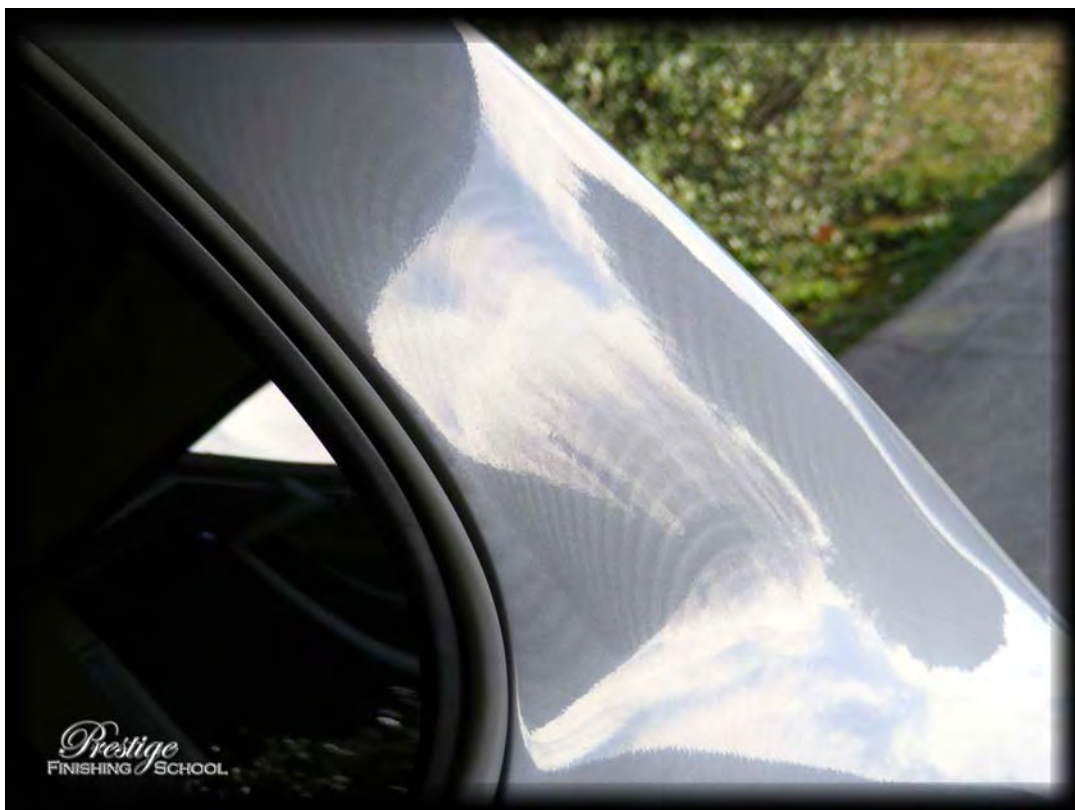
The “Last Step Product” for this detail was Blackfire’s “Wet Ice over Fire” solution. This begins with the “All Finish Paint Protection” Polycharged Sealant, which is applied by machine, then buffed off and left to ‘cure’ for 8 hours. The Meguiars G220 Dual Action Orbital Buffer and Meguiars finishing pad was employed for this.

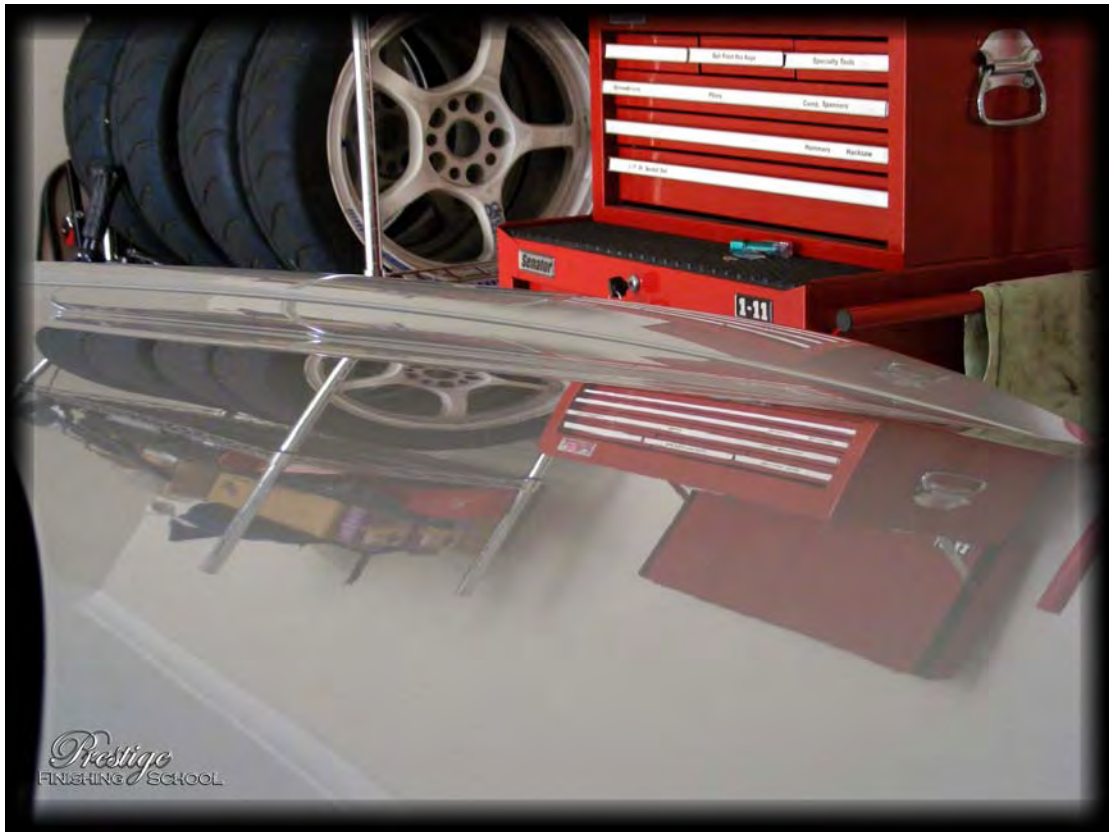
It is then followed up with two coats of “Midnight Sun” Ivory Carnauba Wax, applied by hand – again separated by 8hours. This leaves a spectacular finish!

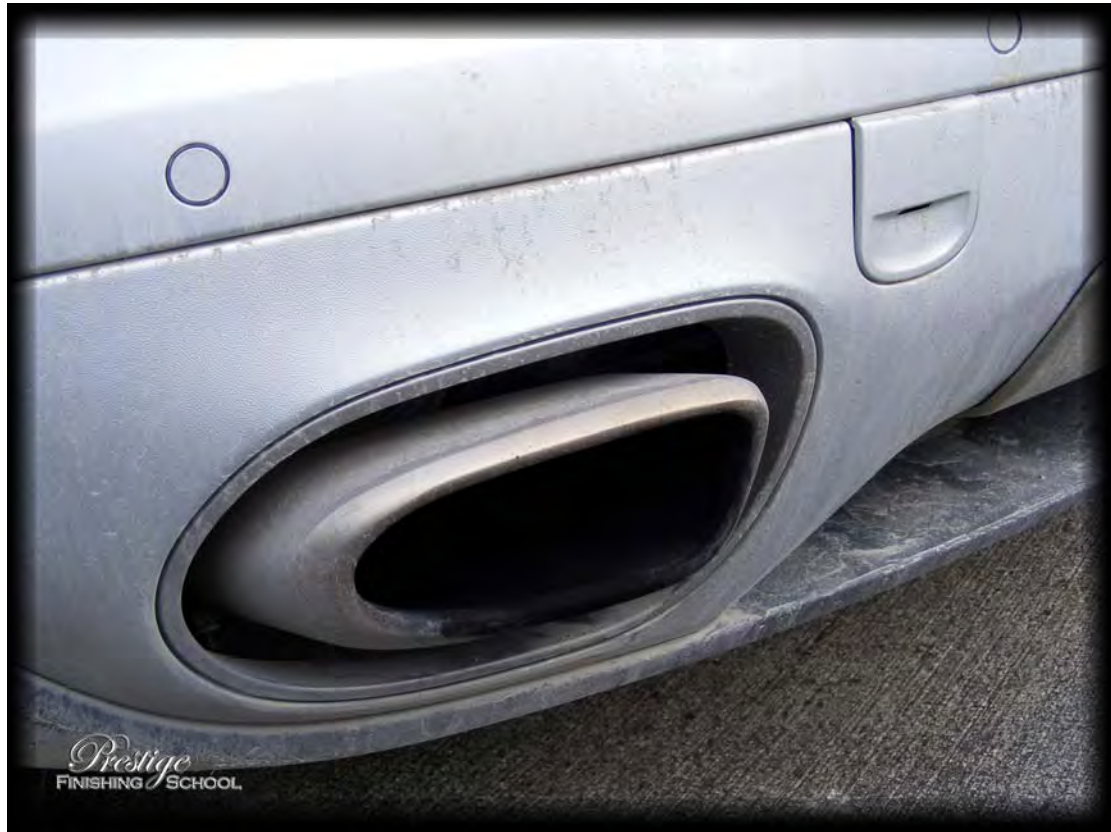
Remember those nasty looking exhausts?

They were cleaned up with Meguiars NXT Metal Polish.

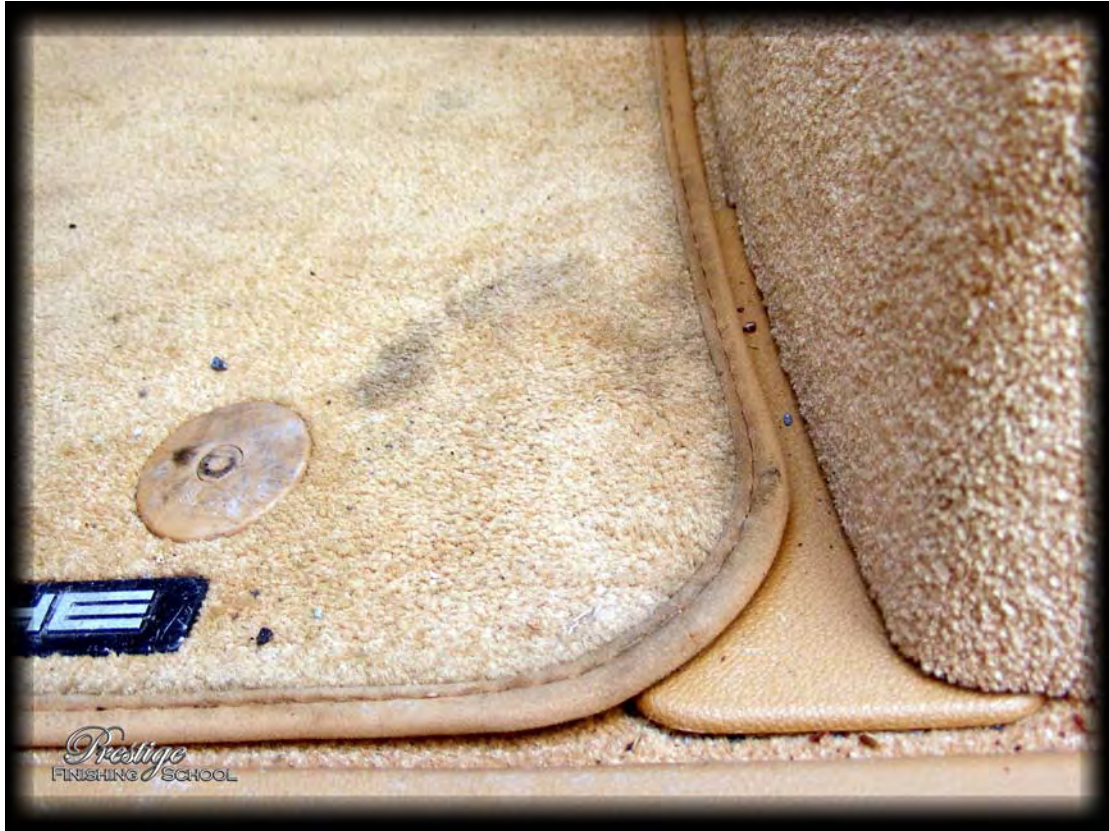
Inside the wagon was the usual assortment of stains...

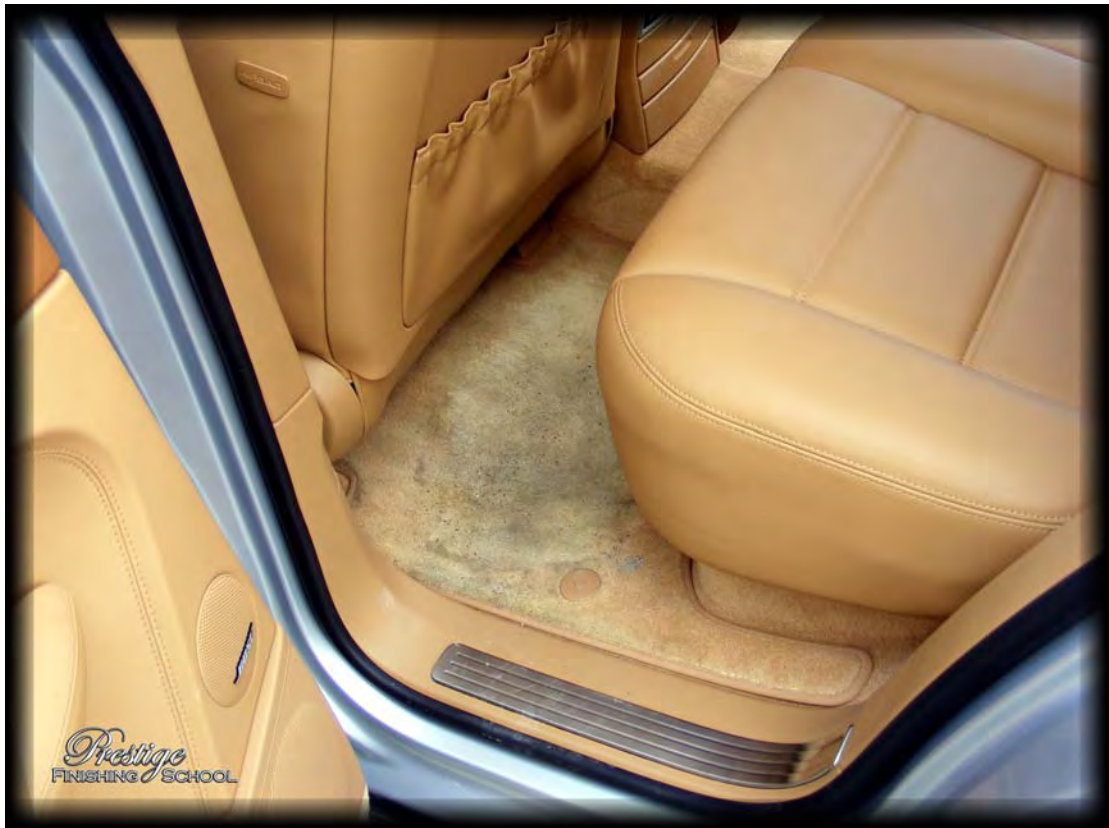
...and ground-in dirt.

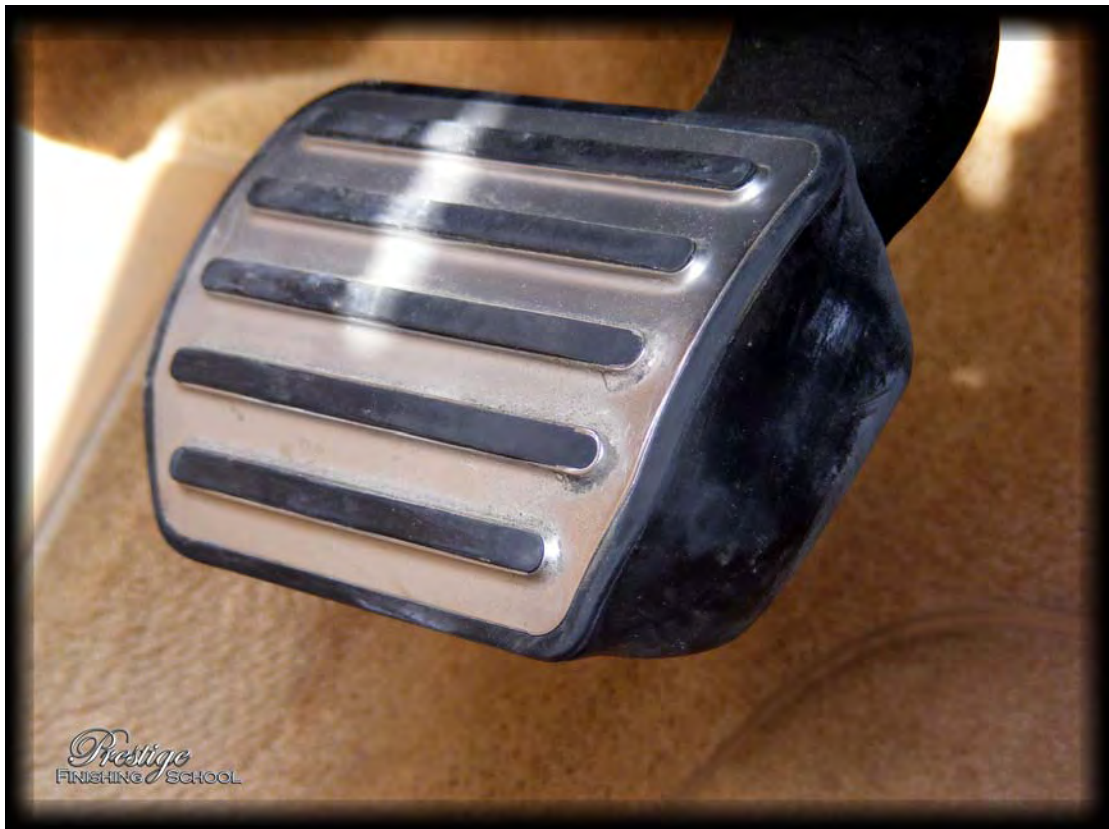
And several of the hard surfaces were also looking a little worse for wear.

These were cleaned up relatively easily...

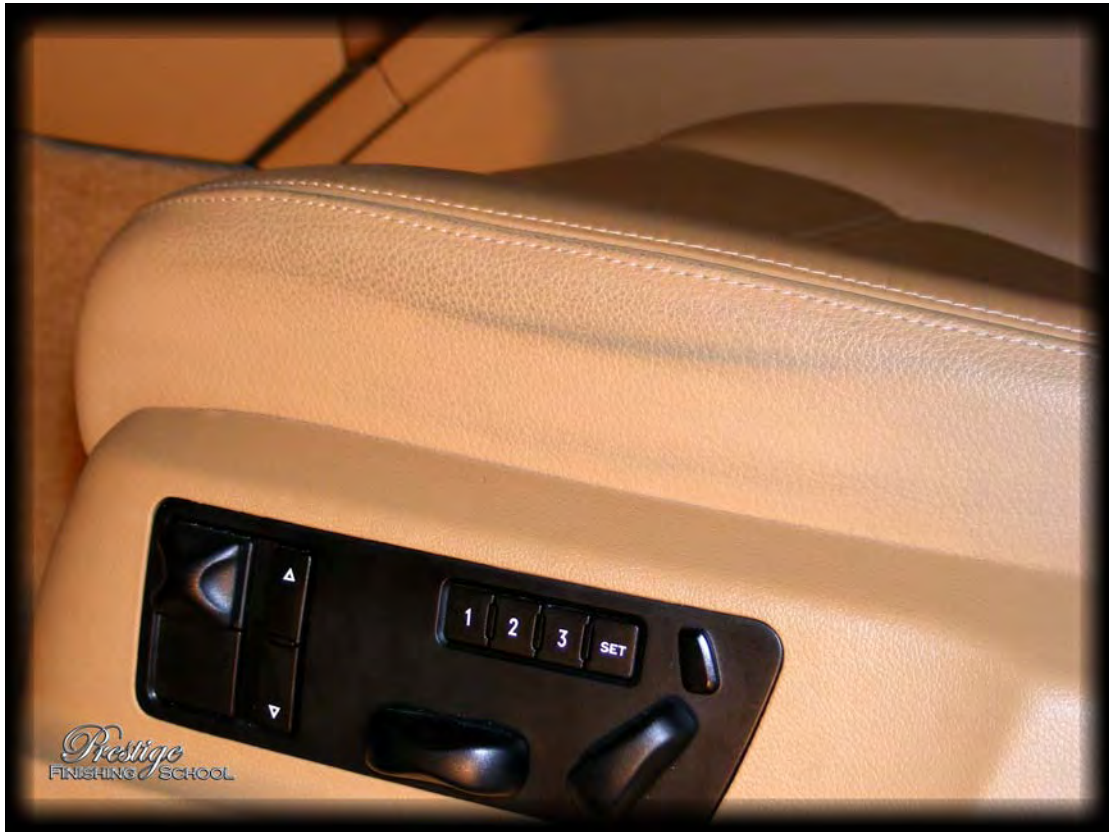
There was some dye transfer from clothing on the passenger's seat.

Which was vastly improved with a gentle application of leather cleaner.
