Report Card:

2004 Subaru WRX STi (Blue)

1.0 Enrolment:

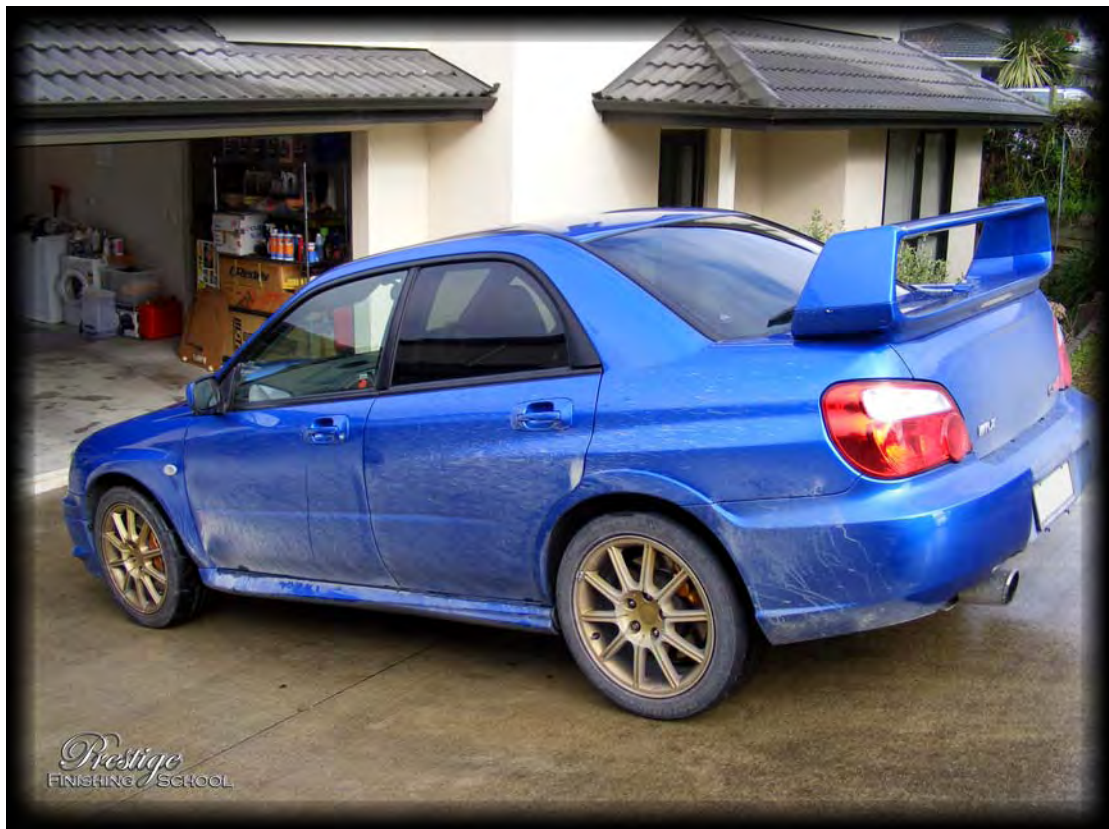
A 1,000km journey across some of New Zealand's most enjoyable roads can leave a rally-bred road weapon looking decidedly dirty.

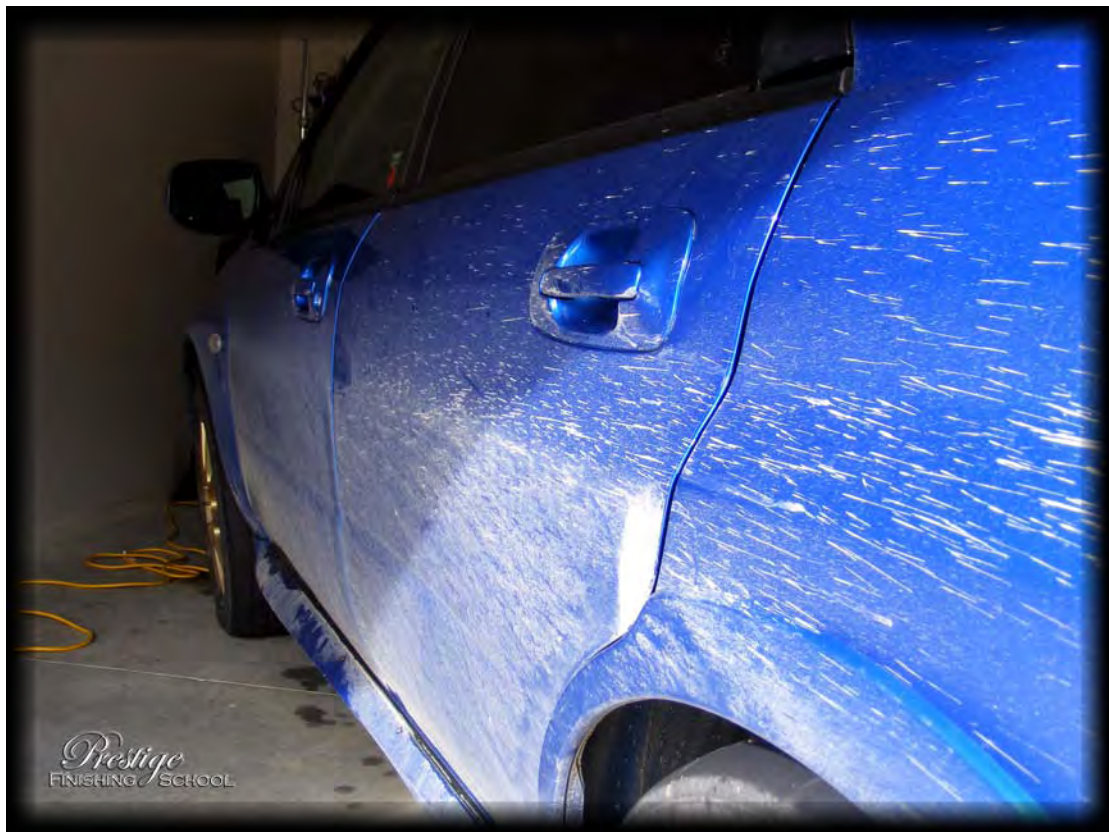
And of course, where the rubber meets the road, the mud accumulates the most:

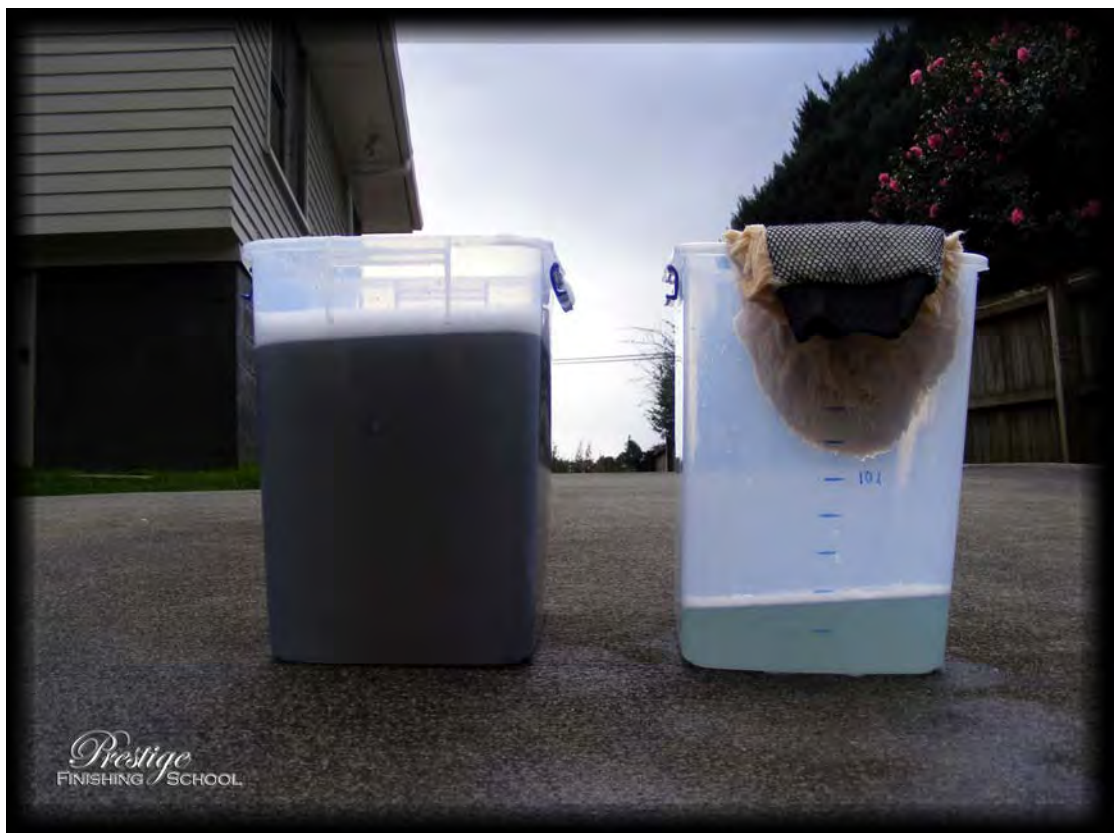
Again, look at the state of the rinse bucket after completing the wash...

The two-bucket-method really does work! Next, the car is rinsed off again at high pressure, and moved inside for claying and drying.

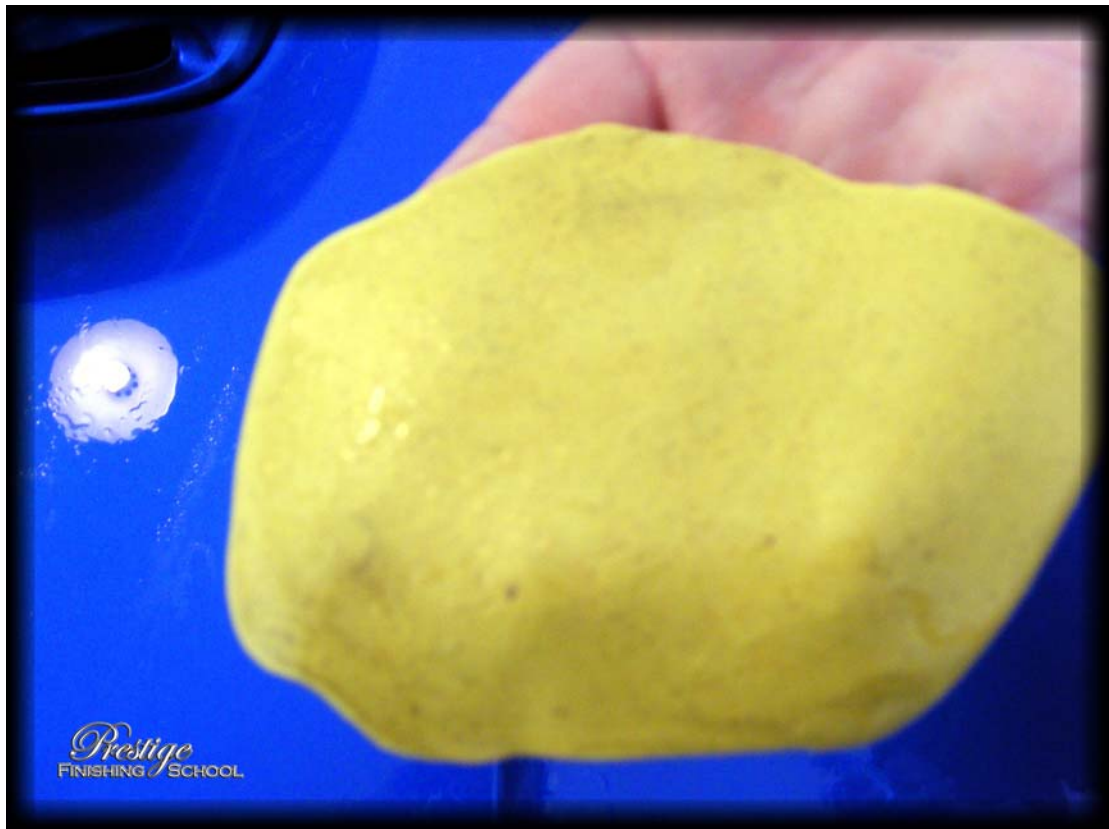
A reasonably large amount of contamination was removed from just this section of the bonnet.

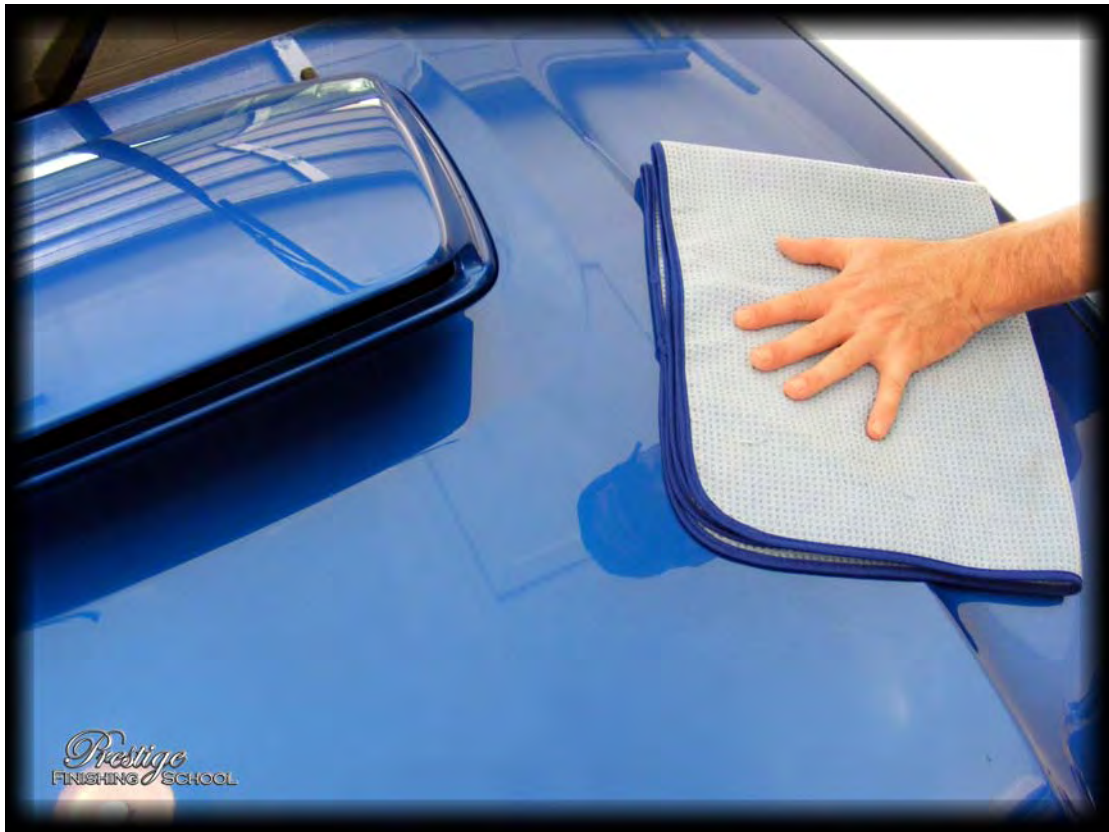
With the vehicle's exterior now in a perfectly clean and dry state, you really do begin to see the benefit of regular, 'safe' washing technique, with very little evidence of wash induced marring to be found.

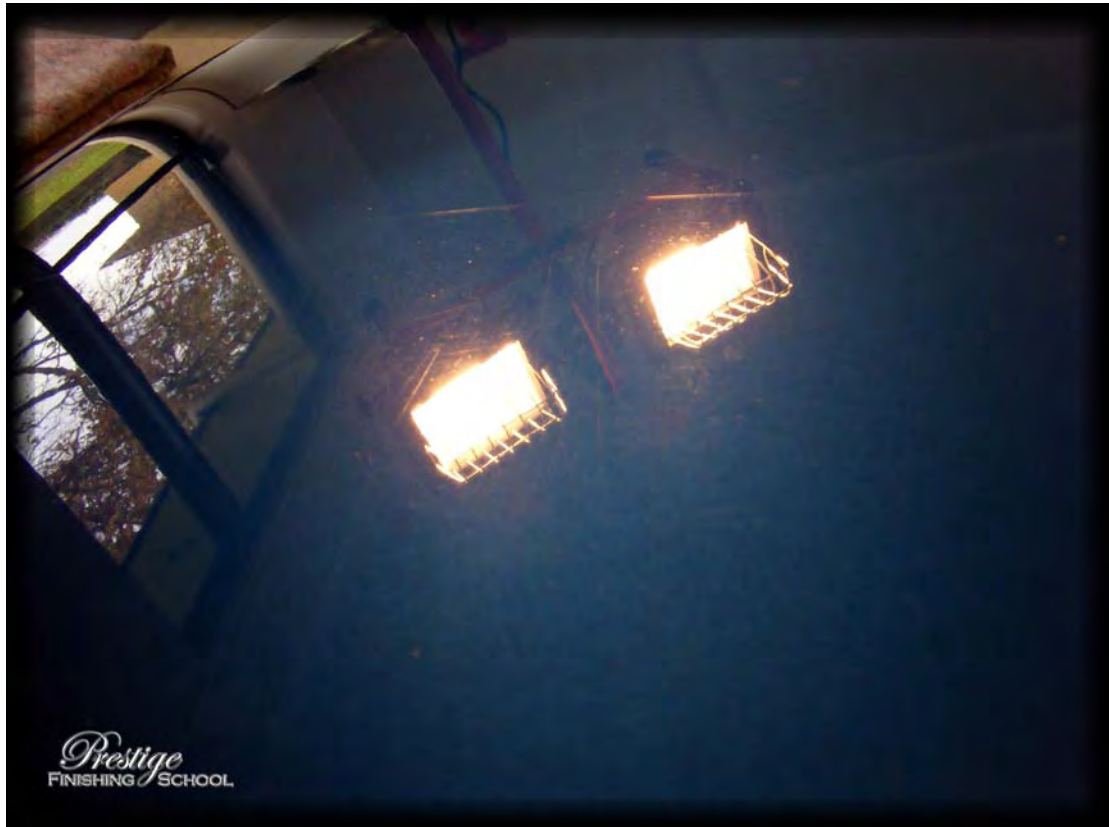
At this point, we deviate somewhat from our standard Clean & Protect detail regime. The customer had identified a reasonably deep scratch running in an almost straight line down the middle of the bonnet, and also some severe 'scuff' marks on the side skirt where careless feet had done significant damage. There was also a nasty scratch on the top of the rear spoiler. He asked us to correct these specific defects in lieu of detailing his vehicle's interior, and we were happy to oblige. Under the unforgiving twin 500W Halogen lights, the defects were plain to see:

Though quite difficult to photograph, in this picture you can clearly see the deeper scratch, just above the reflection of the lights, as well as some minor swirl marks.

We tackled the bonnet with a Meguiars G220 Dual Action Orbital Polisher and Meguiars 6.5” Polishing pad. Menzerna RD3.02 was the polish used to address the scratch. Menzerna RD3.02 is designed to restore dull, oxidised, neglected paint and remove major paint defects such as severe swirl marks and deep scratches. This polishing compound has revolutionised the paint correction process, as it is capable of removing such defects without leaving any surface hazing, meaning that fewer subsequent polishing steps with progressively finer polishes are required to refine the finish.

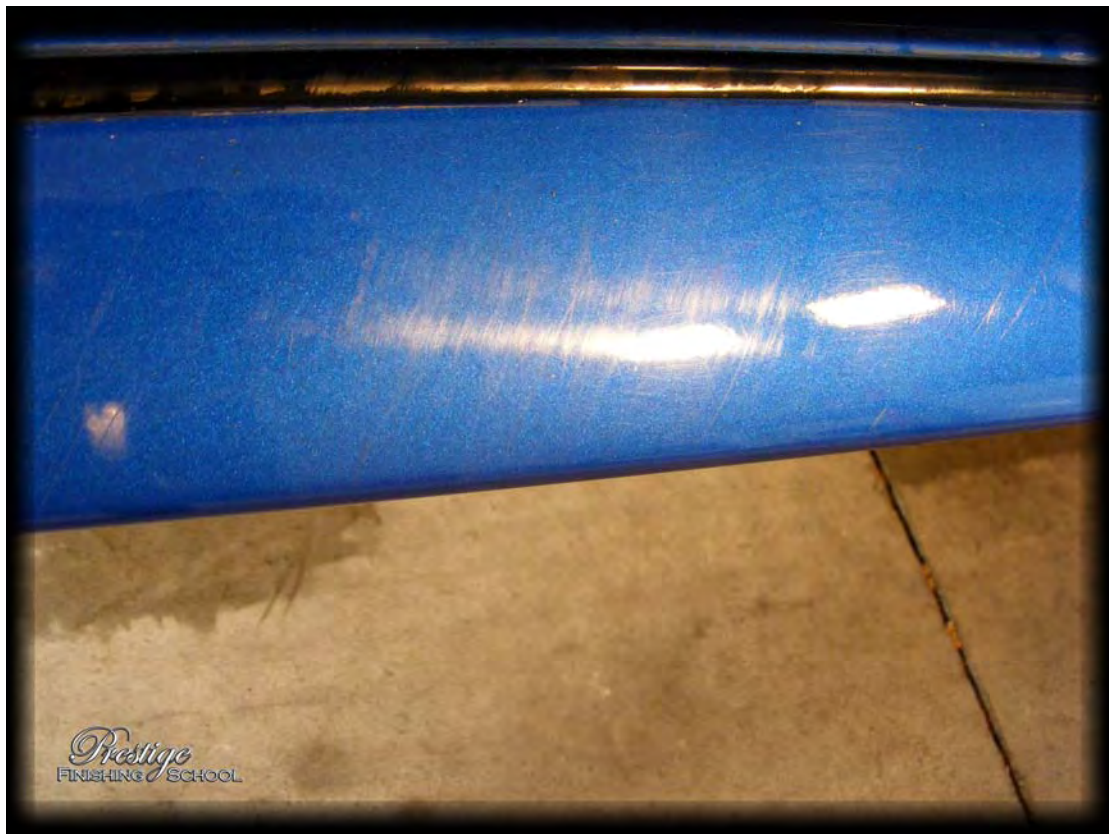
And again, notoriously difficult to convince the camera to focus on the defects, but you can plainly see the damage caused by footwear being scraped on the sill. This shot of the spoiler was snapped out in the sun prior to the wash.

The same product was employed on the driver's side skirt, this time applied on a smaller 4inch Lake Country CCS cutting pad.

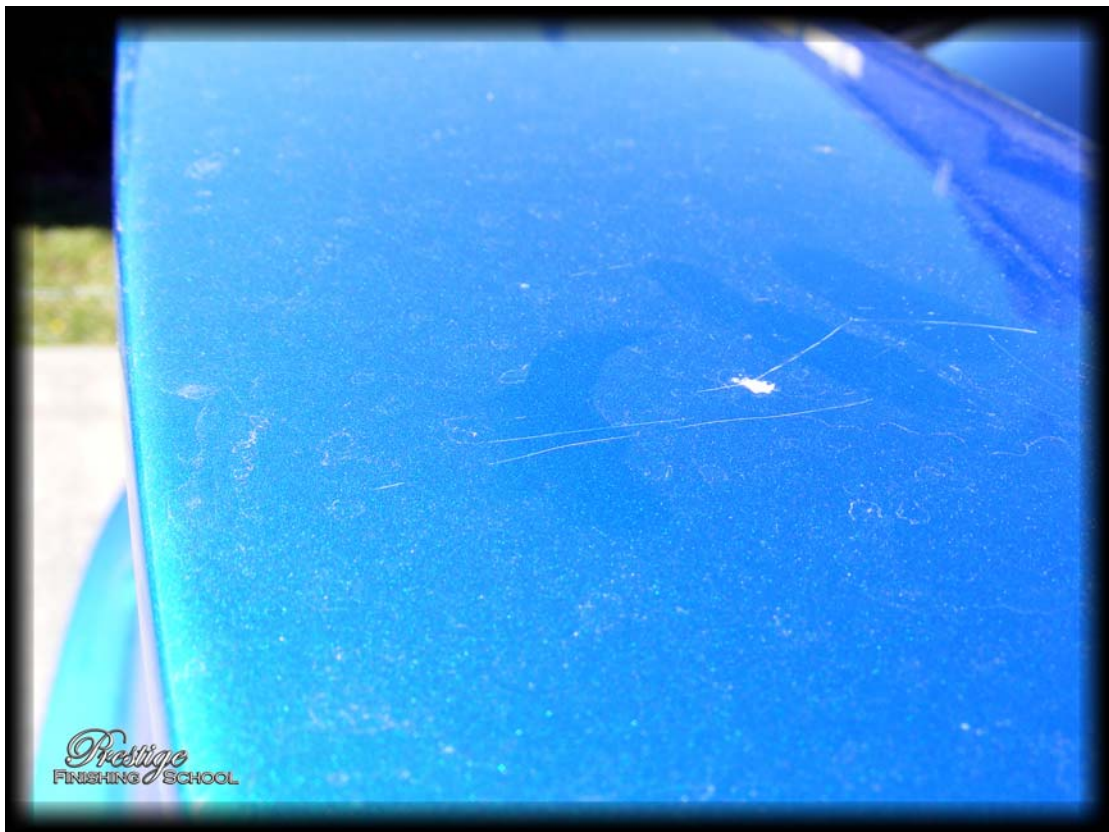
This kind of damage can be reasonably quickly resolved.

100% correction of the panel achieved. The spoiler was also hit with the 4" pad, we grabbed a photo of the finished panel back out in the sun for a direct comparison.

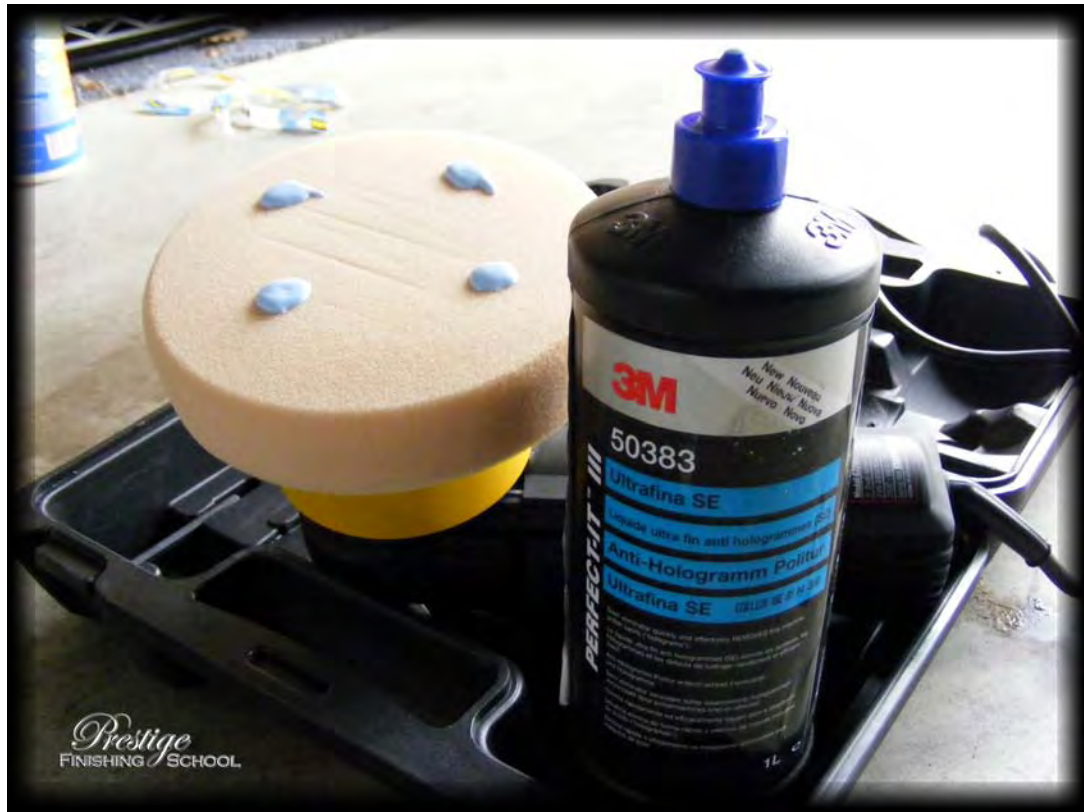
To completely restore the clarity and mirror-like finish to the paint, 3M's long-serving Ultrafina SE was applied on a Meguiars 6.5inch Finishing Pad to the vehicle.

Significant cutting or compounding can be a necessary step in paint correction, and these processes can result in painted surfaces looking slightly 'hazy' or 'dull' with micro-marring from the aggressive polishes being evident on close inspection.
