Report Card:

2003 Subaru Impreza WRX Hatch (Black)

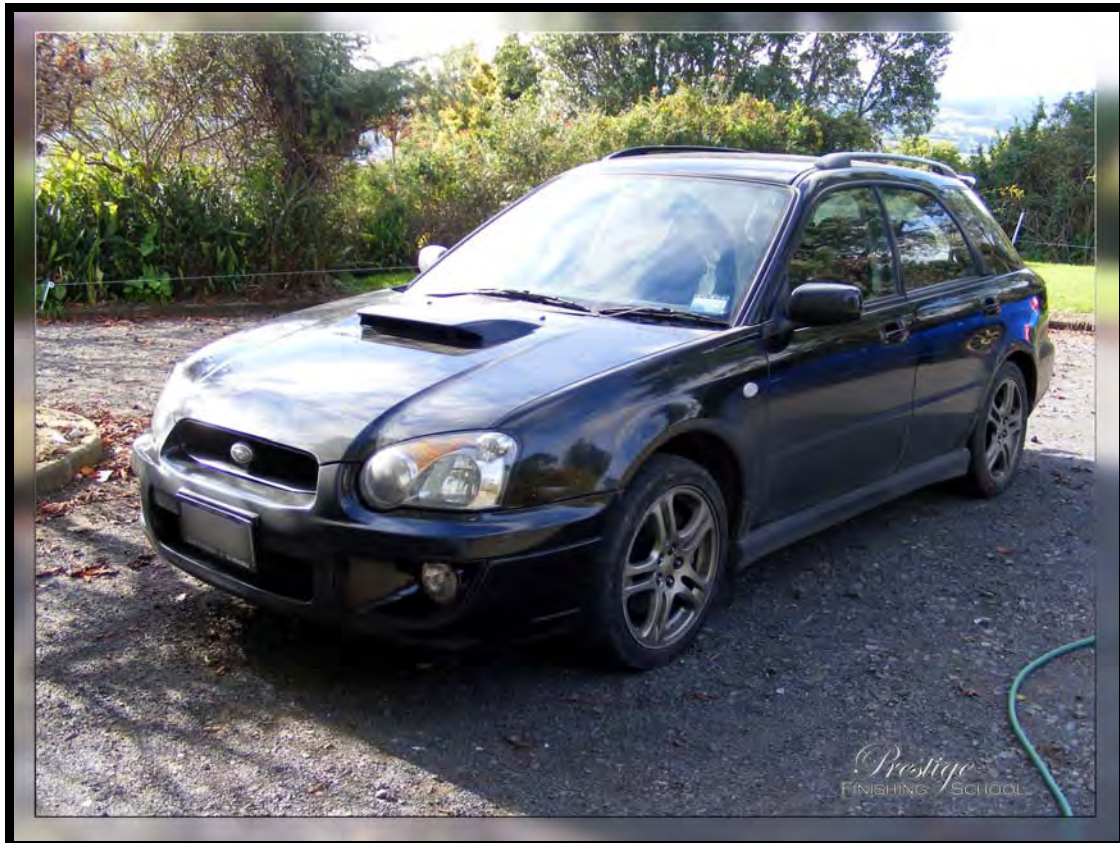
This Subaru Impreza Wagon was purchased new in 2003 and the owners have put it to good use as a general workhorse on their Pukekohe farmlet, with daily commuting into Manukau thrown in for good measure. From a distance, things weren't looking too bad:

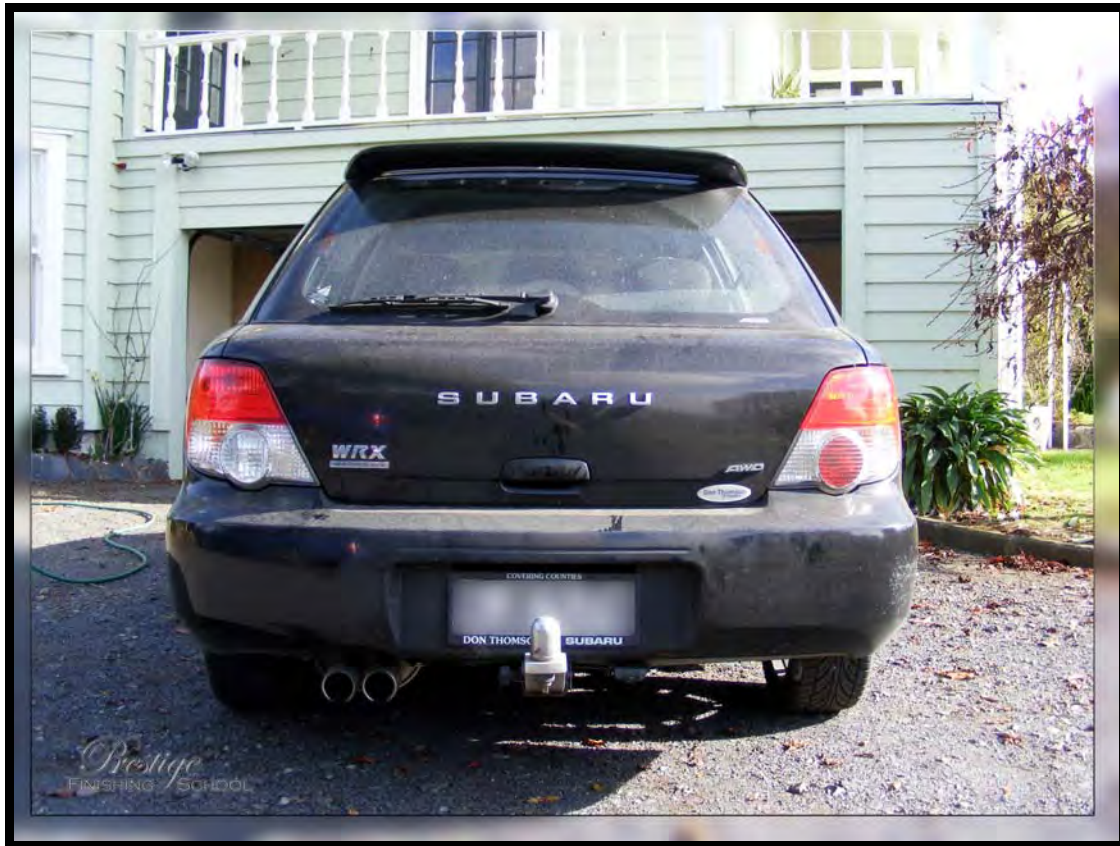
However, as you near the vehicle, you begin to get some idea of the task ahead:

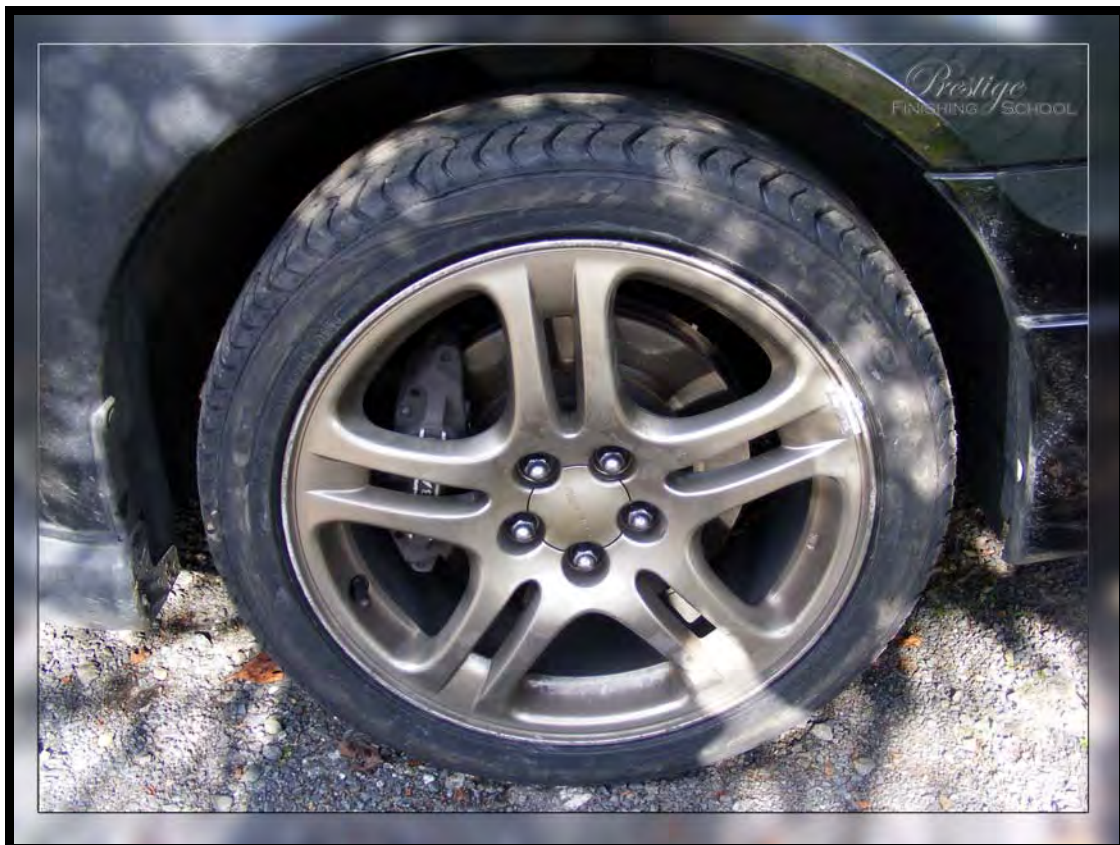
The wheel rims appeared to be in especially poor condition:

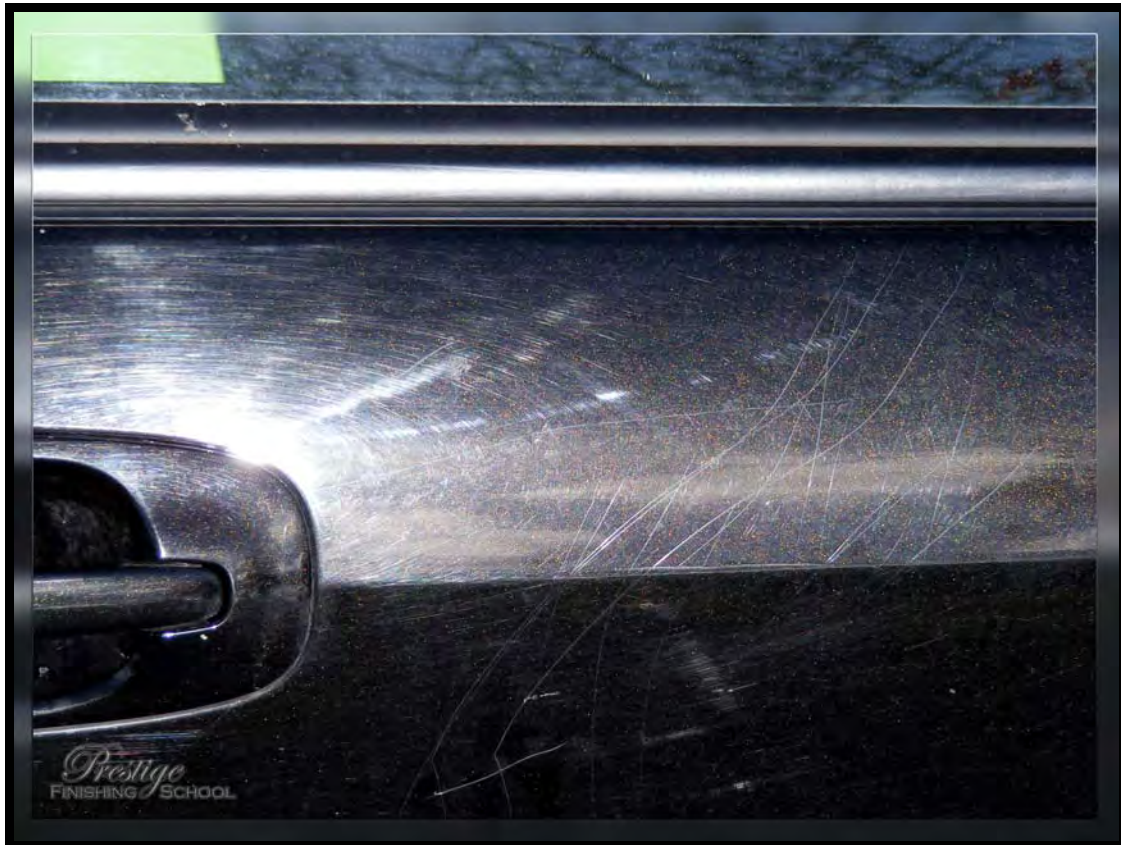
And even more disturbing, several areas covered in particularly deep scratches:

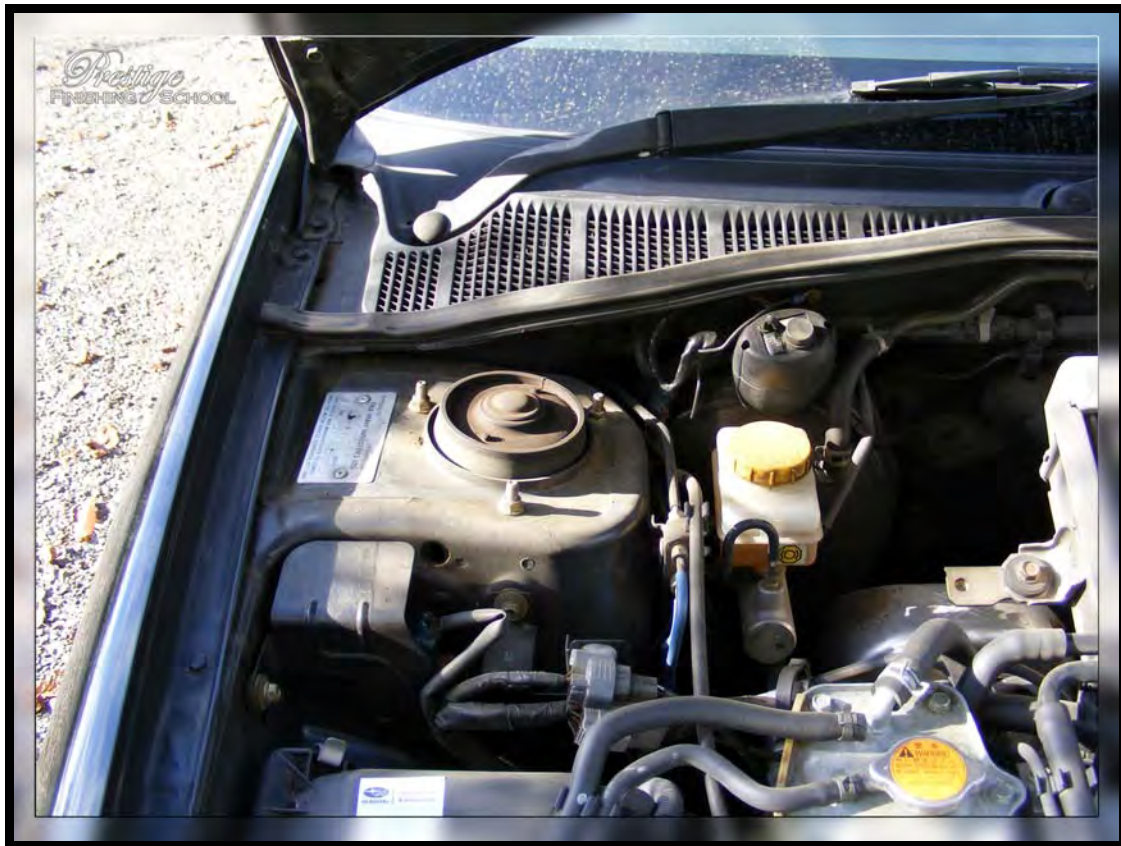
Engine Bay

To begin, the engine bay is detailed. It was in no better state than the vehicle's exterior:

We tackled this with Meguiars All Purpose Cleaner:

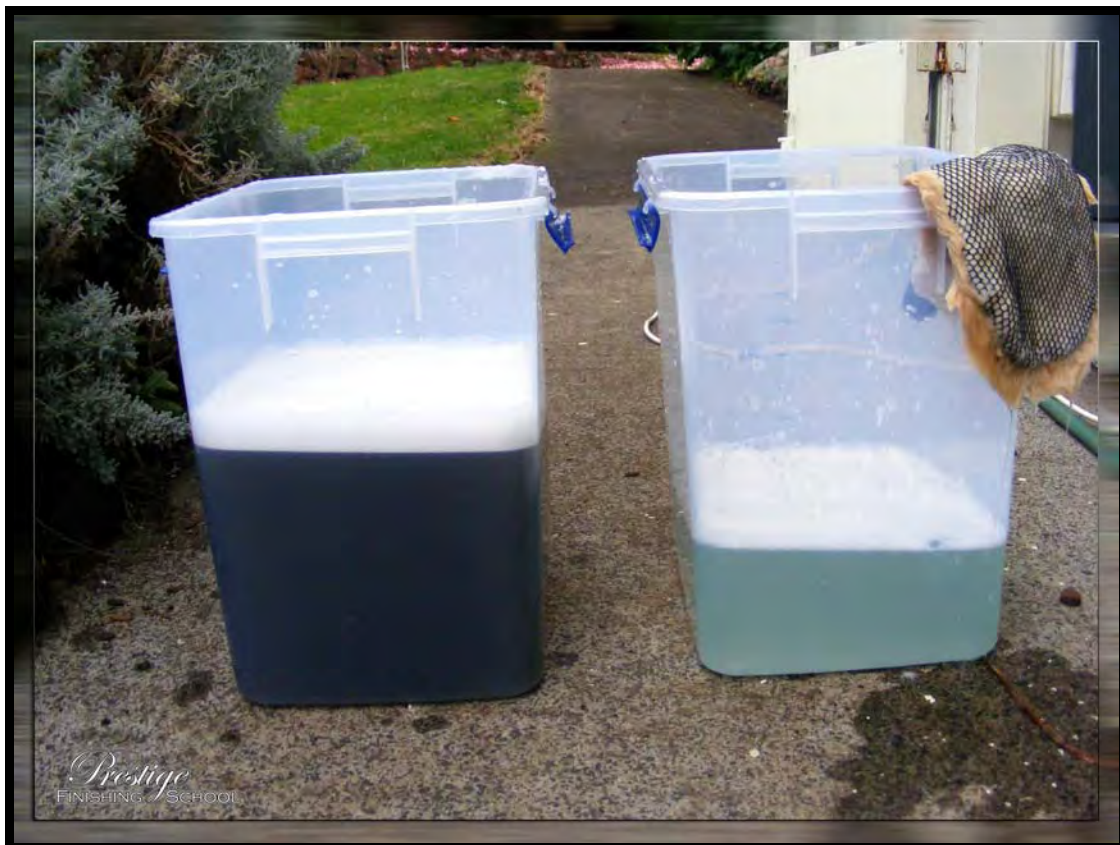
If you consider the use of two buckets 'overkill', consider the state of the rinse bucket after completing the wash:

Would you consider wiping your car with anything soaked in the left bucket?

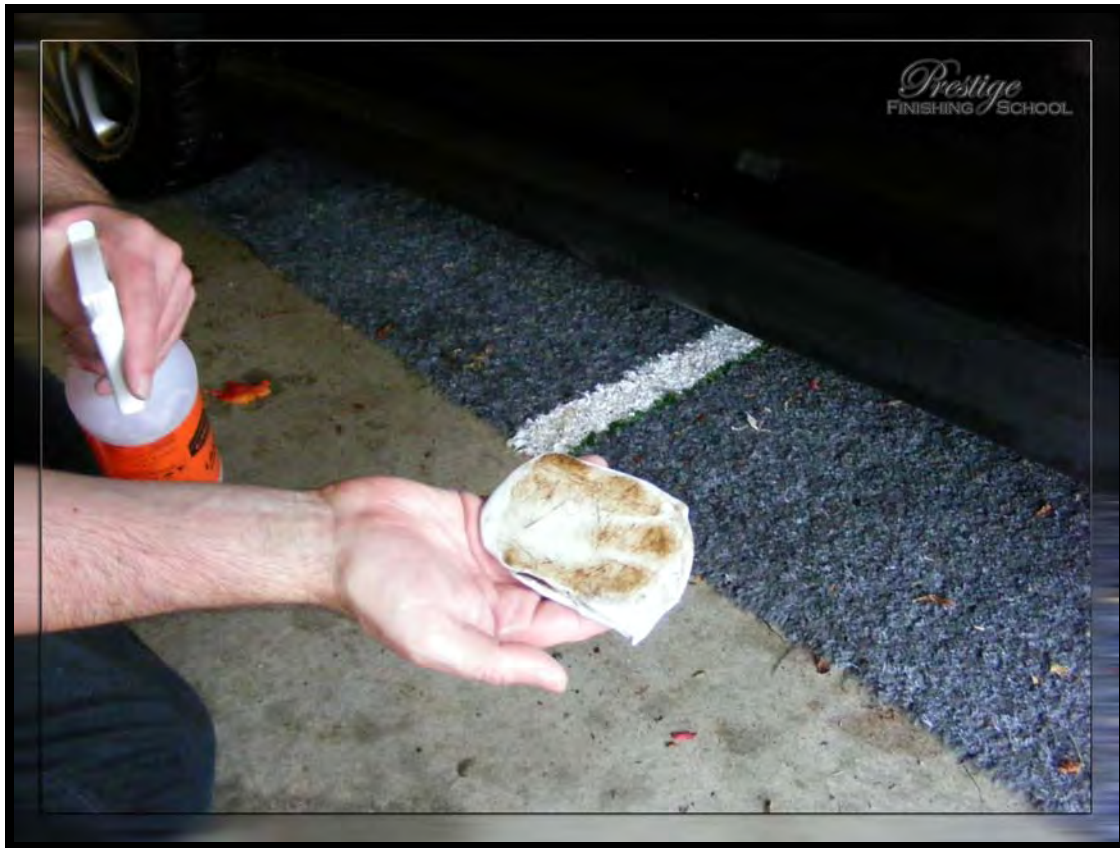
It's a source of constant amazement just how much contamination remains on a vehicle's surface after comprehensive washing!

The final step in ensuring a perfectly clean paint surface is the removal of bonded contaminants with a detailing clay bar. This can include tar spots, tree sap or industrial fallout, all of which contribute to making the paint surface rough to the touch and dull to look at. In this instance, a Meguiars 'Quick Clay' bar was used with Meguiars Last Touch (diluted 1:1) as lubrication.

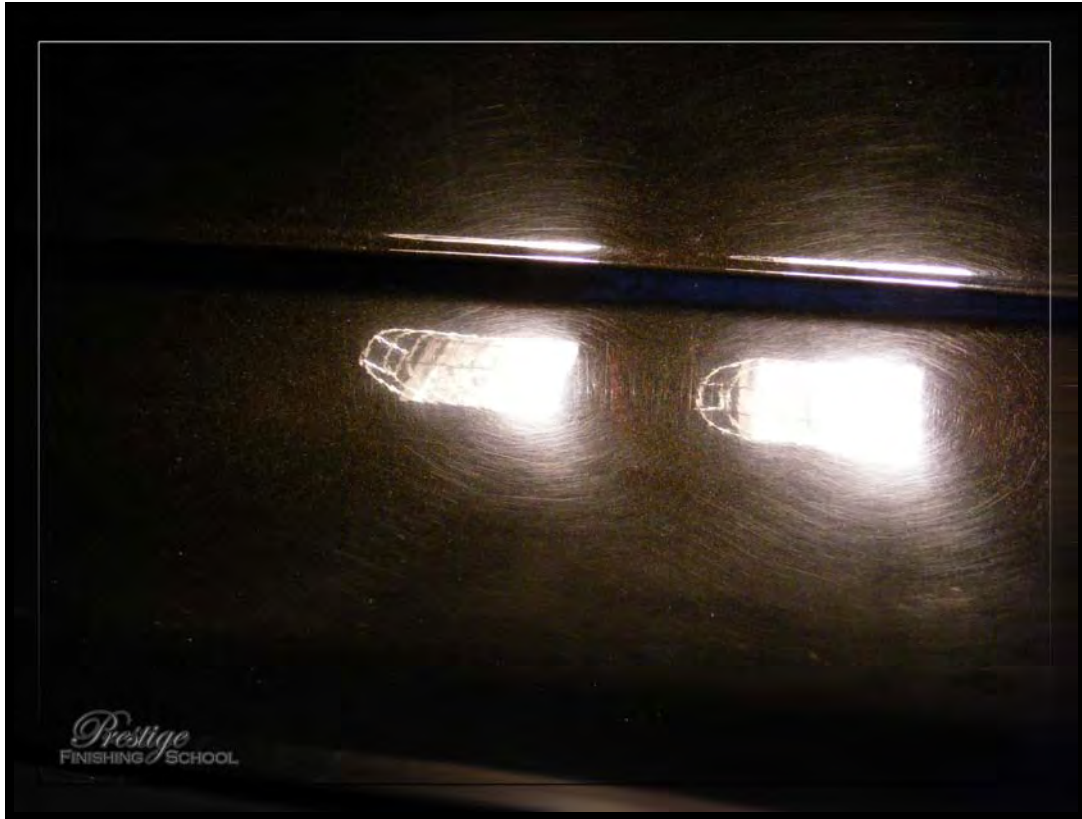
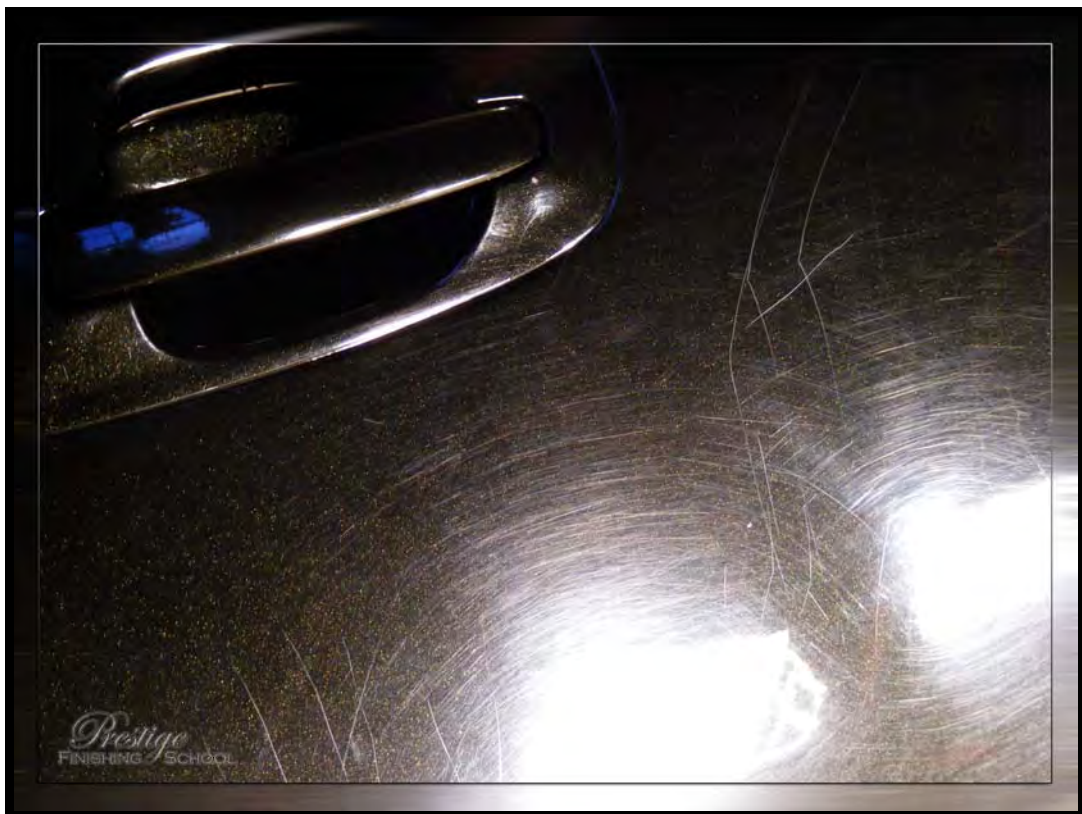
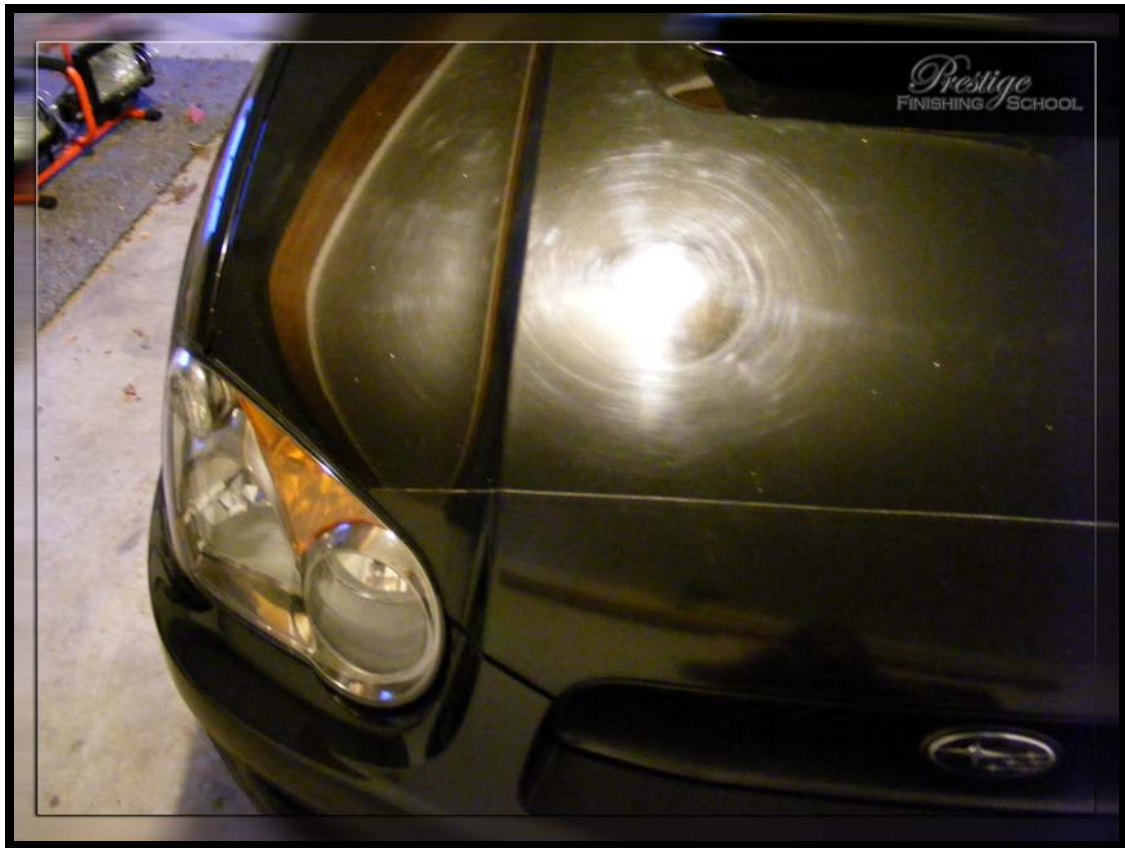
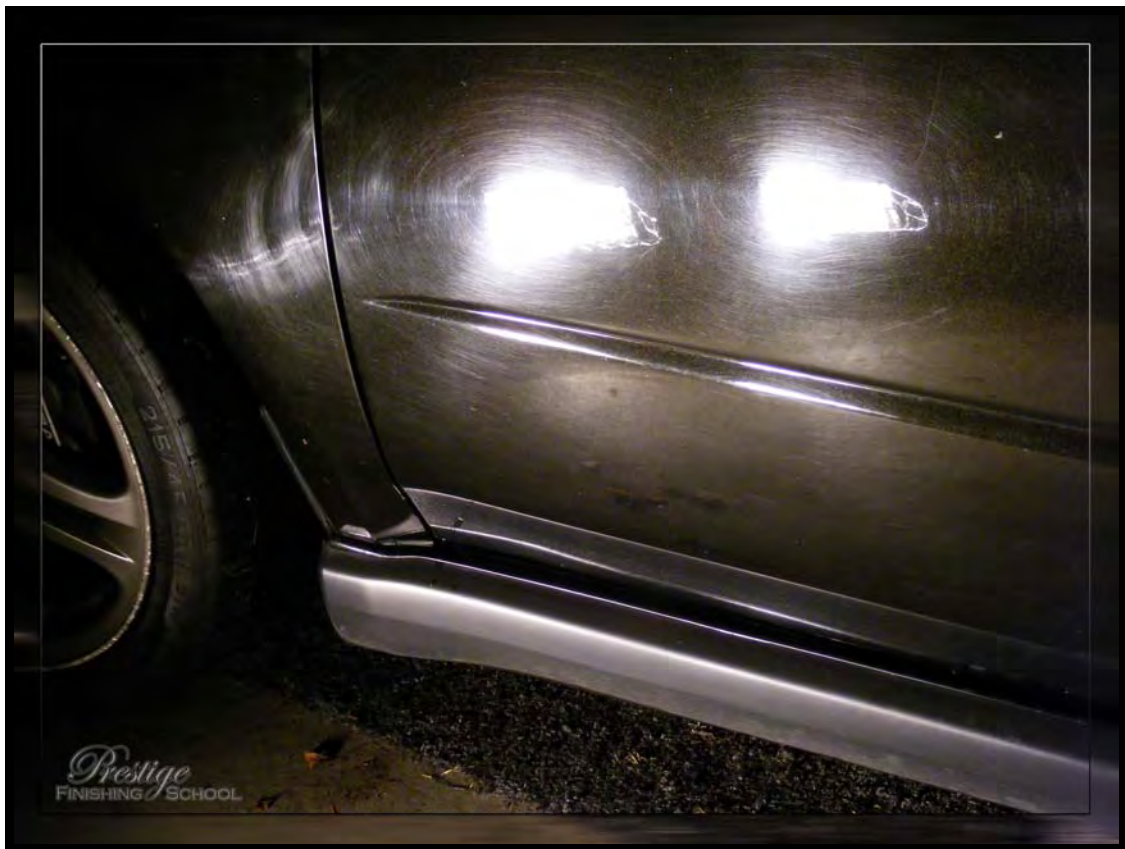
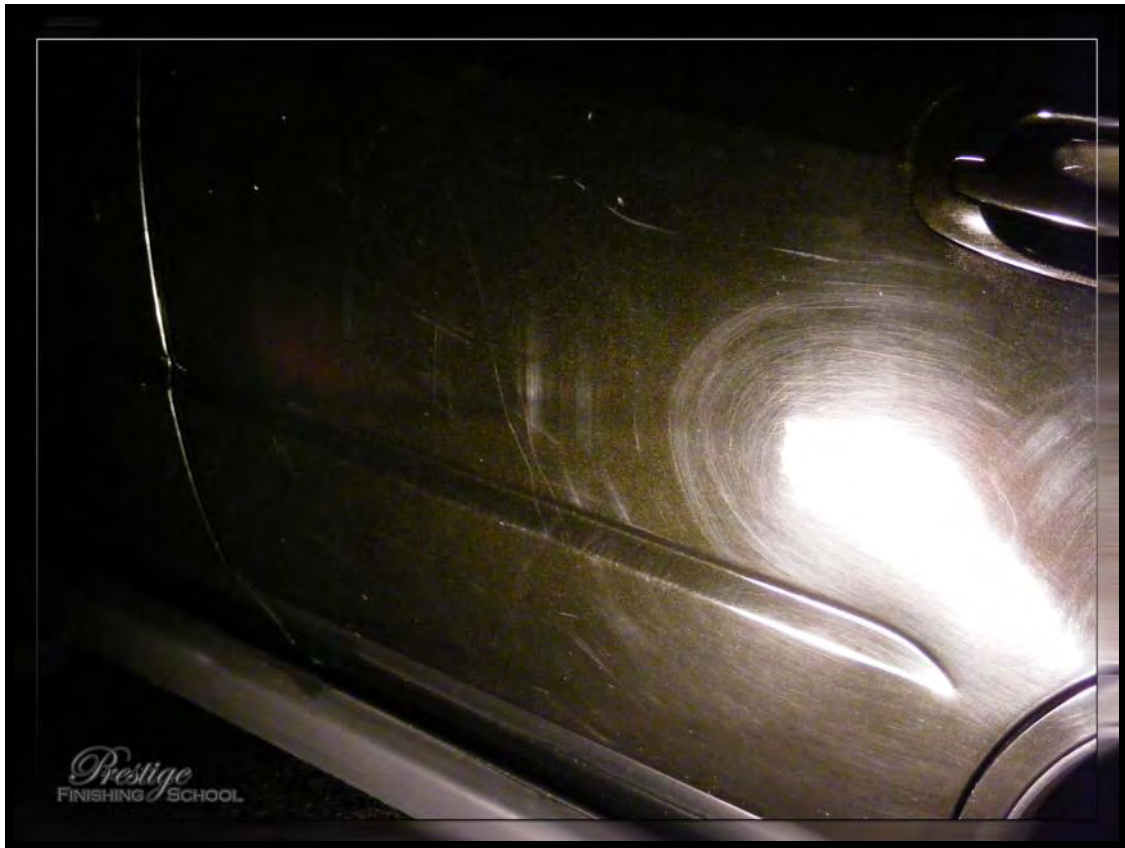
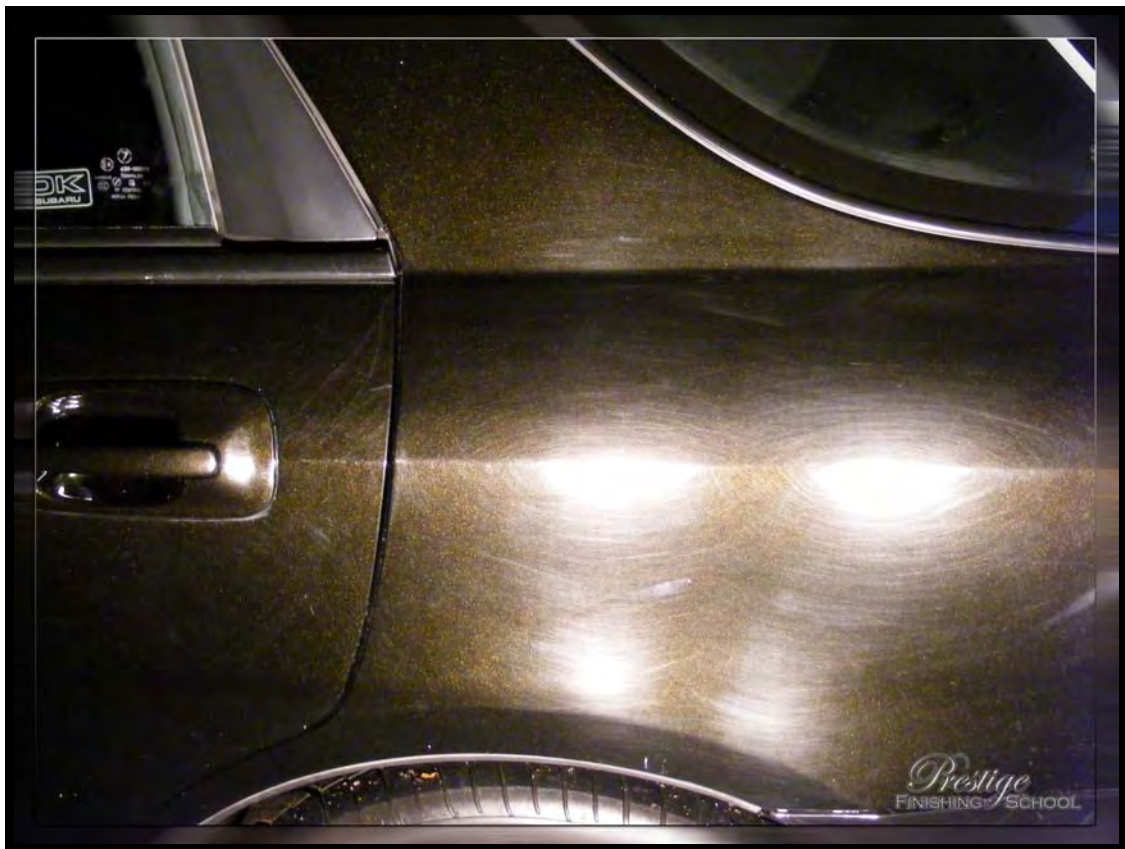
3.0 Initial Assessment:

At this point, we get to see and understand the true and unadulterated state of the vehicle bodywork. Without the benefit of any (defect masking) wax and under the unforgiving twin 500W Halogen lights, things were not looking good!

As you can see, the paint has suffered significant damage over the past few years. It is incredibly difficult to capture on film the extent of the swirling on the paint. It almost looks like it has been scrubbed, top to bottom, with steel wool! Of more concern, however, were the much deeper scratches (that look to have been inflicted by the family dog jumping up against the doors), dings, and even paint transfer from various parking 'incidents'.

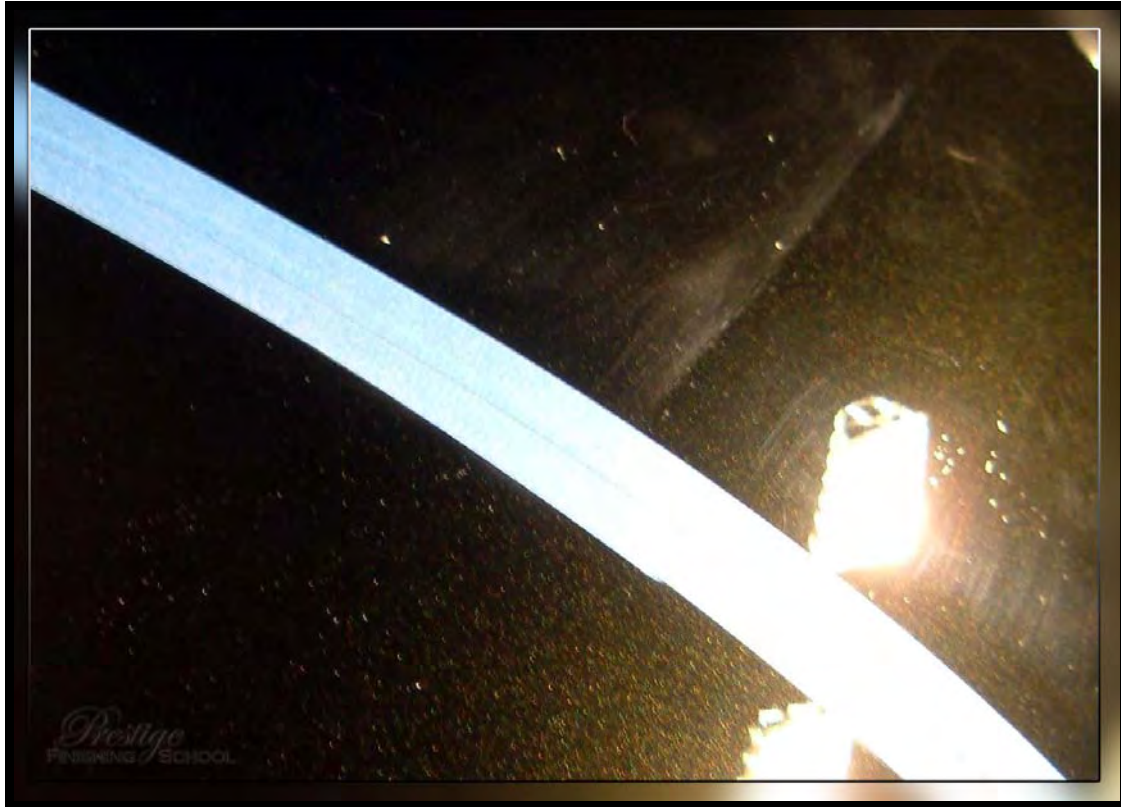
This is a particularly interesting shot. The left half of the bonnet has been corrected, but on the right there are two different finishes. The upper part is heavily swirled from years of neglect, but the lower portion has been covered with a plastic film since the car was delivered in “brand new” condition. Look at the swirling evident in this ‘virgin’ paint – it’s quite unbelievable how much damage some car dealers inflict on “new car” paint in their efforts to “valet” them prior to sale. This is precisely why it’s not unheard of for us to perform correction details on brand new cars.

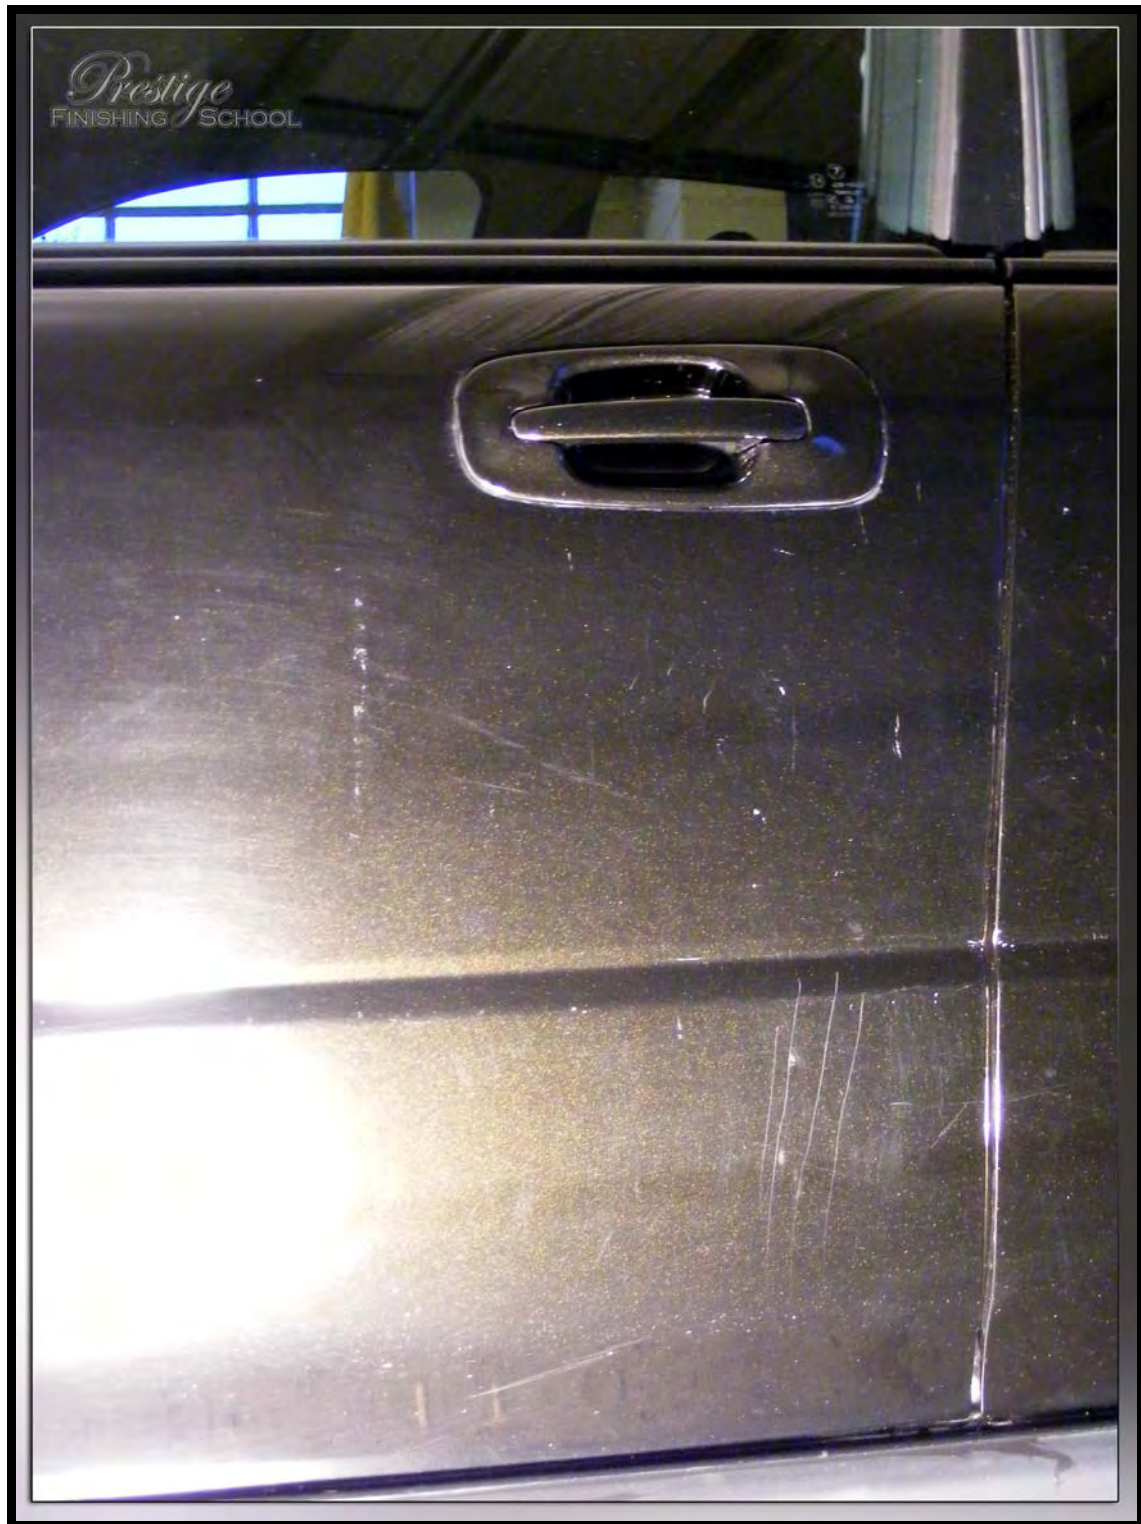
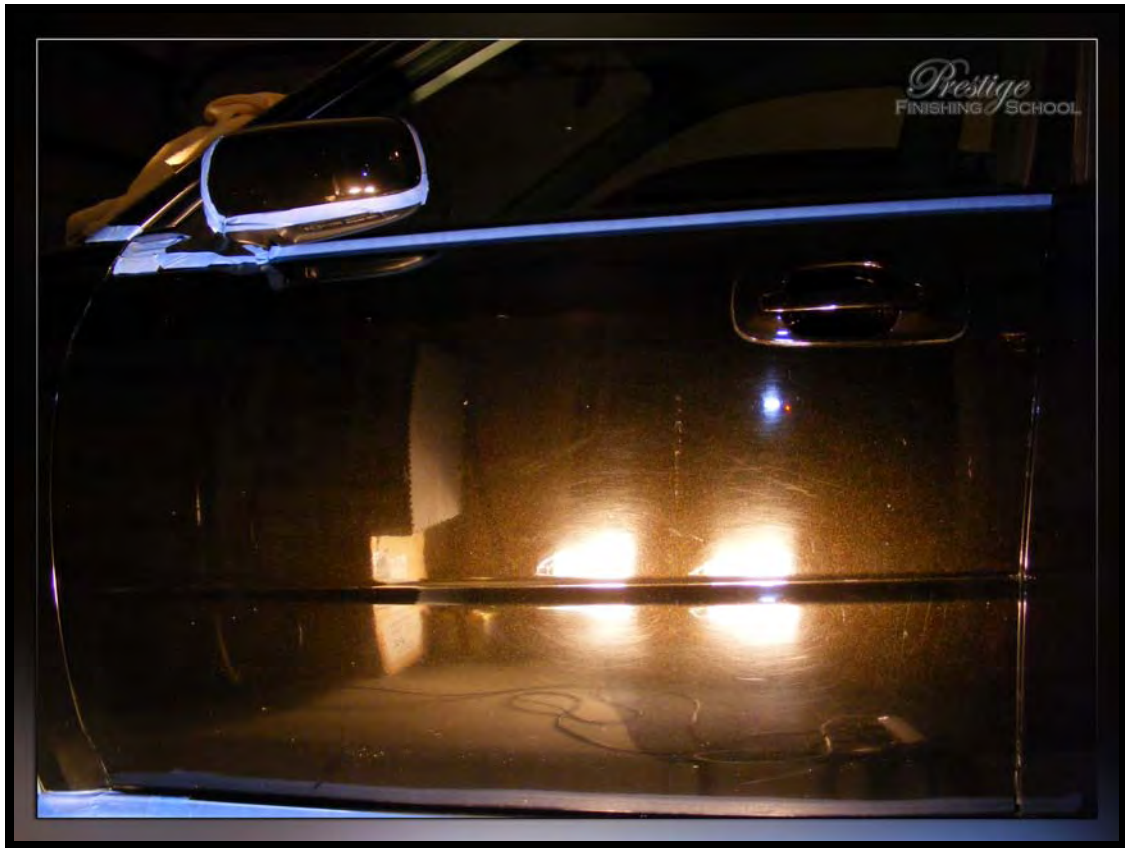
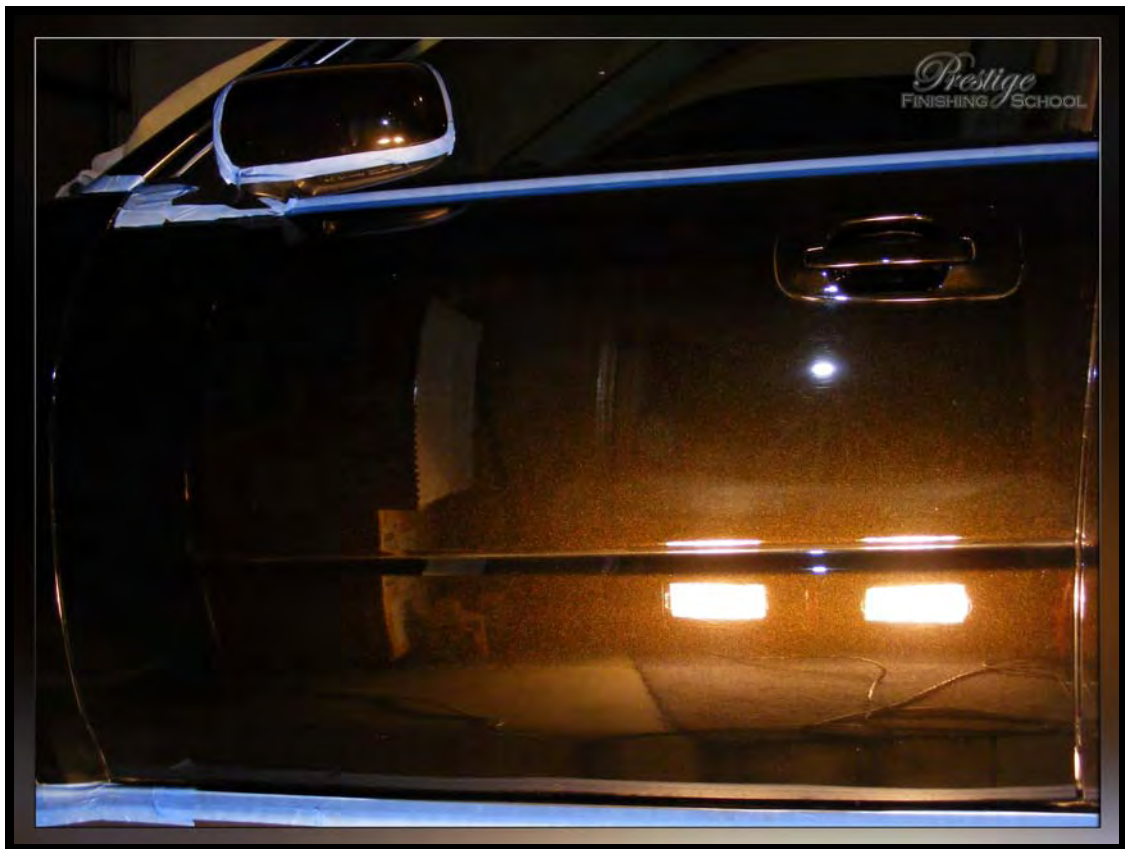
Near Side Front Door

This panel was showing evidence of many types of particularly harsh defects. As well as severe swirl marks, there are many deeper scratches as well as what looks to be impact damage from the door being opened against a post or other stationary object.

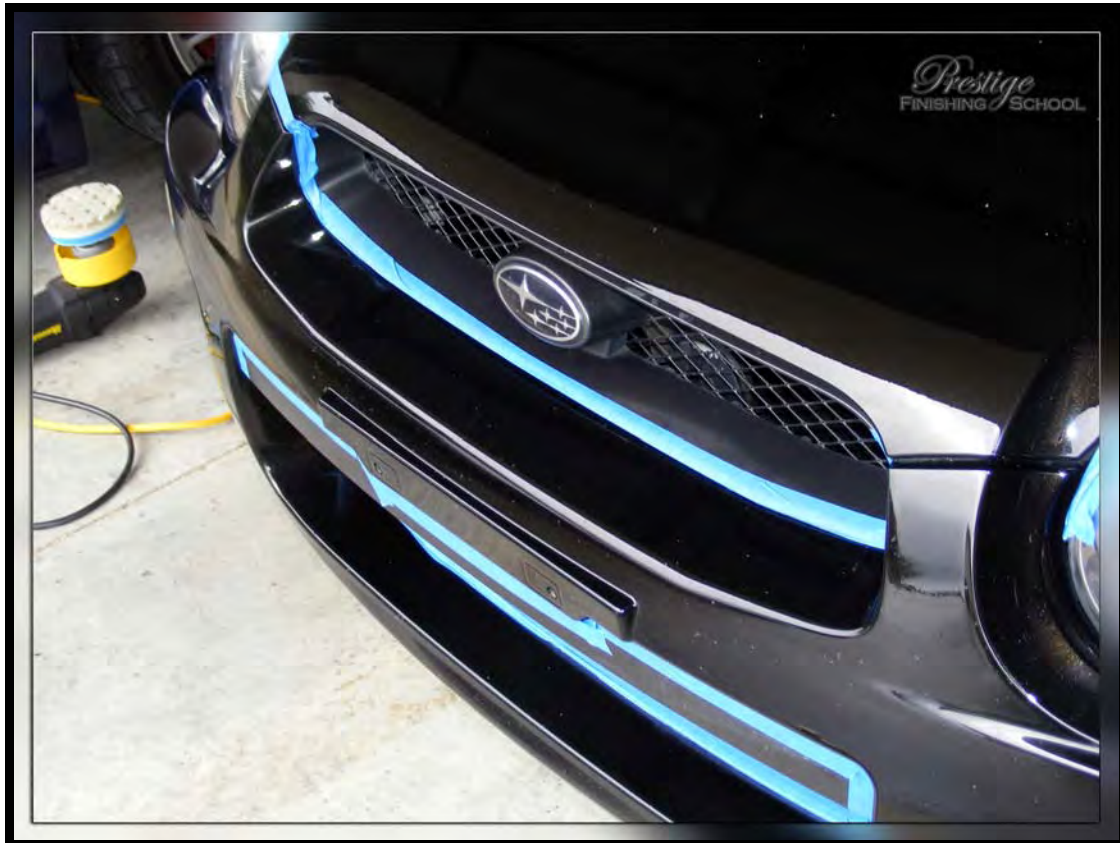
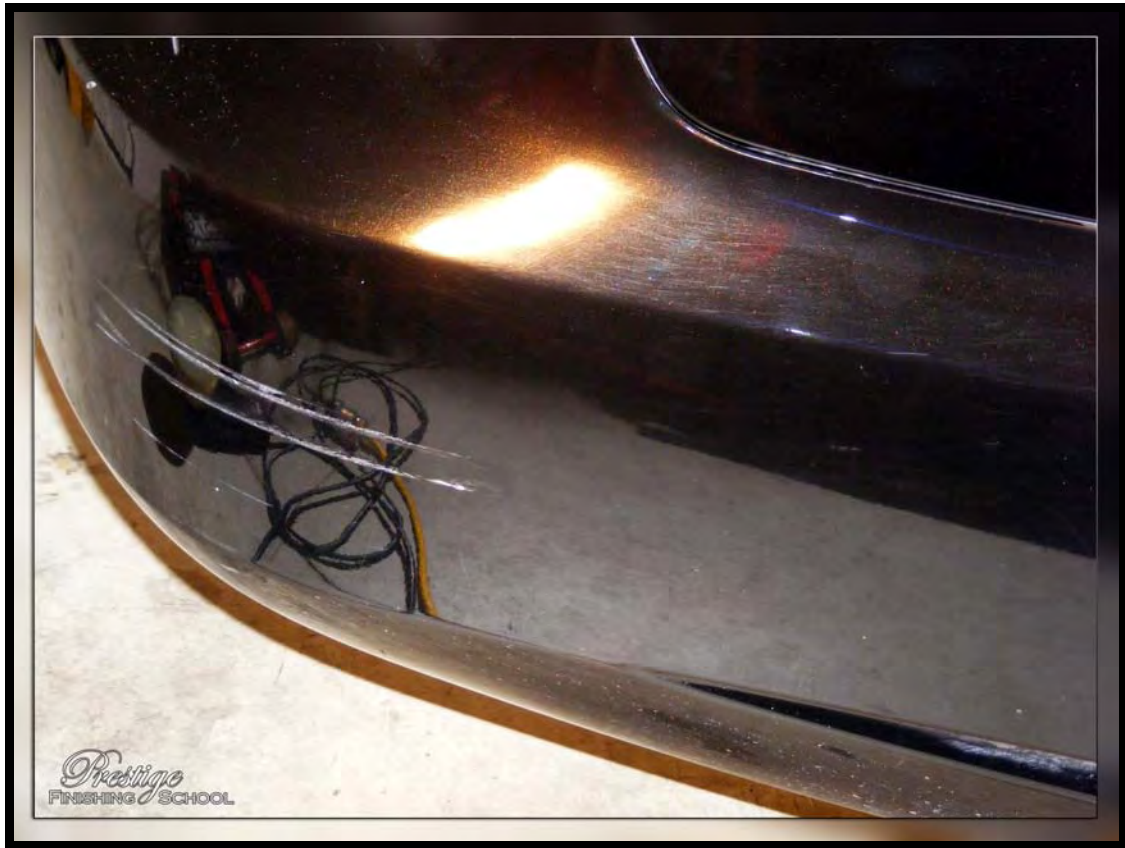
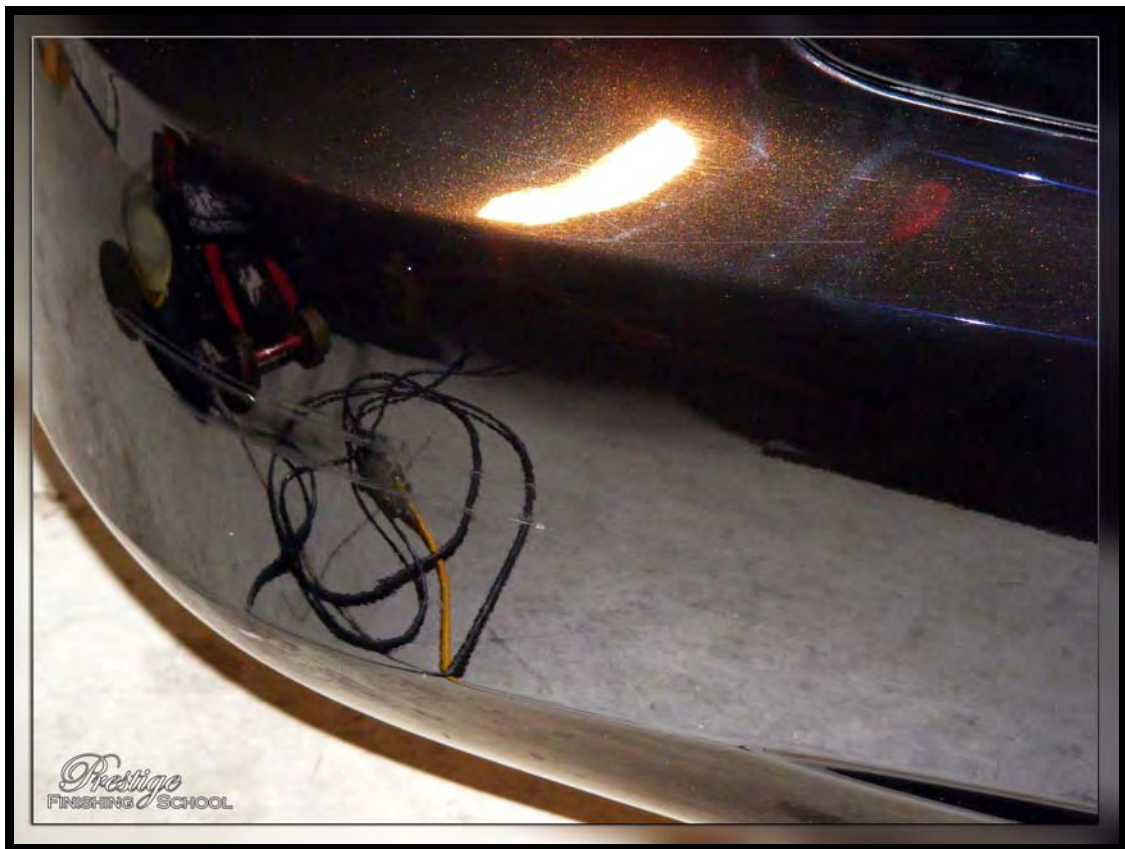
Bumpers

The bumpers were in a very bad state. A history of bumps, scrapes and a large number of stone chips all contributed to a generally poor state. These were tidied up as much as possible with a 4" light cutting pad on the G220 polisher.

The rear bumper was even worse, with numerous large scratches that went all the way through the paint to the ABS plastic mouldings. The visual impact of these was significantly reduced with the aid of a 6.5" Polishing Pad and Meguiars M83 Dual Action Cleaner Polish.

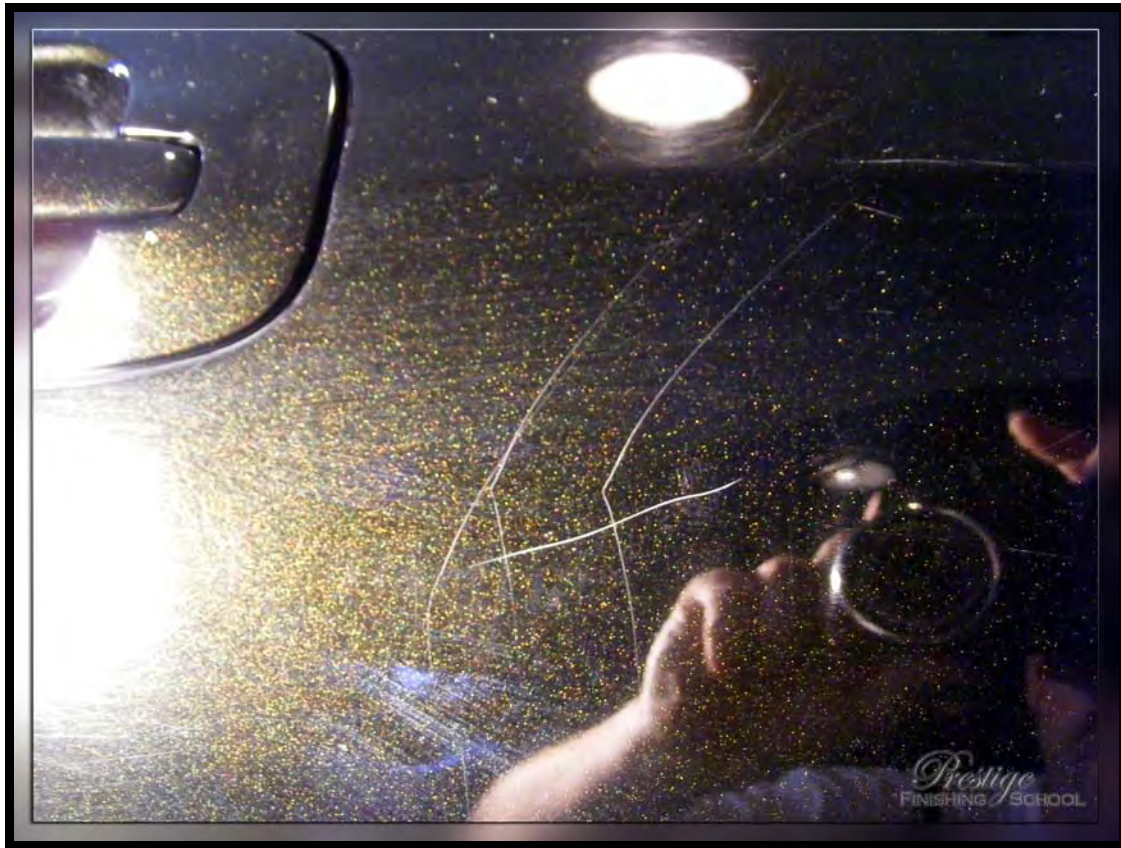
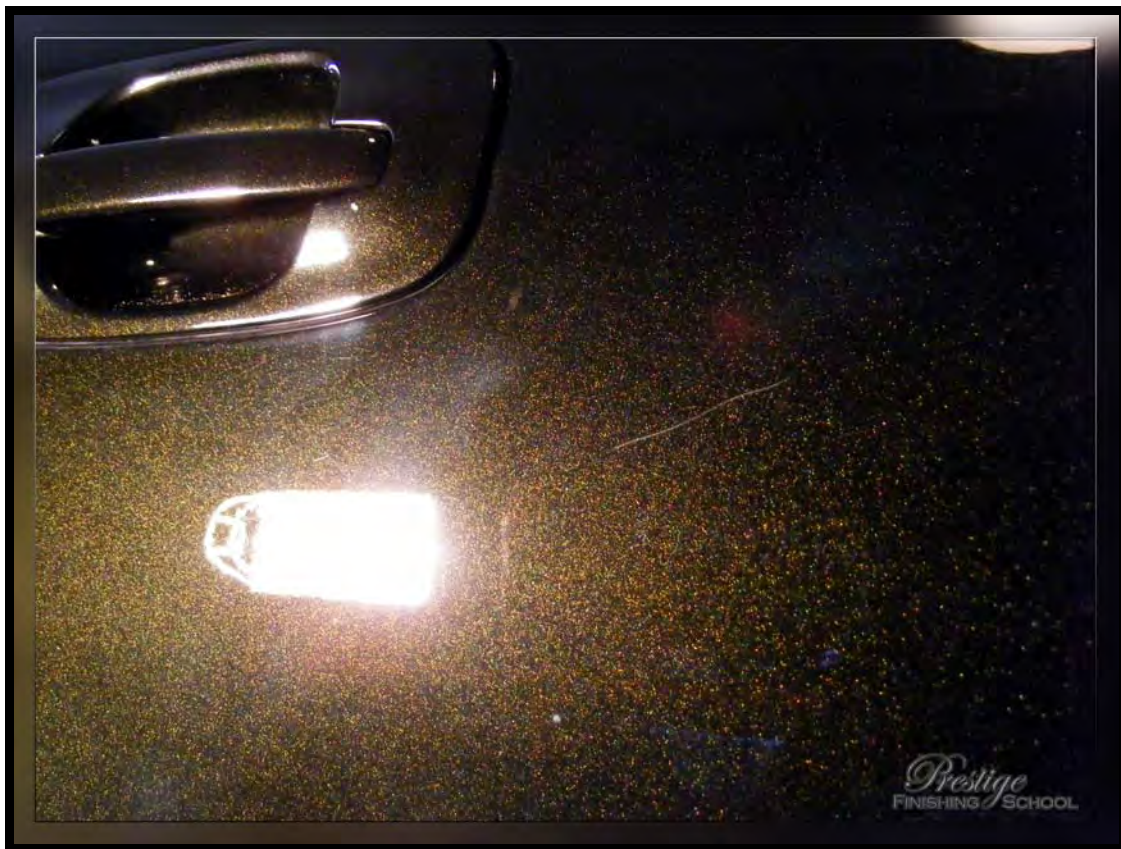
Some deeper scratches to be removed...
