Report Card:

2003 Subaru Impreza WRX Hatch (Black)

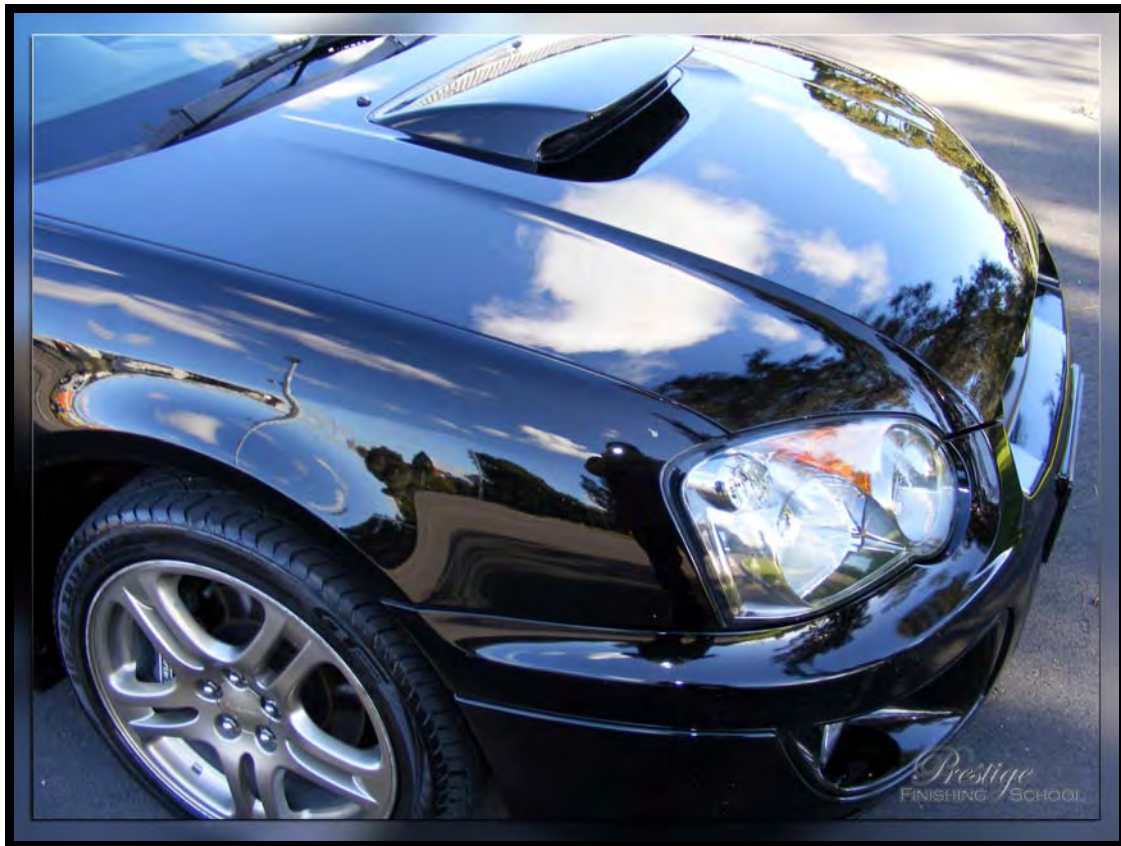
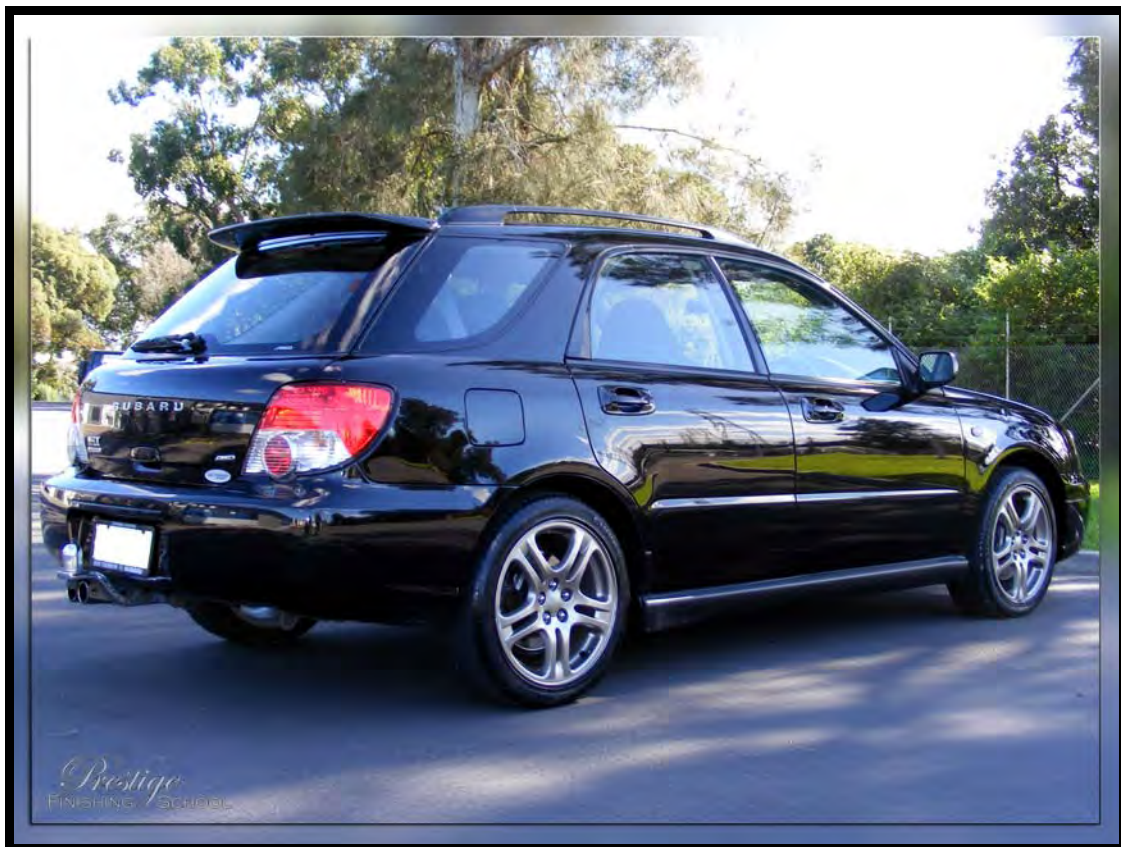
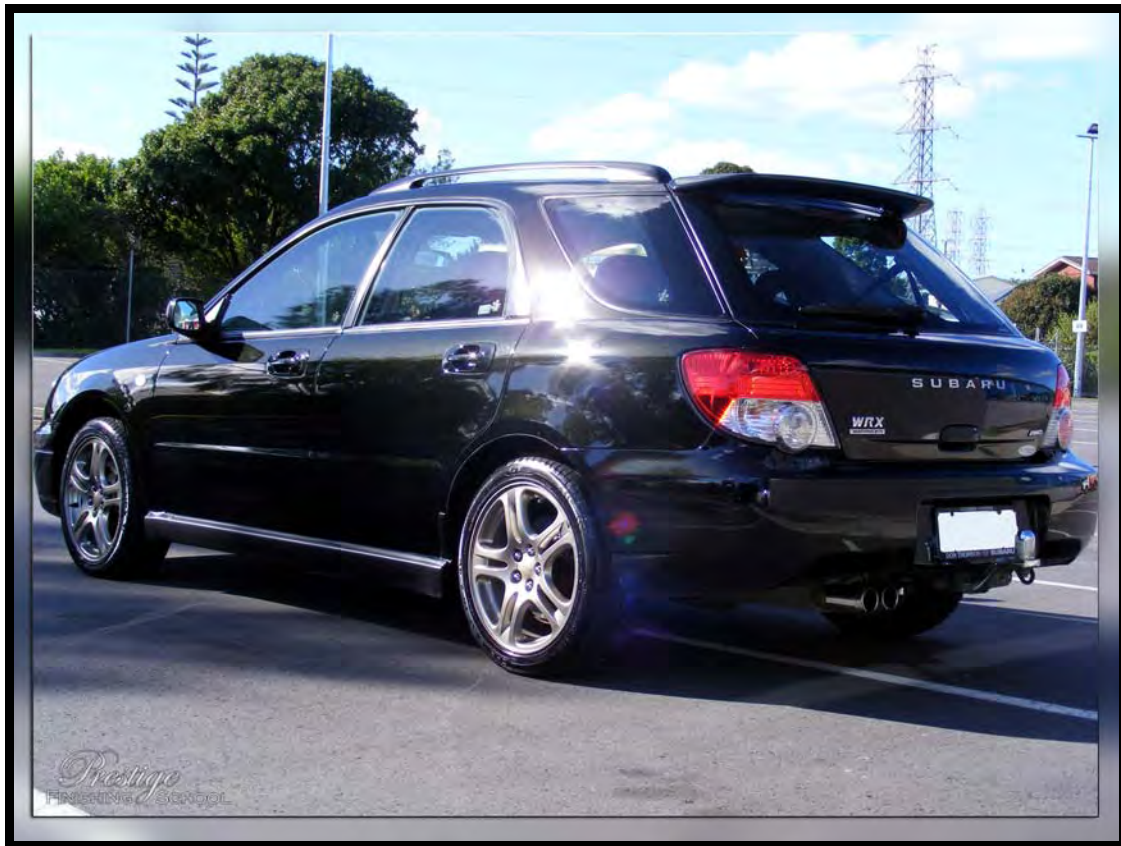
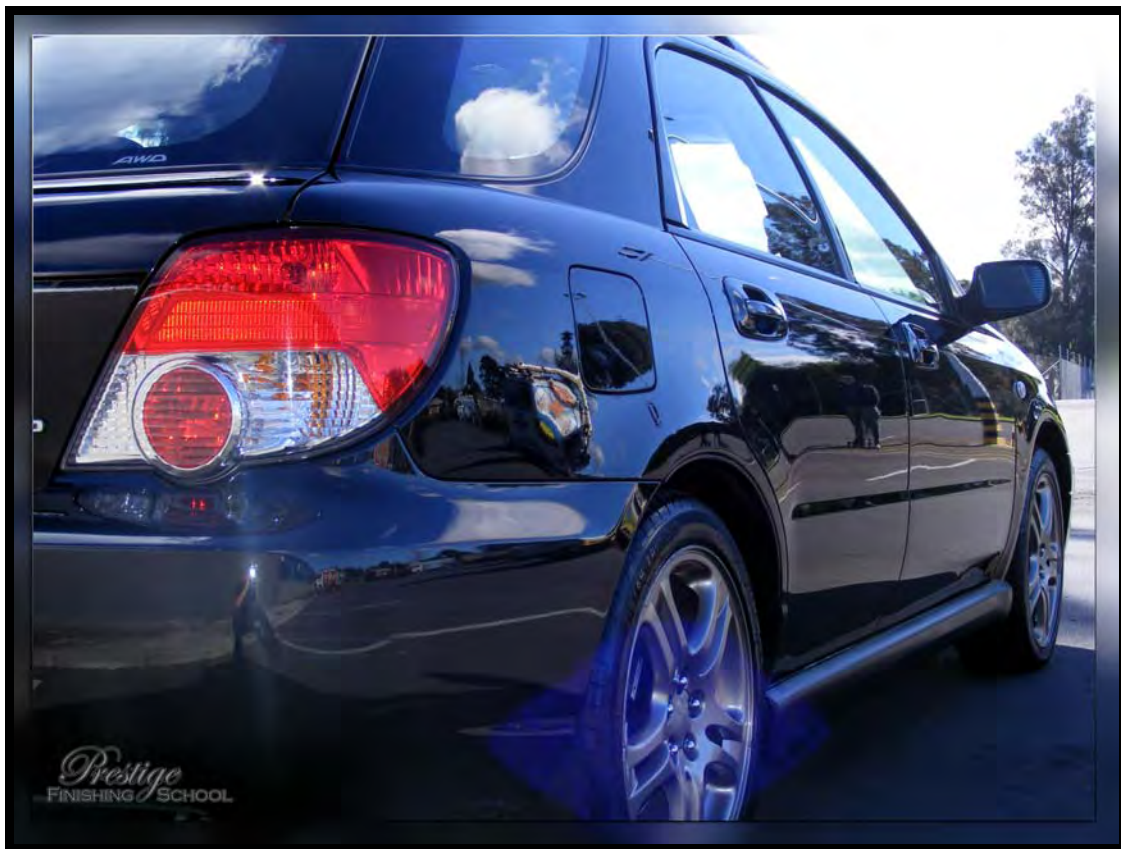
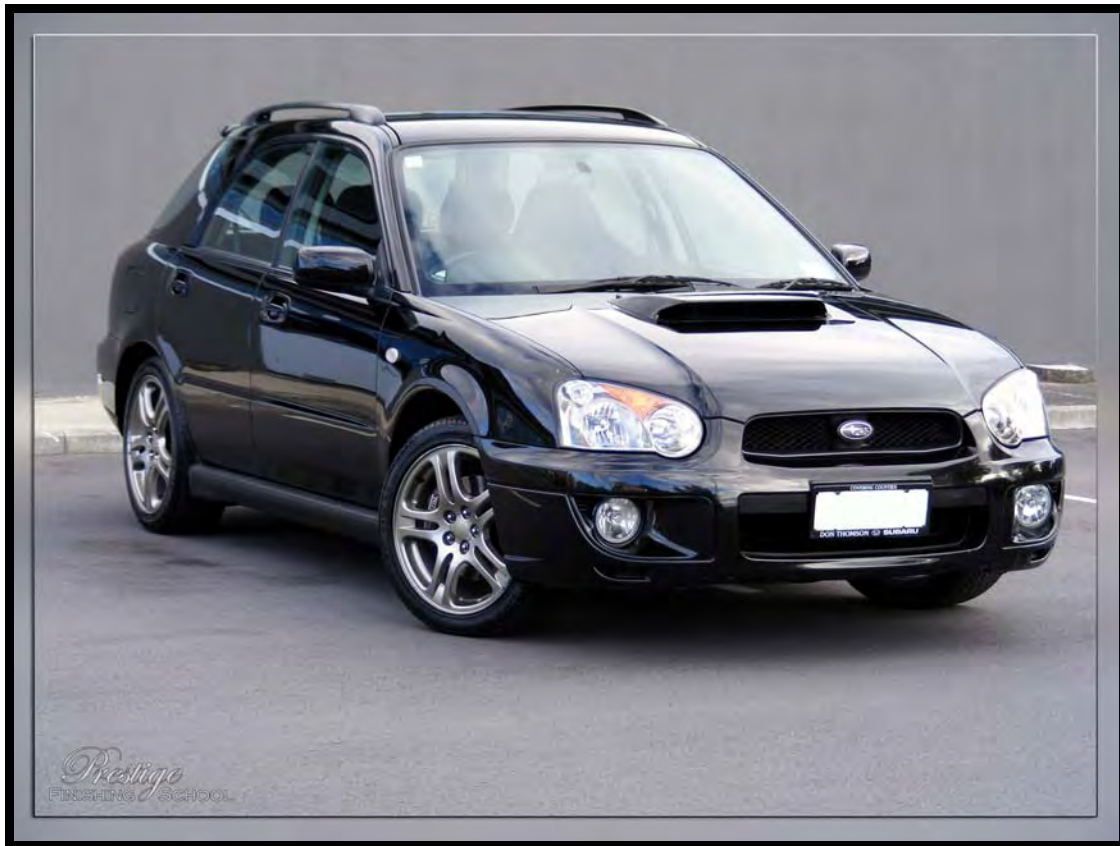
In the end, we are absolutely delighted with the results. This represents more than 19 hours meticulous hard work – with over 12 hours of machine polishing alone!

However, the most important factor is that this mirror finish will not simply “wash off” in the next rainstorm. By adopting a smart wash routine (Avoiding sponges and using the two-bucket-method) and staying away from automatic carwashes, the owners can preserve this level of shine and reflectivity for many years.
