**Report Card:**

2003 Ferrari 575 M Maranello F1 (Silver)

## 1.0 Enrolment:

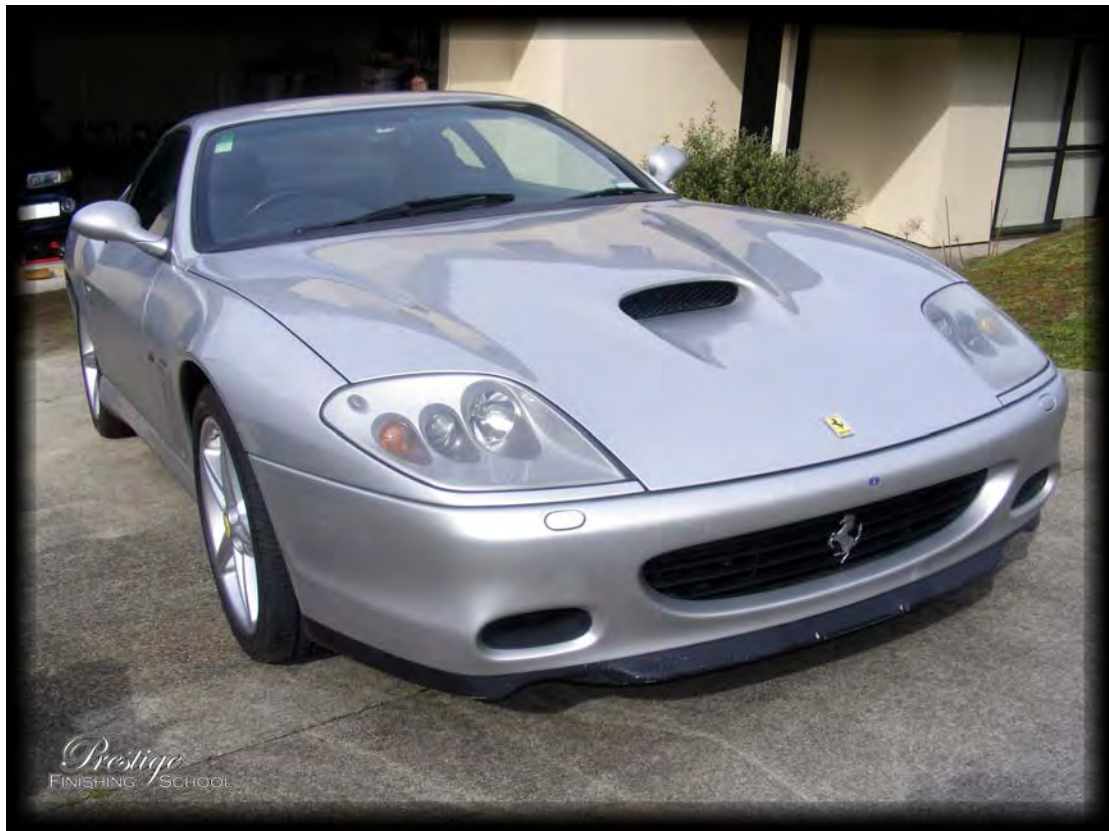
This was the condition of the 'Prancing Horse' on arrival. We promise to keep the equestrian metaphors to a minimum, but clearly this specimen had been "ridden hard and put away wet"!

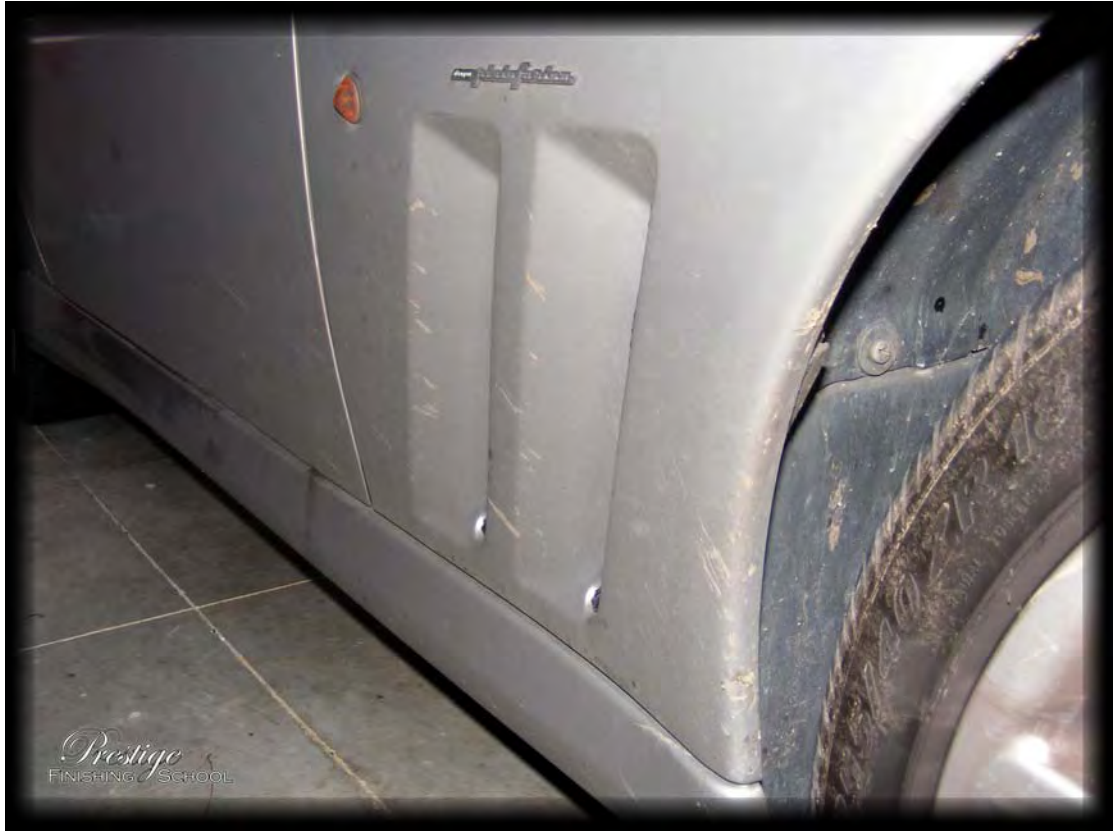
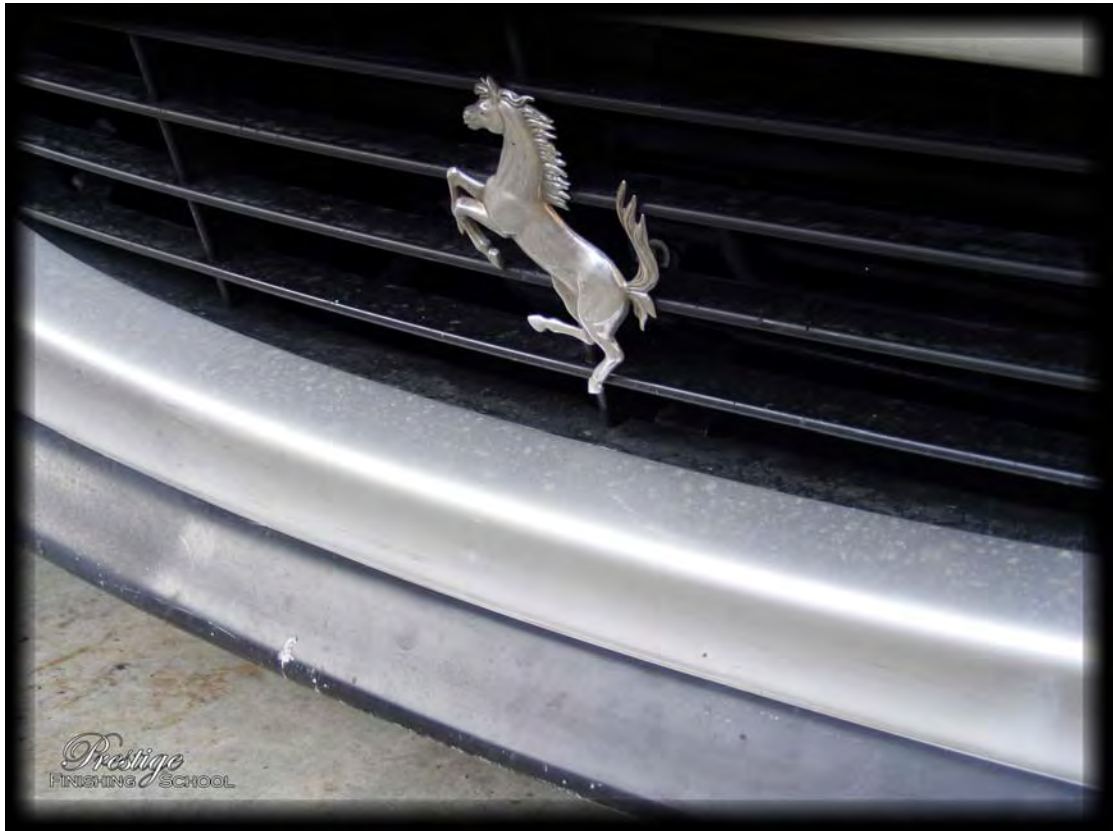
The wheel rims appeared to be in especially poor condition...

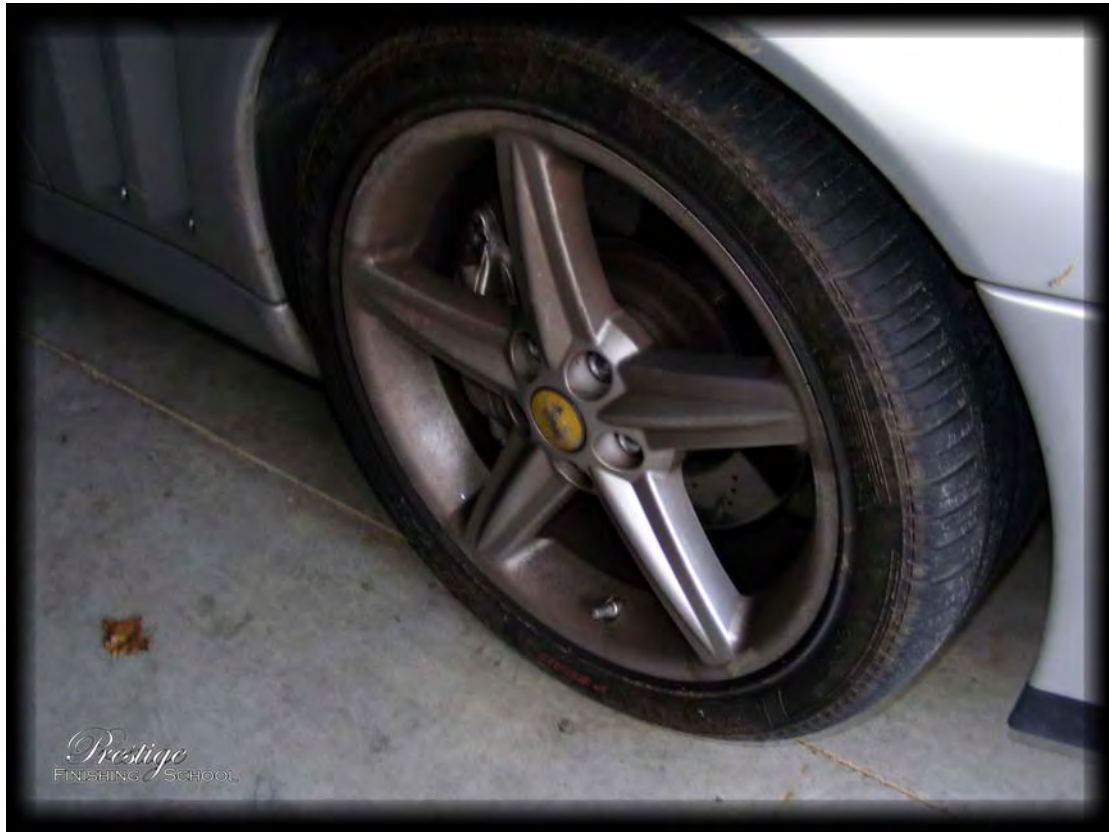
...with a nice collection of bonded brake dust and tar.

To fully clean the leftover tar and etching that the brake dust had left on the inner rims, we used Menzerna Wheel Gel 7.5 from Germany. This product is ph neutral and completely safe for all wheel surfaces.

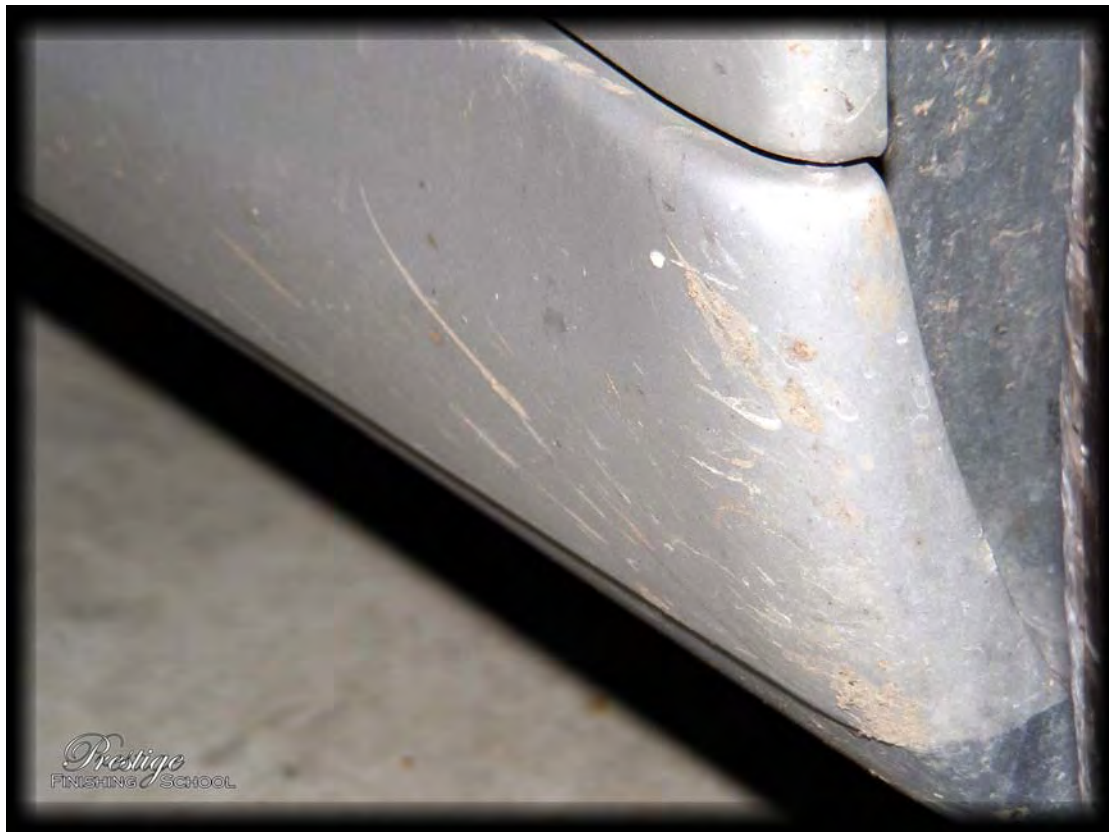
And someone has kindly left some wax behind to help with the detail ☺

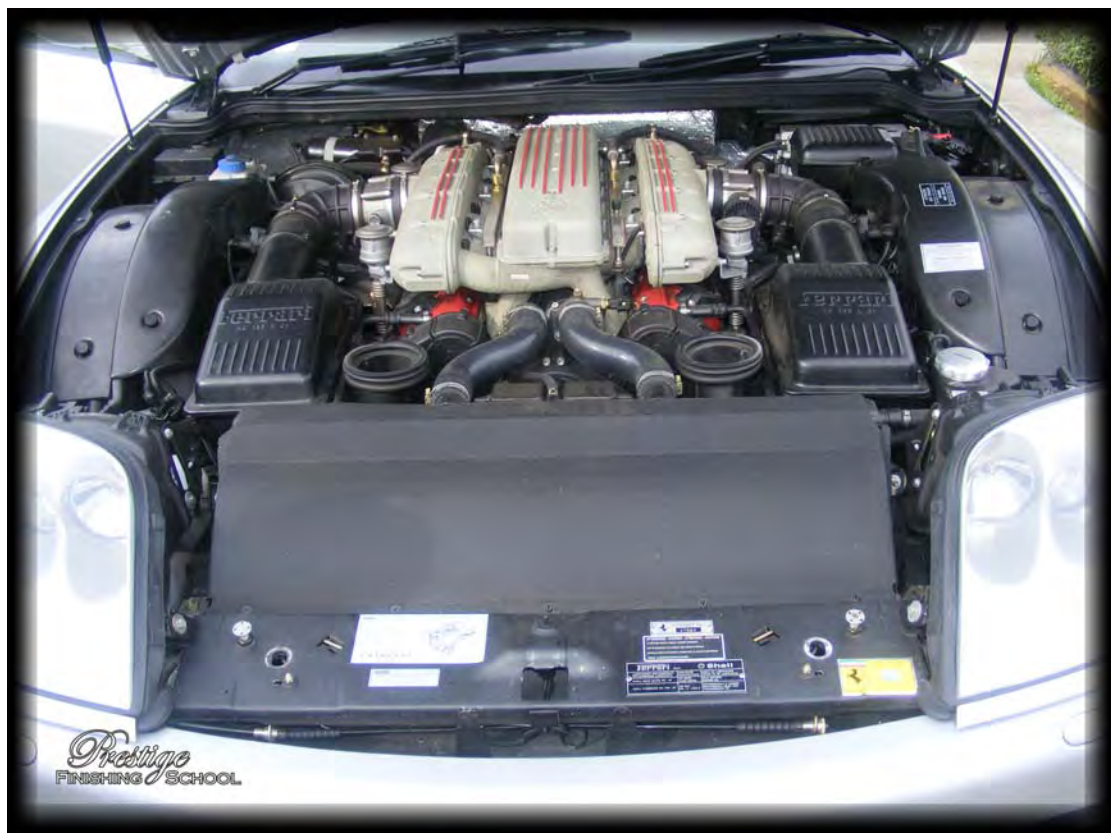
To begin, the engine bay is detailed. On arrival, it was in relatively good shape...

...with only a light dusting of dirt over most surfaces.

This was 'wiped' clean with Meguiars APC rather than 'wet washed' and plastics protected and dressed with 303 Aerospace Protectant.

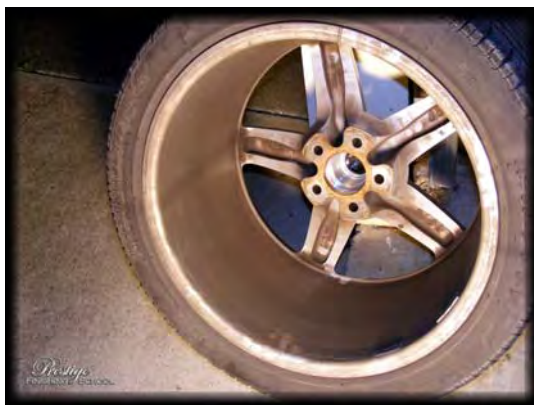
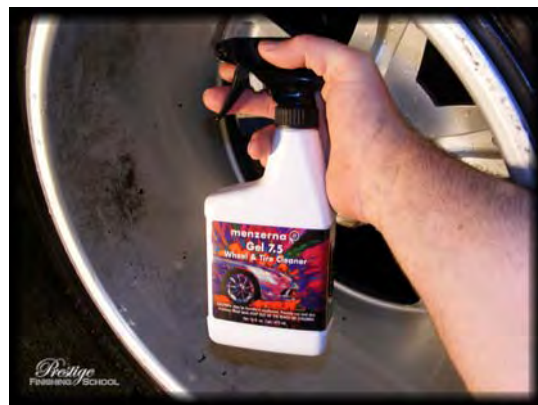
The first picture shows the state of the wheel straight off the car, while the second image represents the state of the same wheel after a thorough cleaning and scrubbing with Meguiars NXT shampoo.

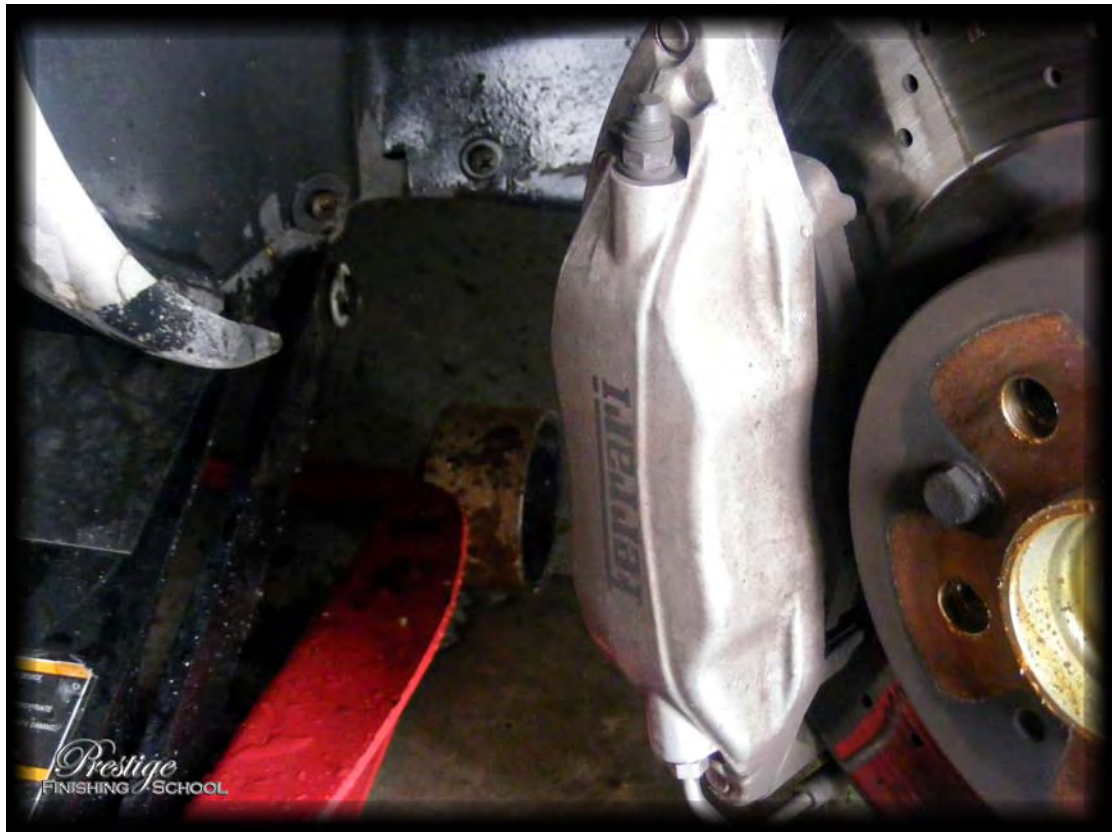
Having the wheel off also gives us the opportunity to completely clean the brake calipers.

Menzerna 7.5 was used again for this application.

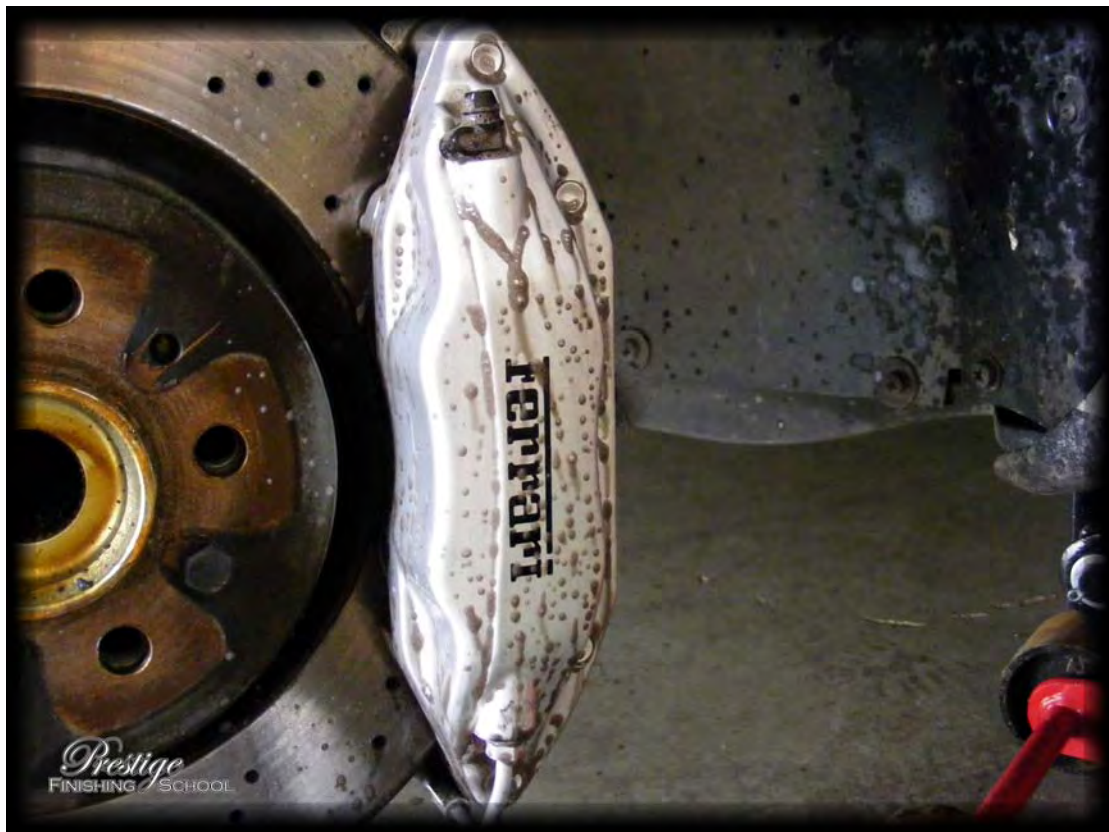
And front wheel wells. Notice the grime on the black arch liners. This was scrubbed clean with Meguiars All Purpose Cleaner.

This gave excellent results.

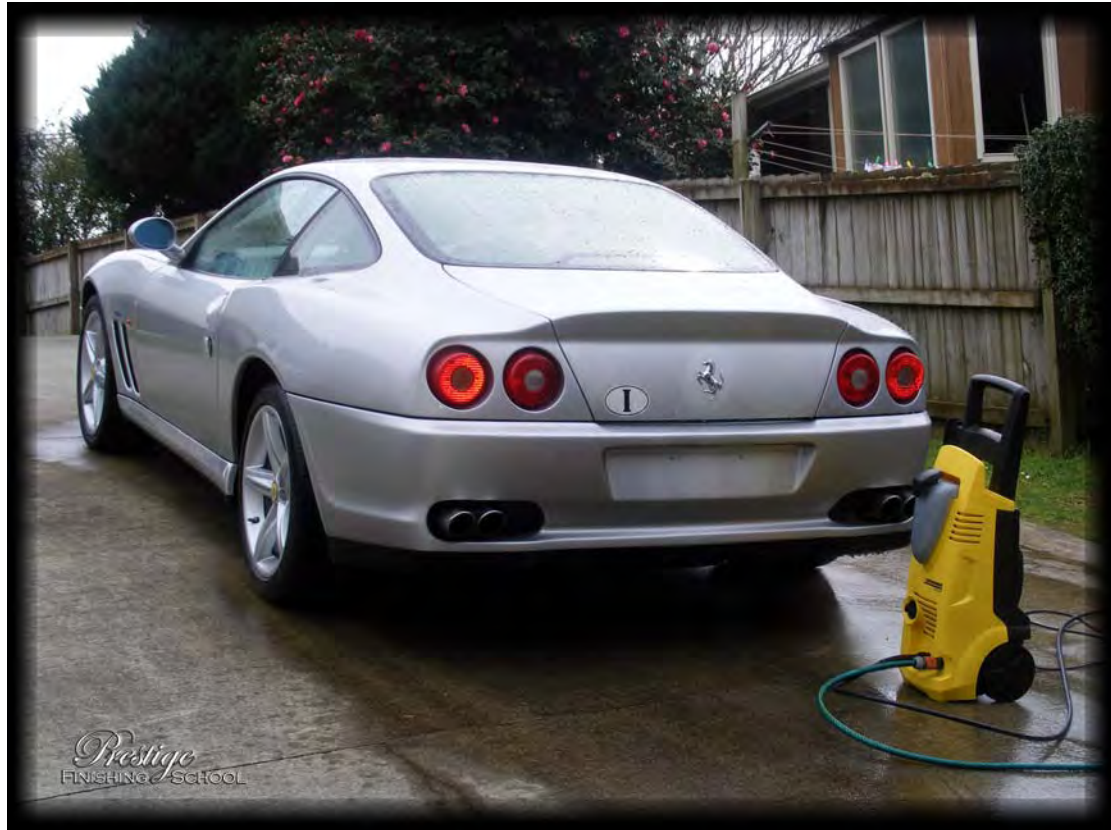
The paint may well look clean after this, but notice the color difference in the paint around the prancing horse emblem on the boot where the APC has been worked in... There is still plenty of dirt left to remove!

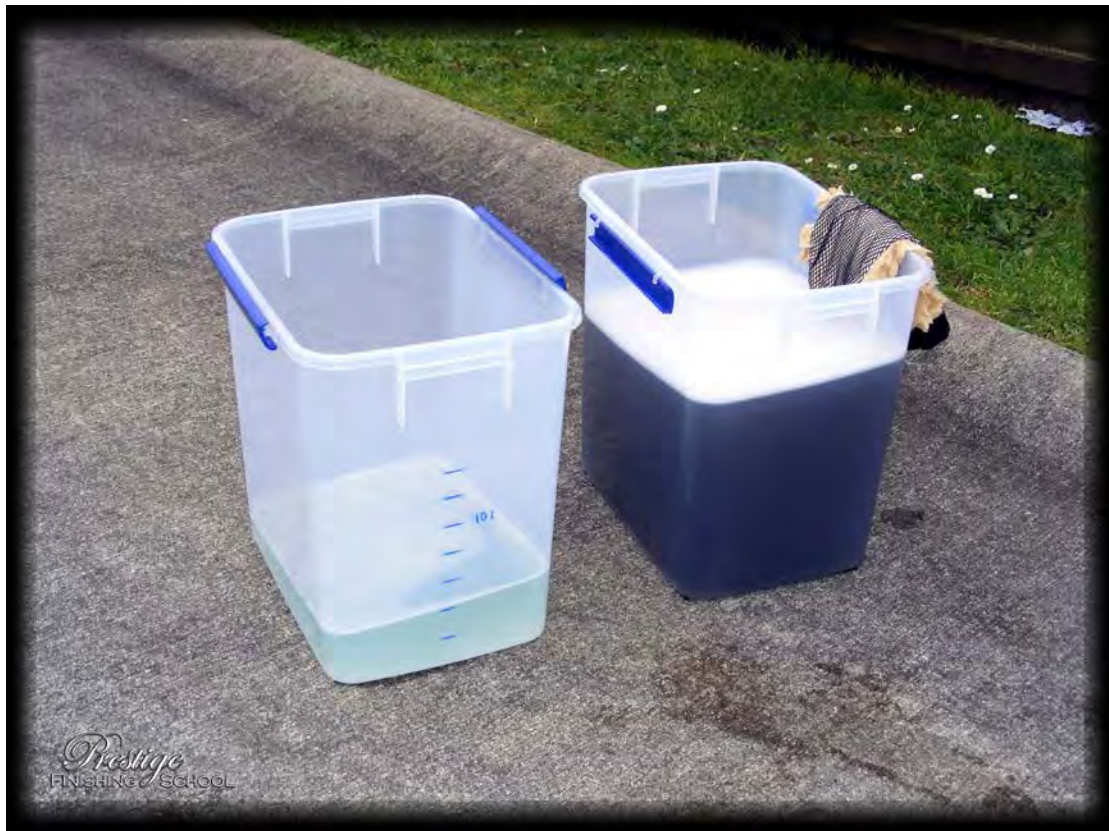
If you consider the use of two buckets 'overkill', look at the state of the rinse bucket after completing the wash.

Would you consider wiping your car with anything soaked in the bucket on the right?

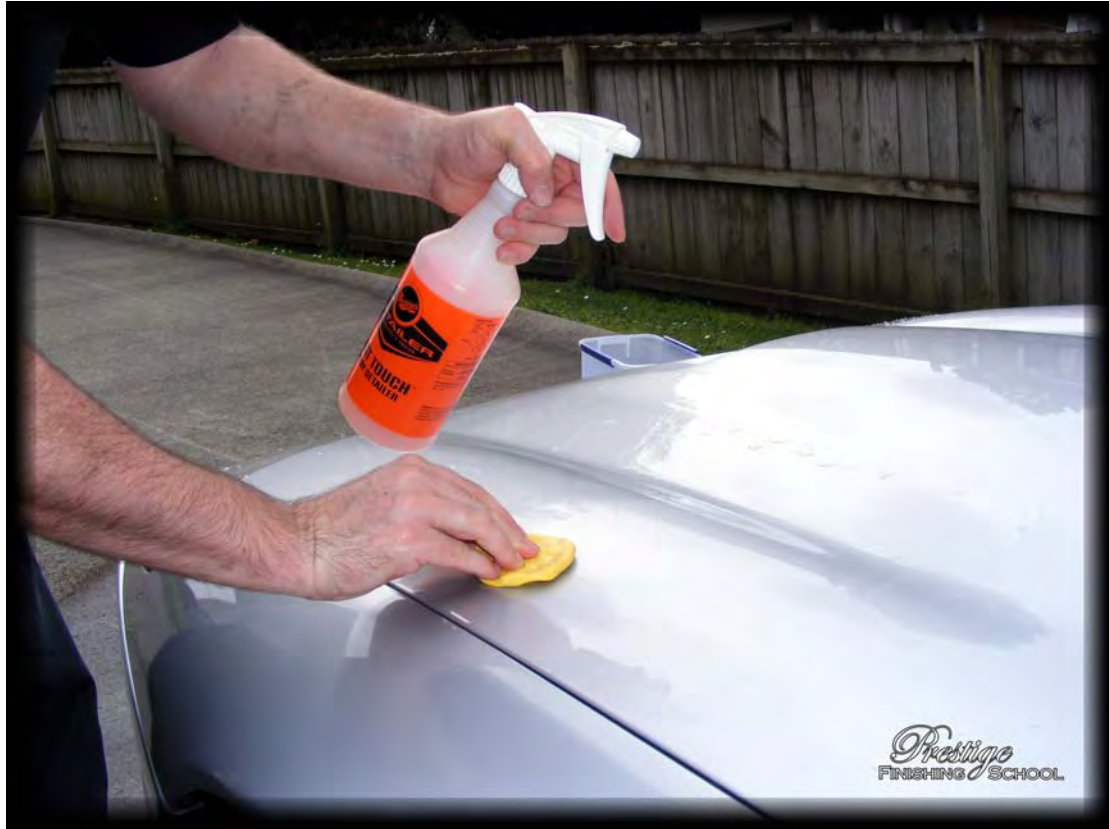
The final step in ensuring a perfectly clean paint surface is the removal of bonded contaminants with a detailing clay bar. This process can remove tar spots, tree sap or industrial fallout, all of which contribute to making the paint surface rough to the touch and dull to look at. In this instance, a Meguiars 'Mild Detailing Clay' bar was used with Meguiars Last Touch (diluted 1:1) as lubrication.

This particular car was almost completely free of bonded material, with an almost perfectly smooth feel to it after washing off the surface dirt. Accordingly, the 'Mild' bar was all that was necessary.

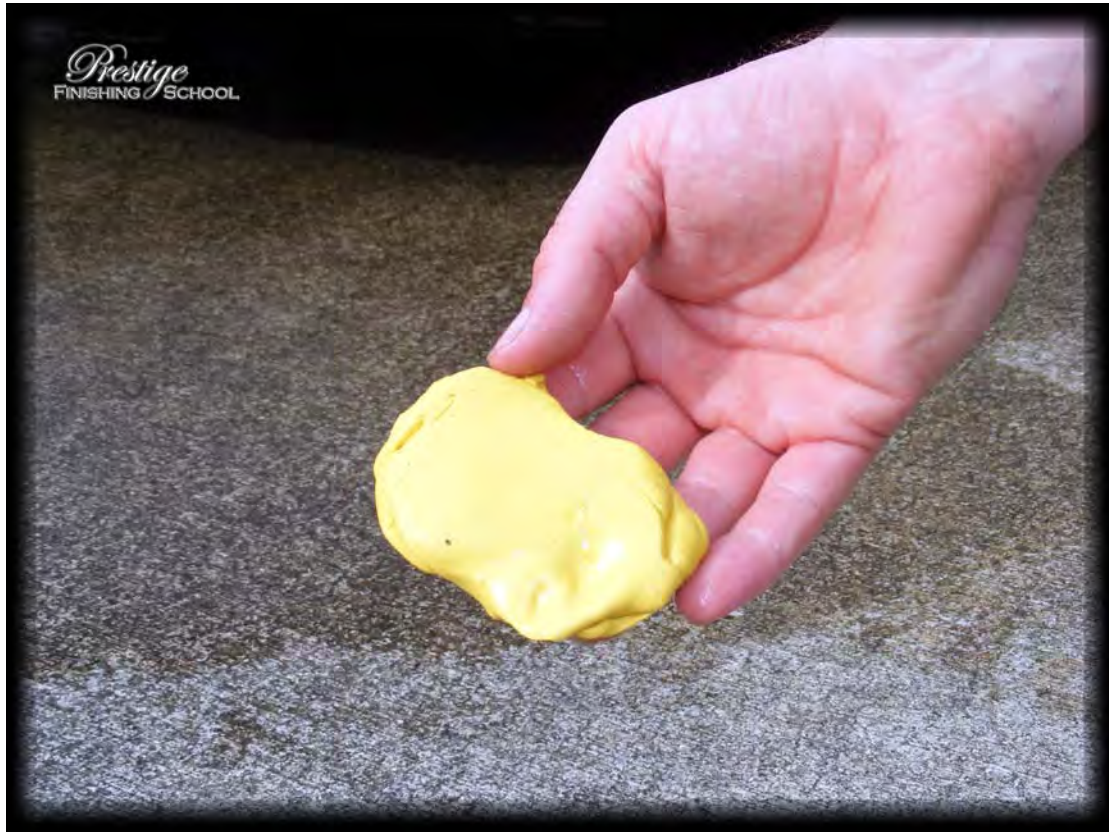
And as you can see, very little contamination was removed from the paint.

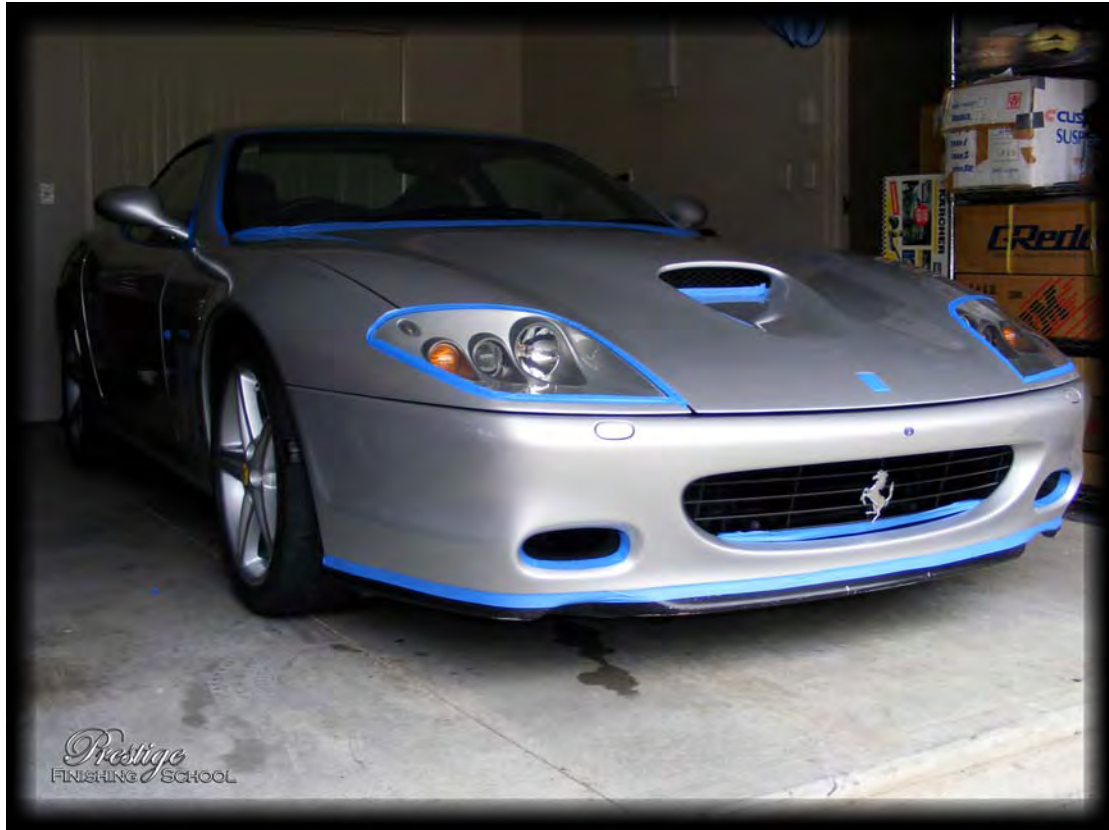
At this point, we get to see and understand the true and unadulterated state of the vehicle bodywork. Without the benefit of any (defect masking) wax and under the unforgiving twin 500W Halogen lights, the paint surface was holding up reasonably well!

The vehicle's trim is masked off with purpose made 3M painters tape. This serves to protect the trim pieces from being stained with residue during the polishing process. Additionally, it prevents damage to badges and sharp edges as well as preventing dusting from the polishing stage from getting into gaps and requiring re-cleaning.

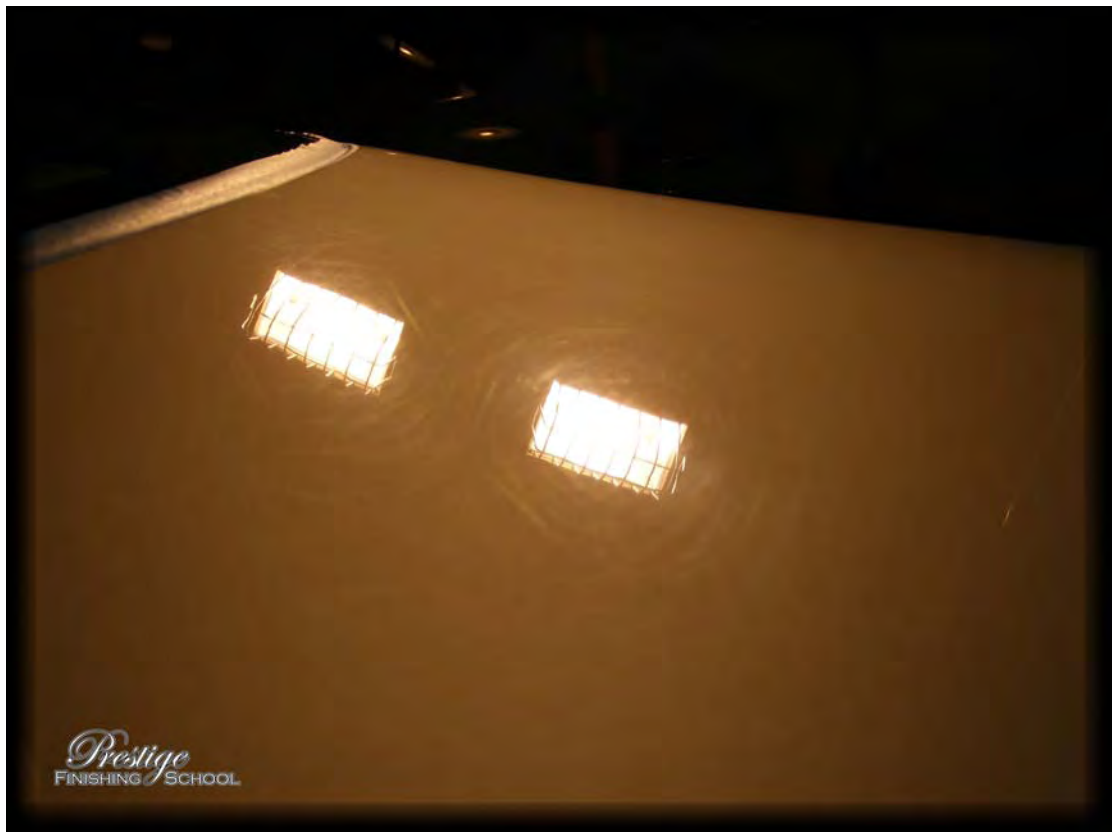
...and on the boot lid.

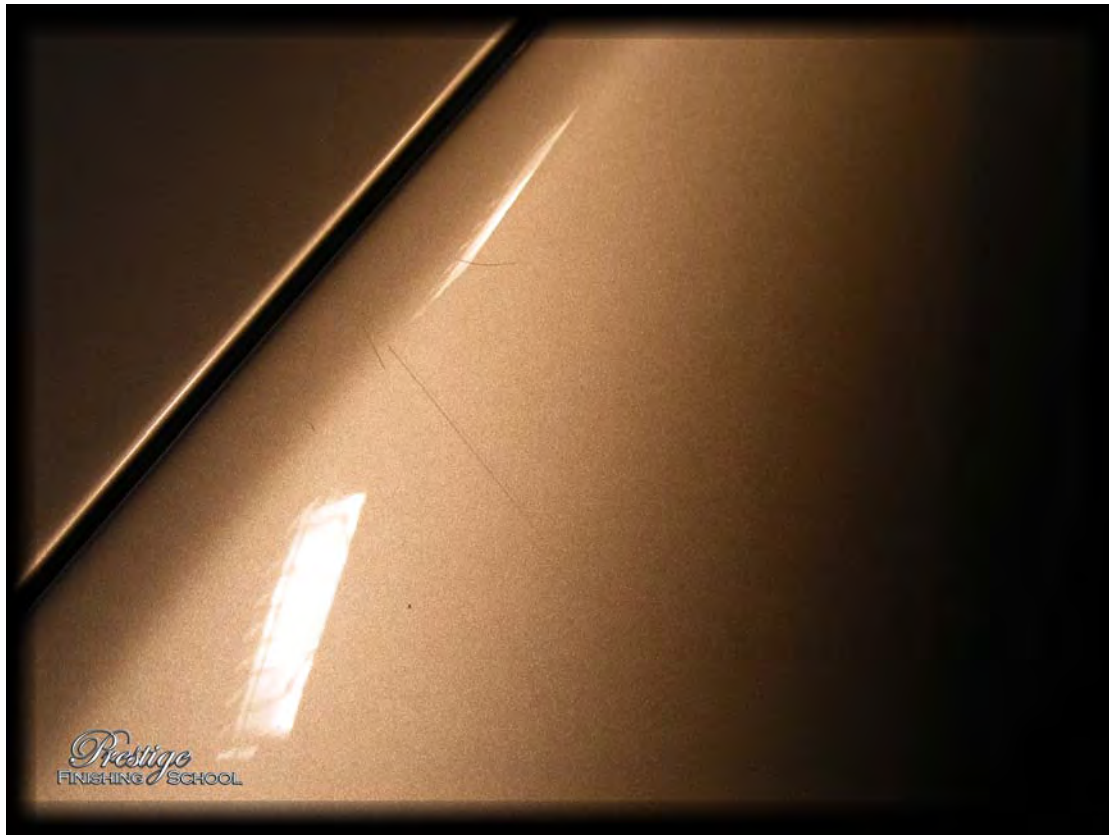
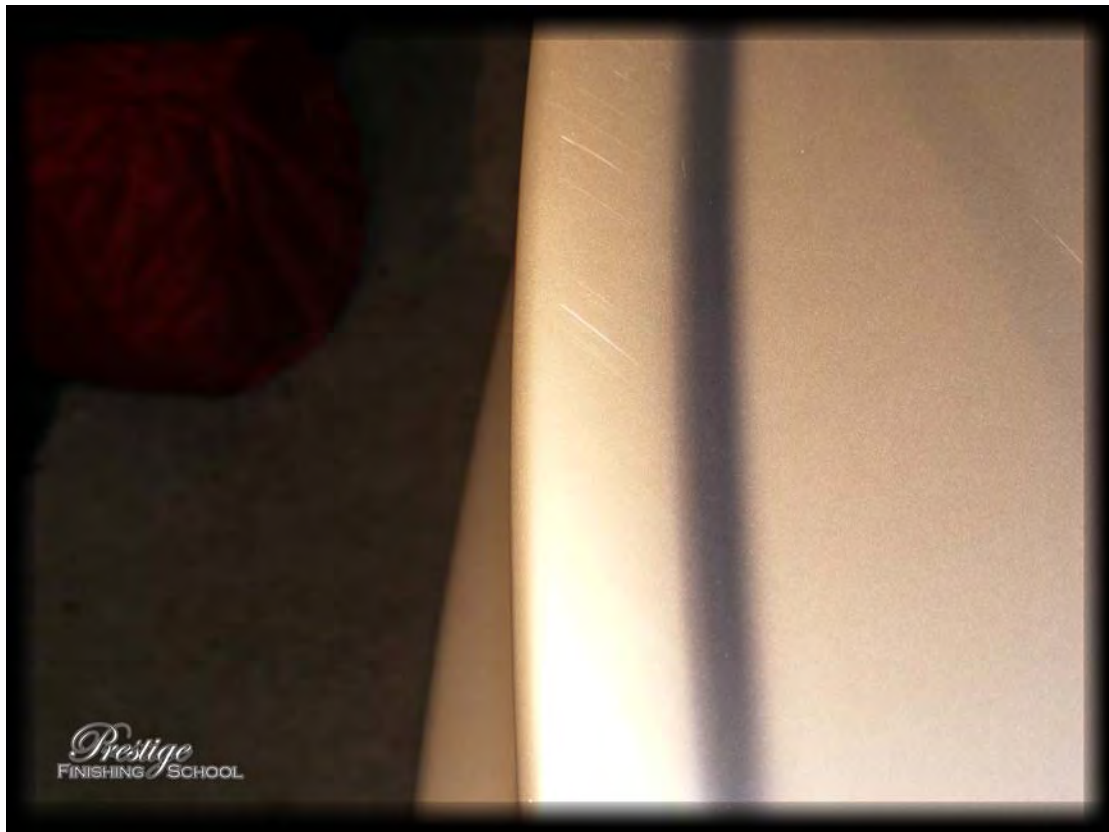
There are a number of small deeper scratches around the vehicle. These would require heavy compounding and cutting, prior to polishing in order to remove them and unfortunately this was beyond the scope of this “Minor Correction” detail.

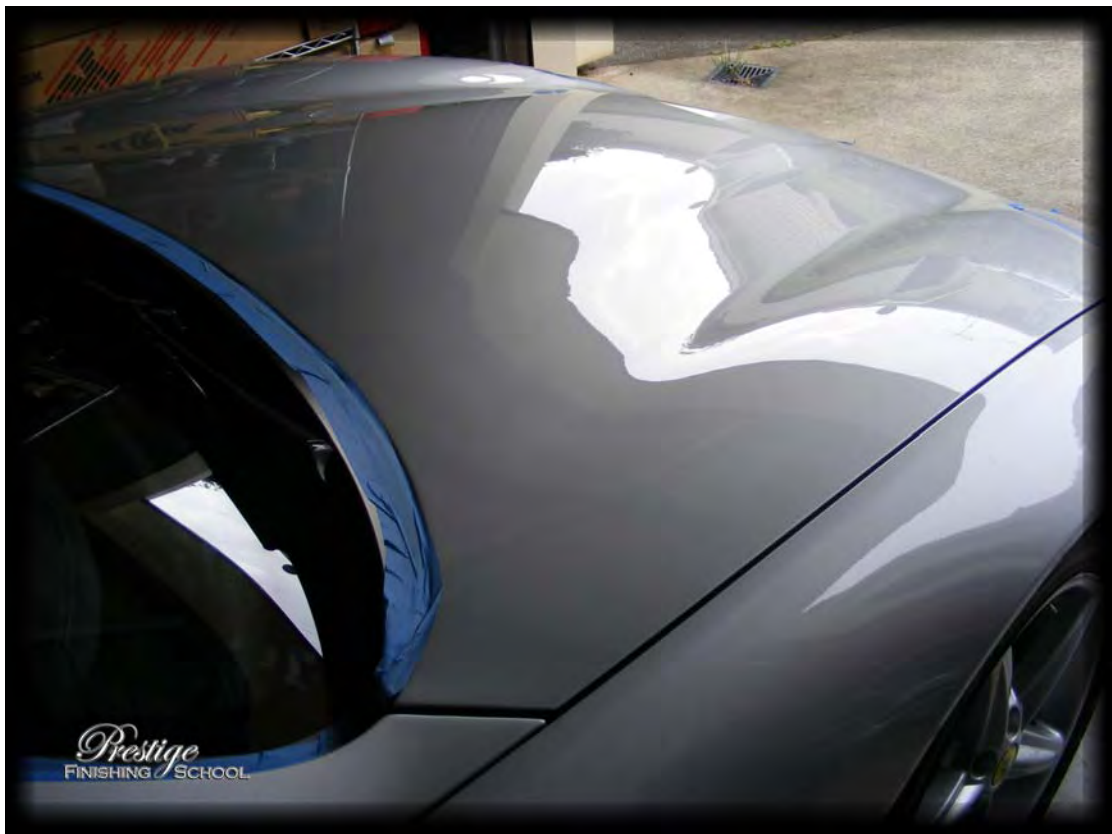
...this gave great results on the bonnet.

We started out with our mildest polish, Meguiars M80 Speed Glaze.

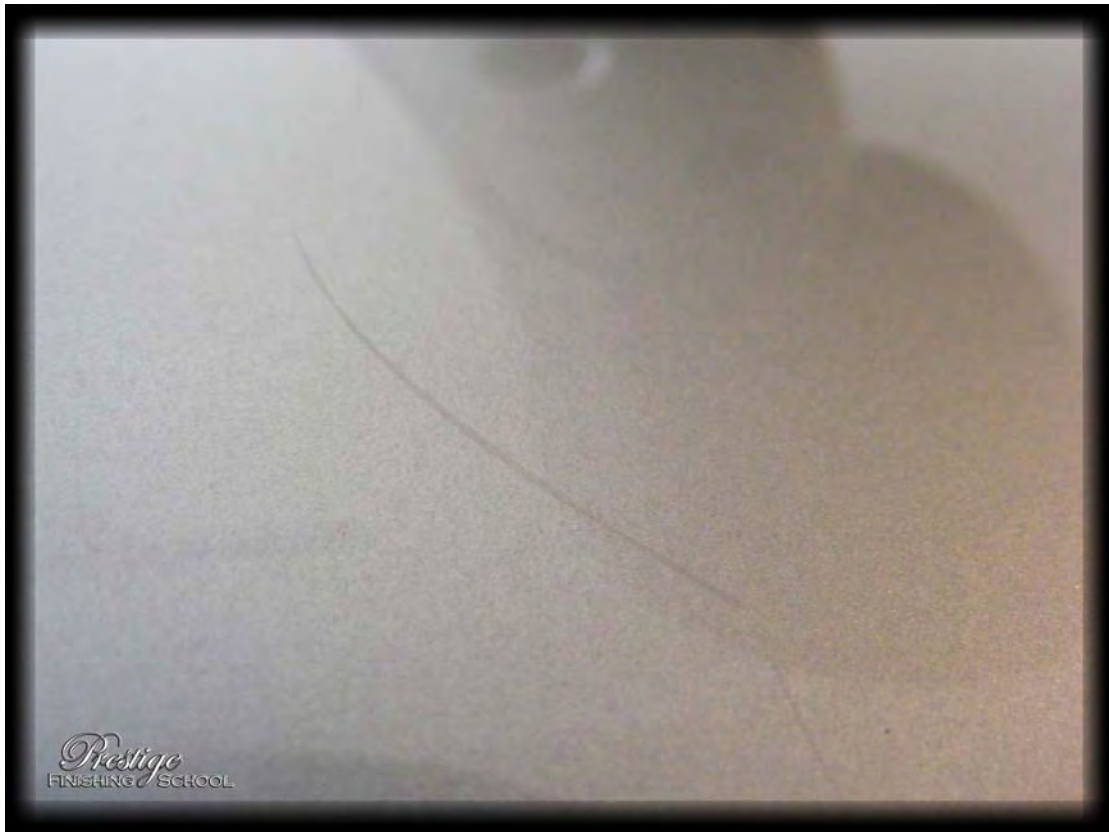
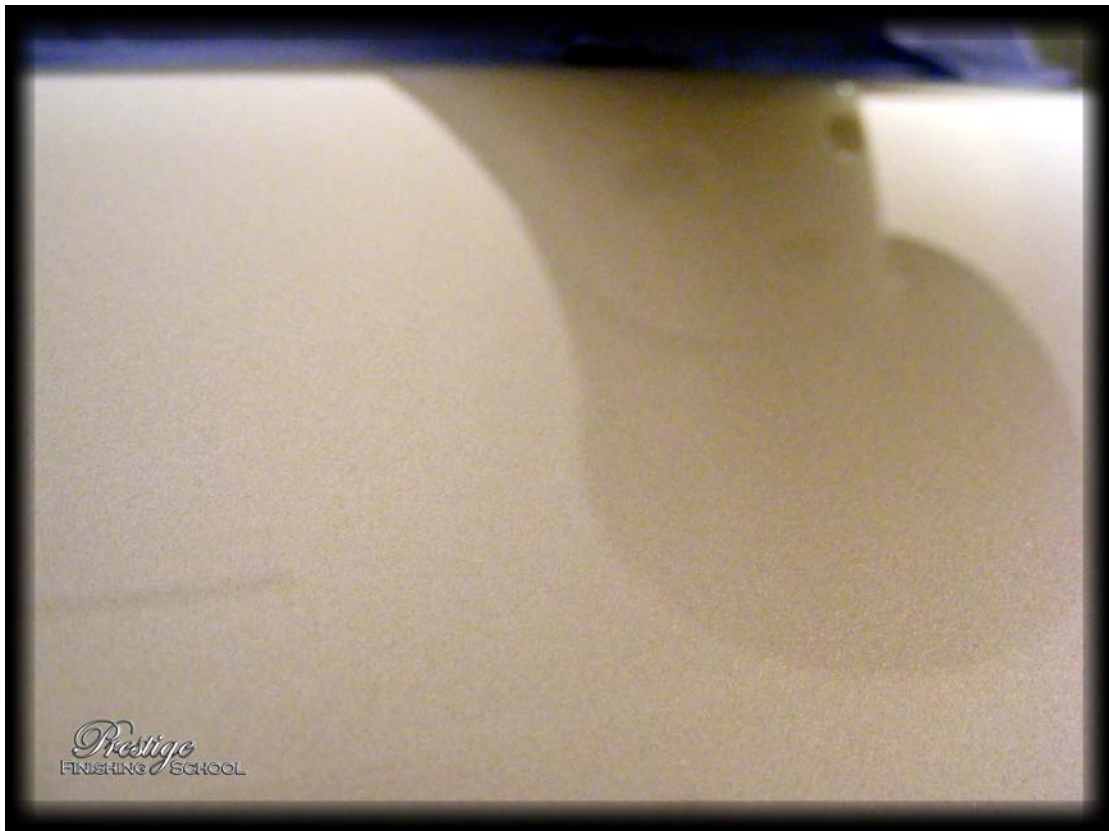
The M83 was also used to remove some of the lighter scratches, such as this one under the wing mirror on the passenger's door.

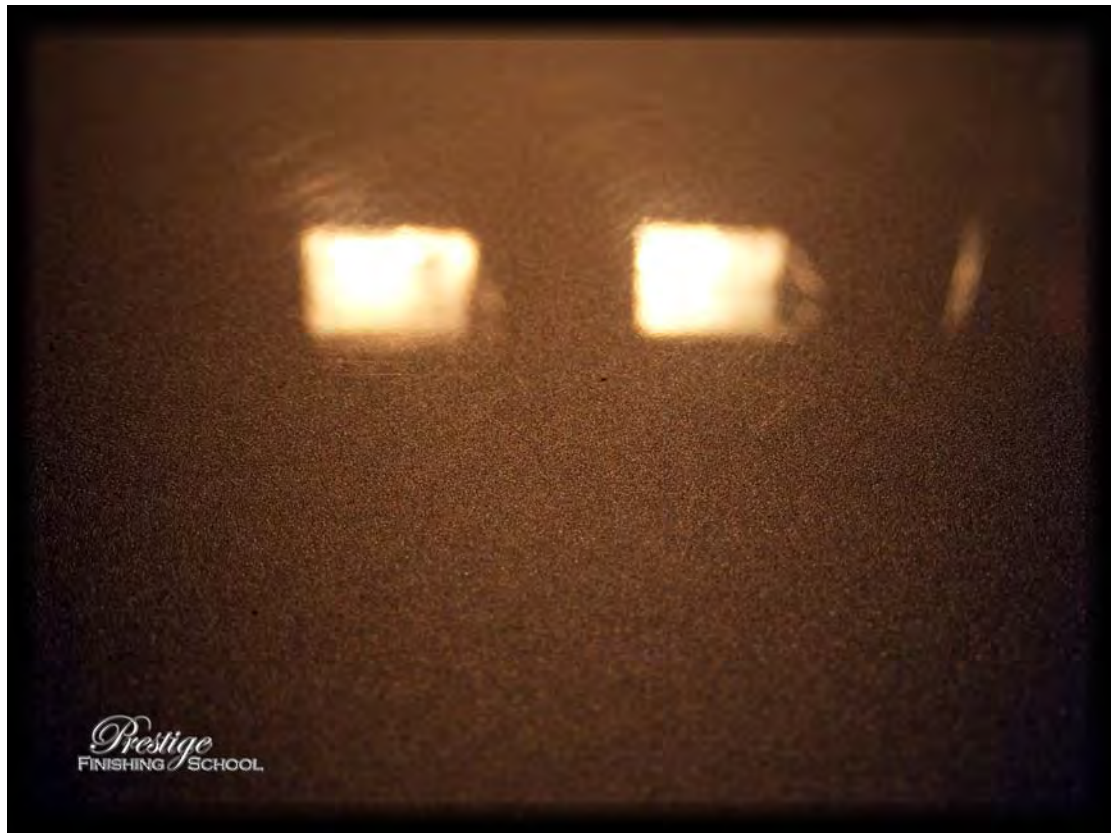
Even the best looking panels were showing faint evidence of light swirling when examined extremely closely

...and these were corrected to a perfectly blemish free finish.

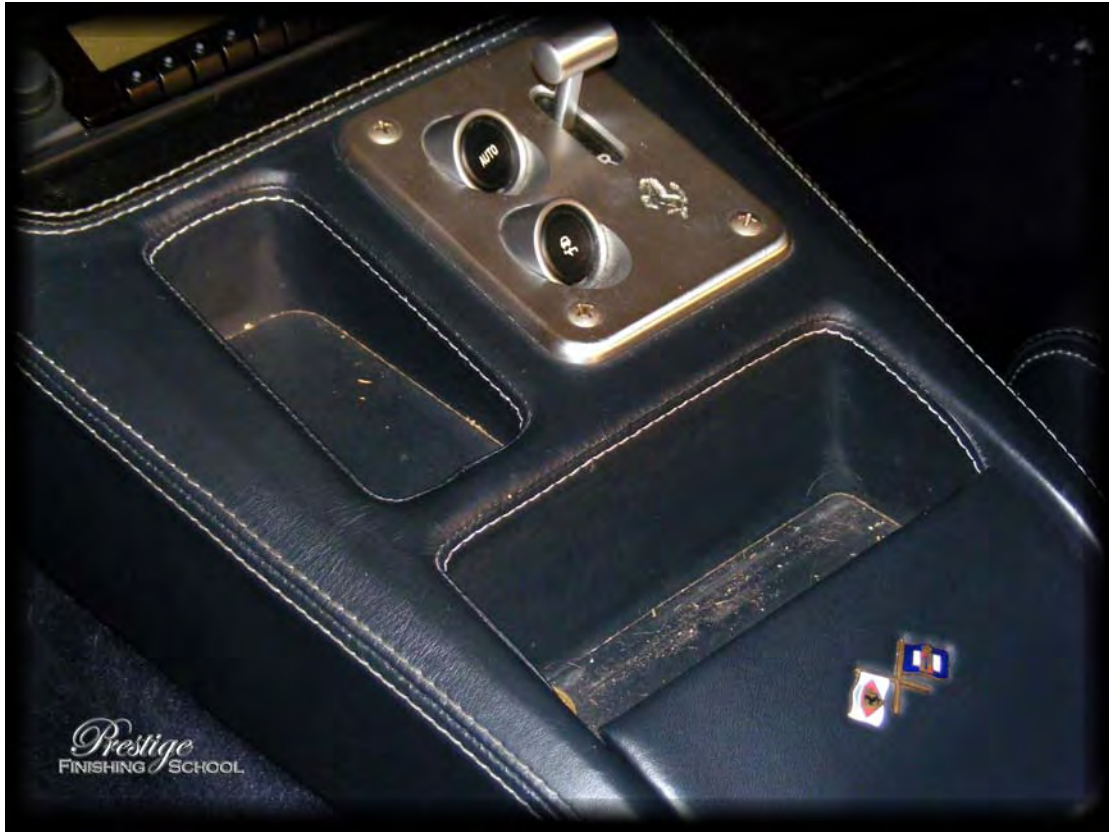
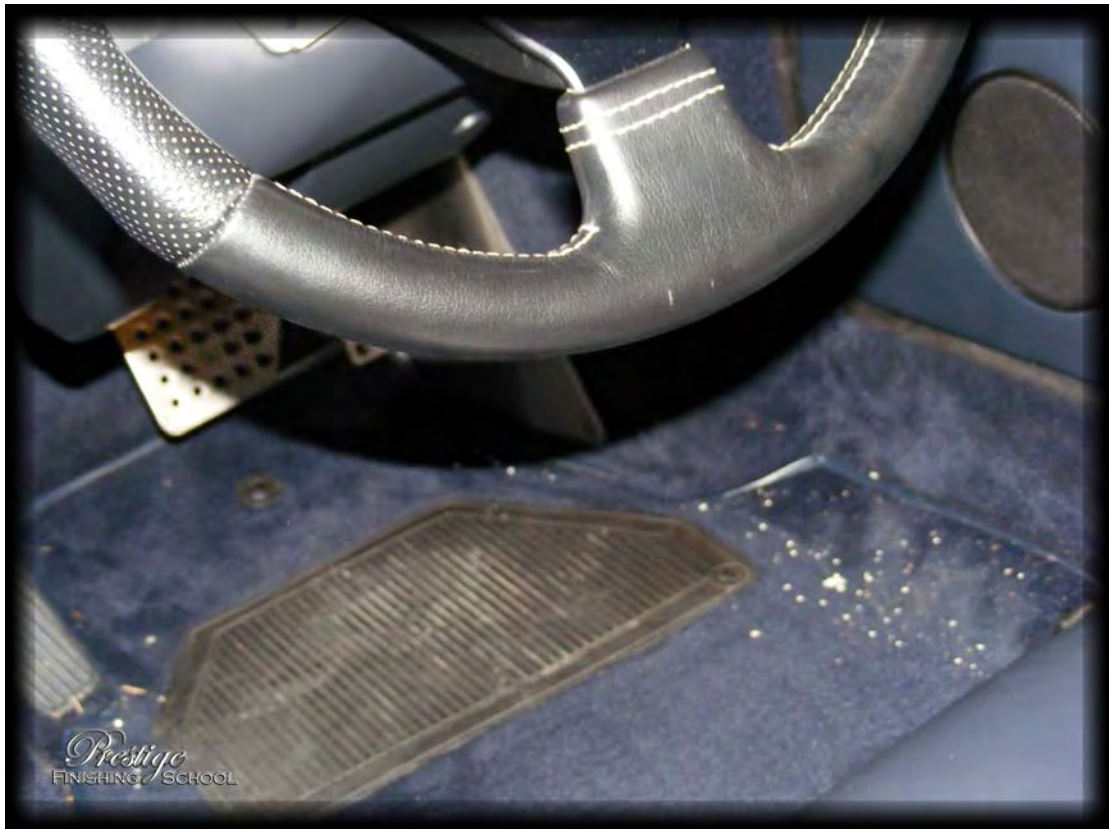
While the Blackfire sealant was curing, we set about cleaning up the interior of the vehicle. It wasn't in especially bad shape, but it certainly wasn't up to standard!

Some areas were more heavily soiled.

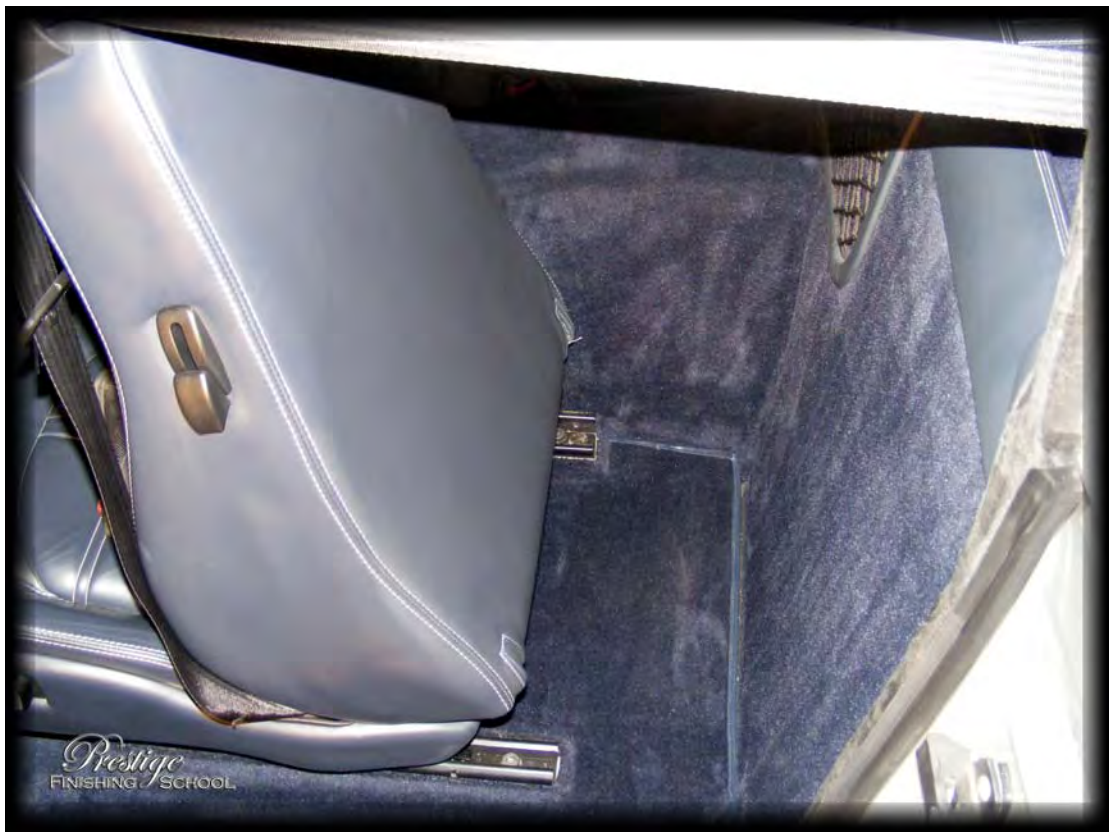
Unfortunately, there were some unsightly stains on the floor mats.

These were removed with a weak concentration of All Purpose Cleaner, and a Meguiars Interior Surface Detailing brush.
