**Report Card:**

2003 Ferrari 575 M Maranello F1 (Silver)

## 1.0 Enrolment:

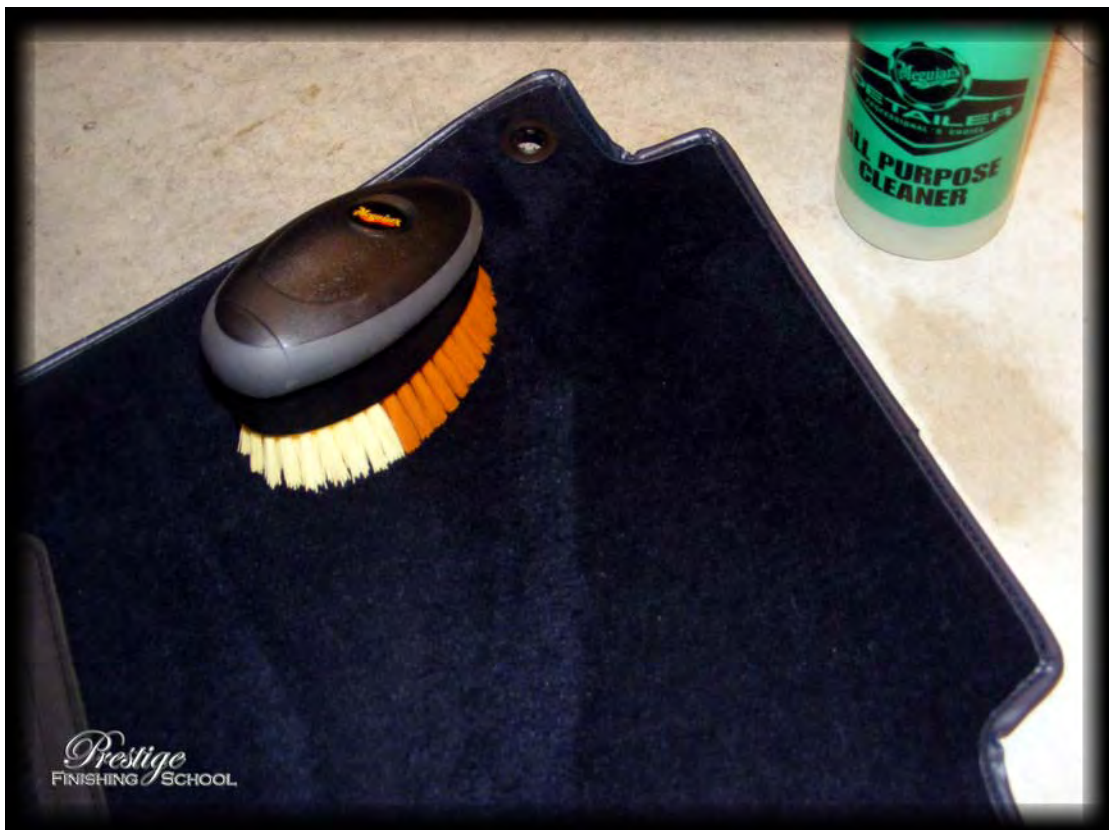
The leather interior was completely cleaned and the hides conditioned.

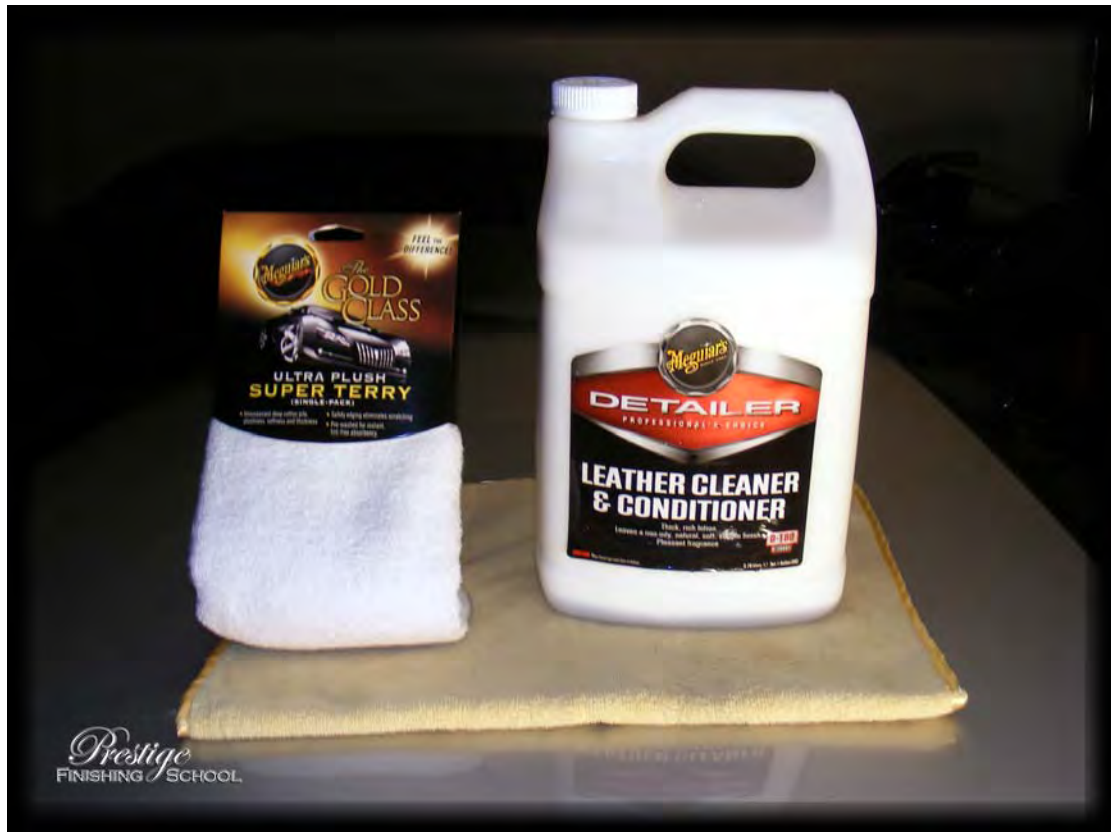
That brand new Terry Cloth shows up exactly how much dirt was removed from the leather by the time we'd finished!

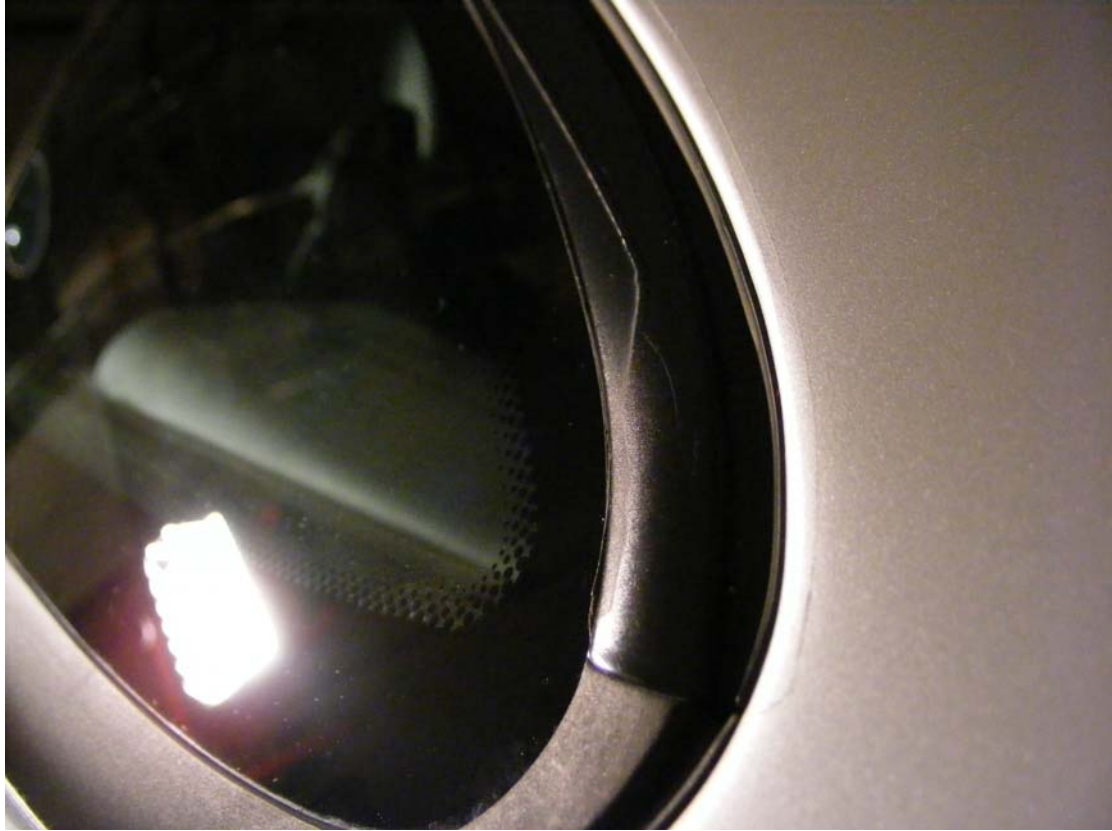
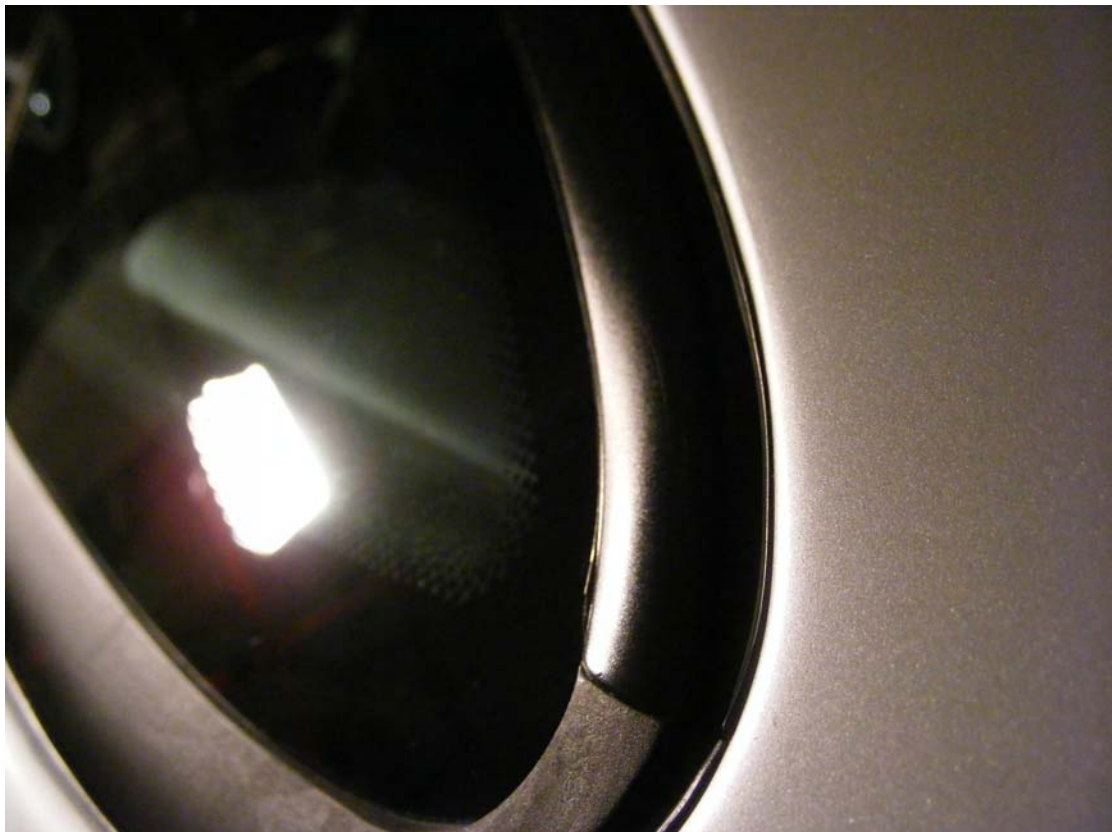
We now turn our attention to the 'little things' that really embody the essence of top level motor detailing. For example, the removal of any leftover masking tape residue.

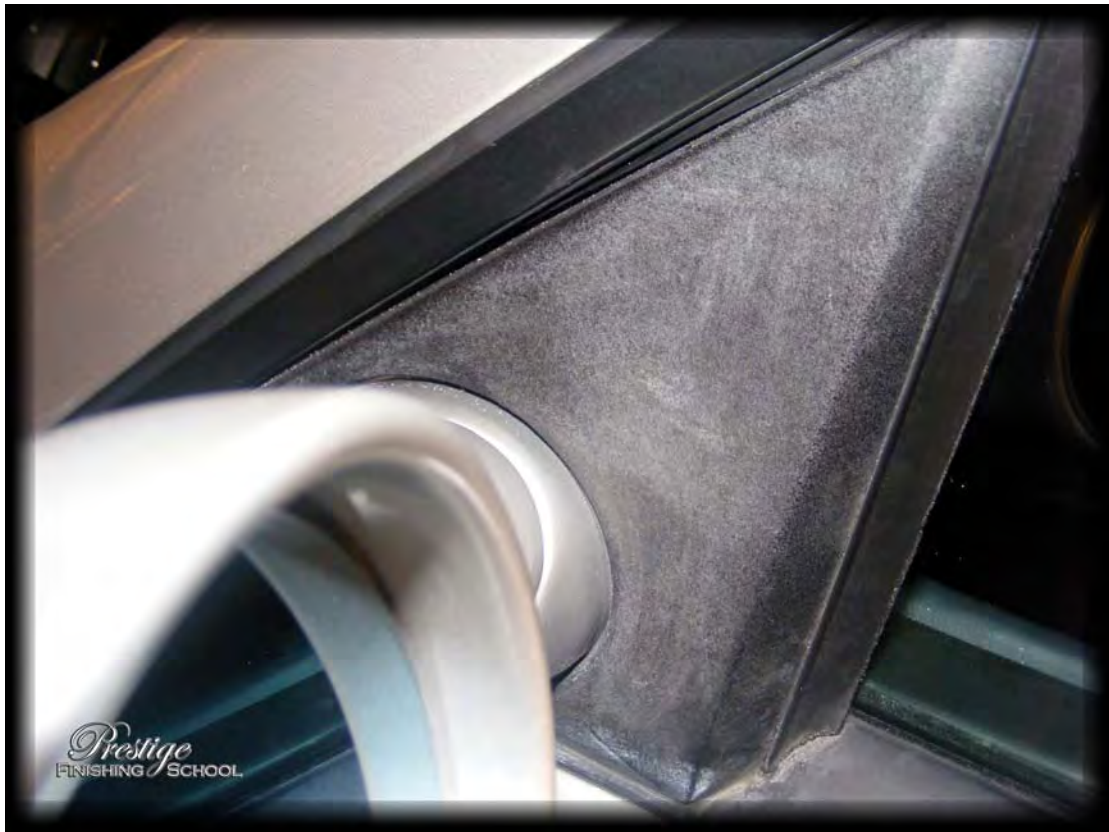
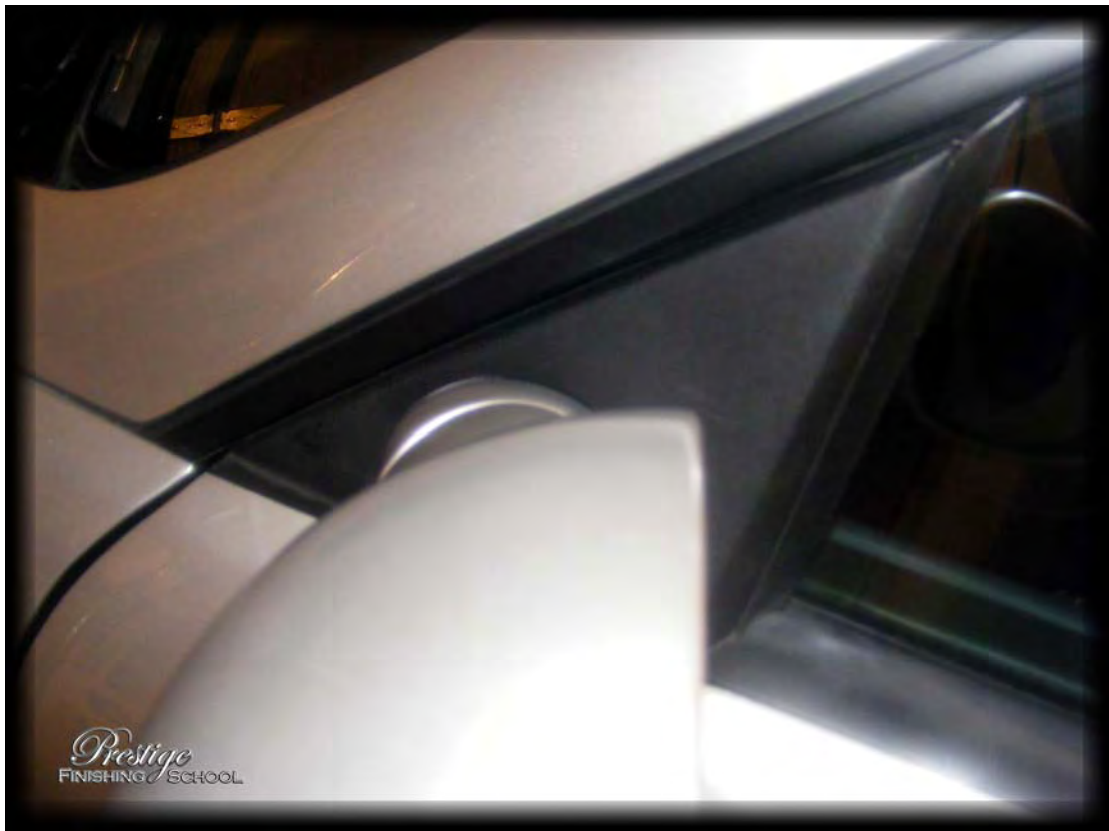
...and the cleaning up of earlier attempts to 'wax' or 'polish' black plastic mouldings and trim pieces!

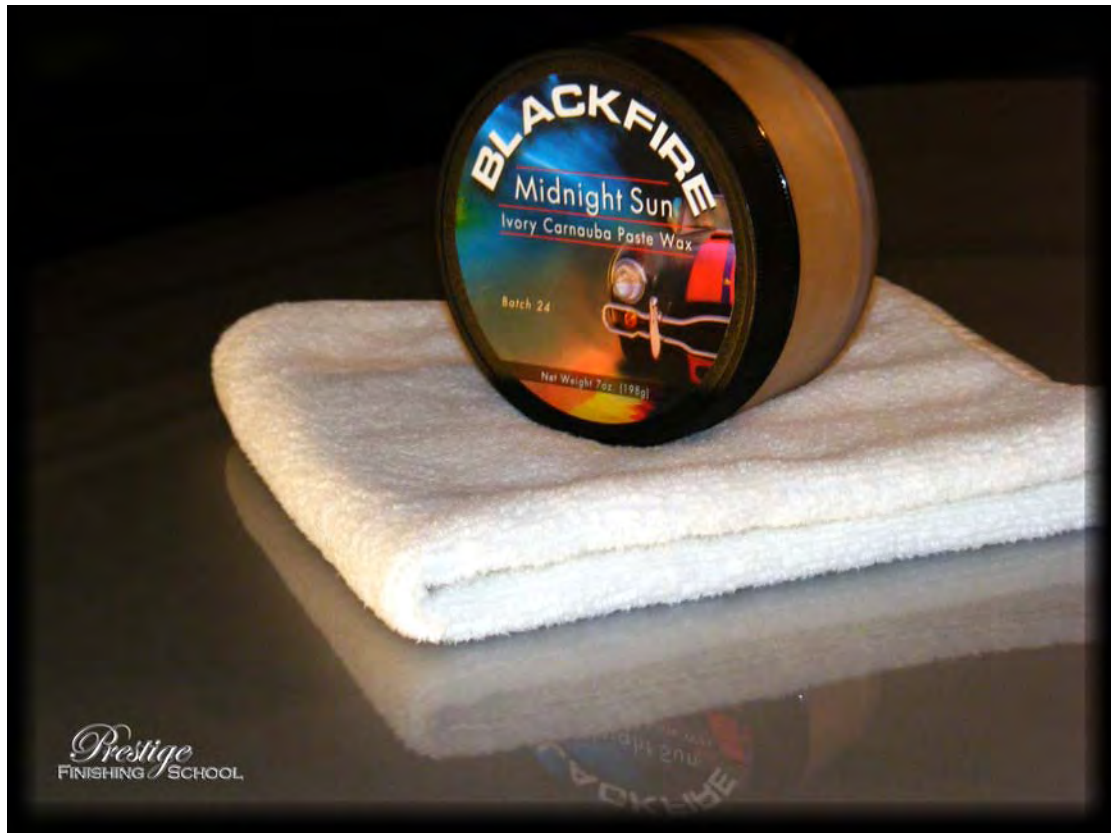
The wax builds on the reflectivity and adds a visible 'glow' to the paint.

By this time, the vehicle is ready for the application of its first coat of Carnauba wax. This is applied by hand, using a foam applicator and buffed off with another deep pile microfibre buffing cloth.

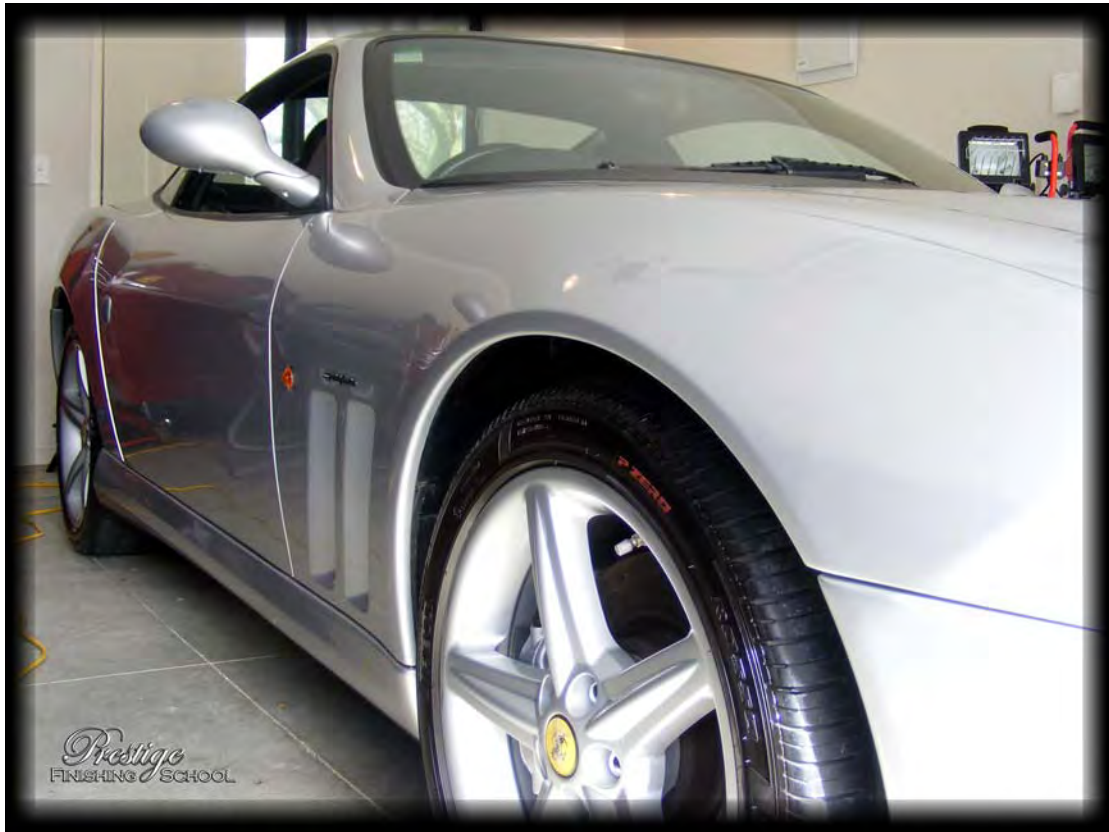
In addition, all glass was cleaned, inside and out with Meguiars Glass Cleaner Concentrate.
