**Report Card:**  
2005 BMW 730i (Silver)

## 1.0 Enrolment:

For the second time in as many weeks, we were engaged to undertake 'Major Paint Correction' services on a newly purchased BMW. In a similar vein to our recent work on the 525i M-Sport, the owner of this sleek executive sedan was disappointed with the condition of the vehicle upon delivery from the dealer - and keen to achieve a showroom-perfect finish.

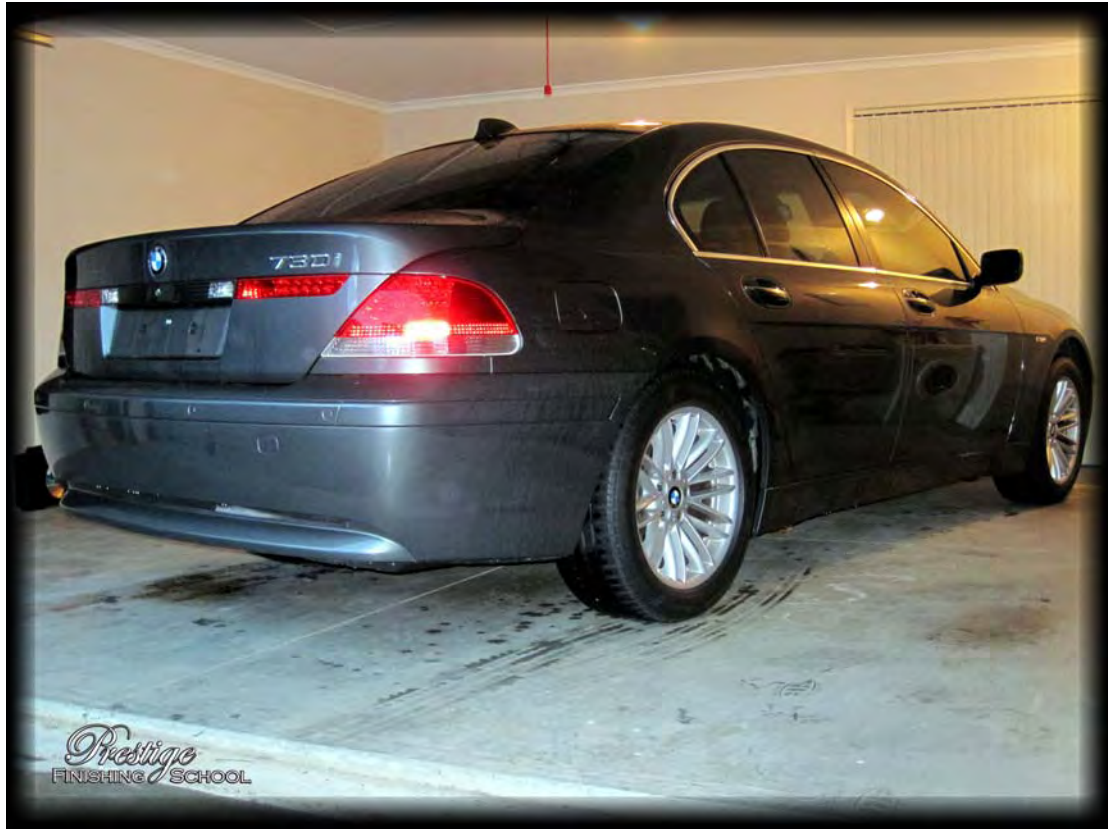
This particular 730i is a 2005 model, first registered in New Zealand less than 3 months ago. It has only travelled 35,000kms and is presented in almost brand-new condition. (Except for the swirls and minor scratches covering much of the vehicle.)

We were requested to make the paint as 'perfect as possible', and additionally to remove the vehicle's wheels for a comprehensive clean of the vehicle's alloys and arches.

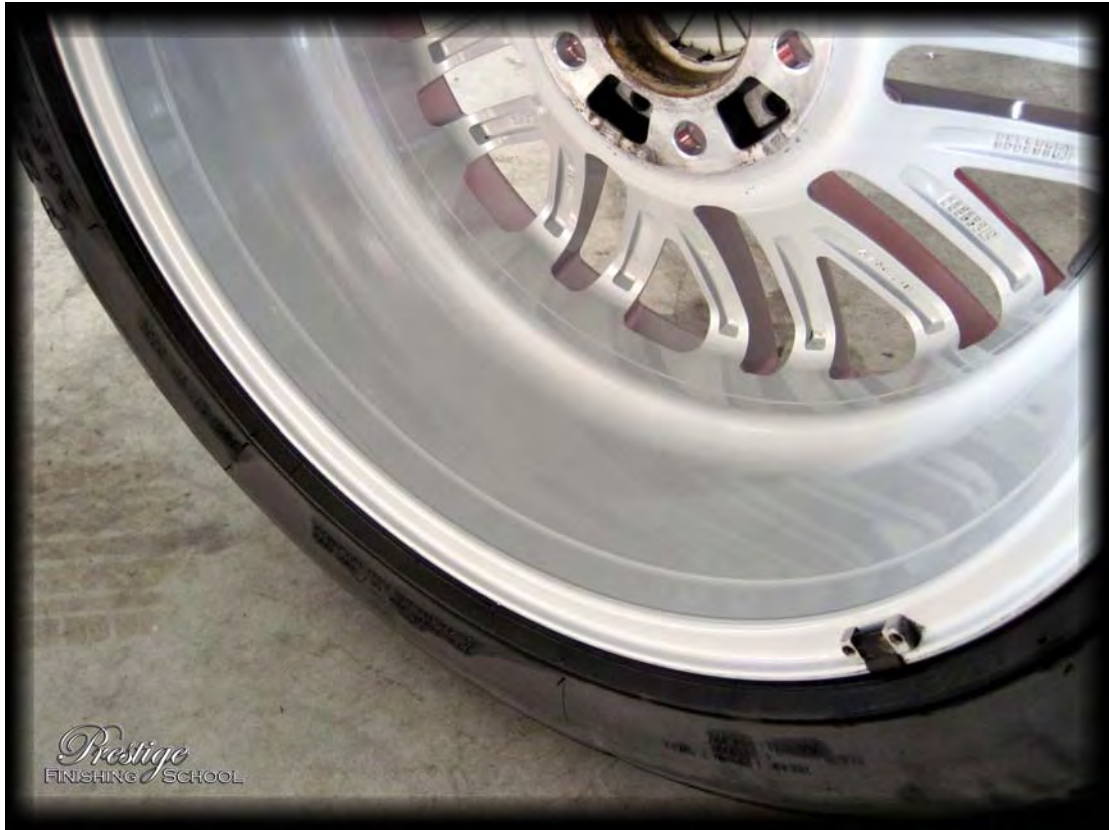
This left us with the etching and bonded particles of brake dust to attend to:

P21S Wheel Gel was employed to remedy the problem, combined with another full hour spent meticulously cleaning each of the rim's 20 alloy spokes. This was followed with an application of Poorboy's Wheel Sealant to protect the rim.

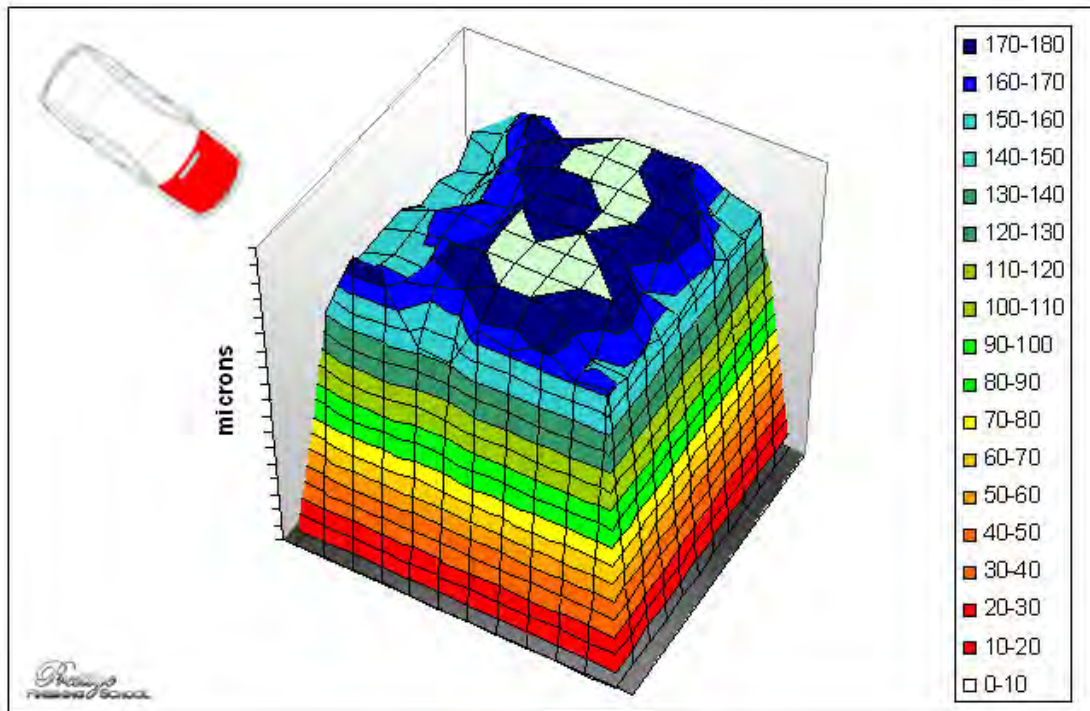
Paint thickness (as illustrated in the diagram below) was consistent across the panel, and averaged a generous 165  $\mu\text{m}$  in total thickness.

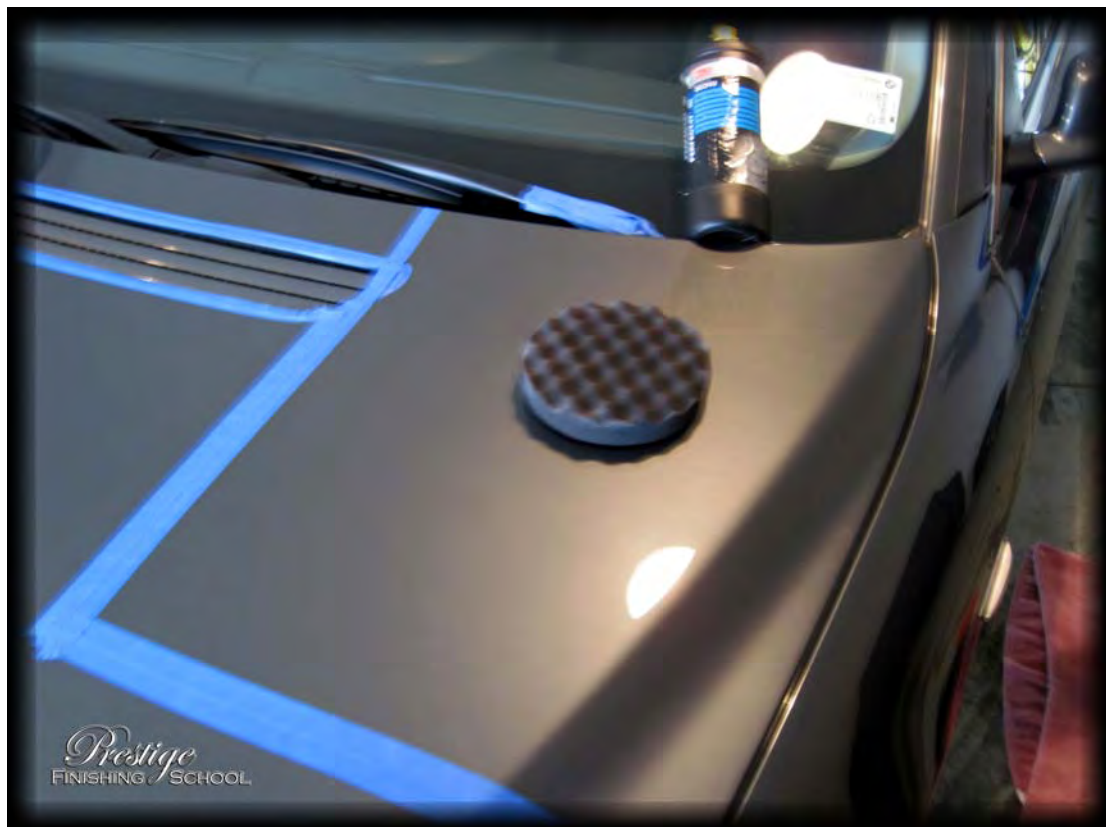
BMW paint has a reputation for being “rock hard” and this specimen turned out to be no exception! We quickly graduated from finishing polishes to 3M Extra Fine Polish on a 3M polishing pad which has a bit more ‘cut’.

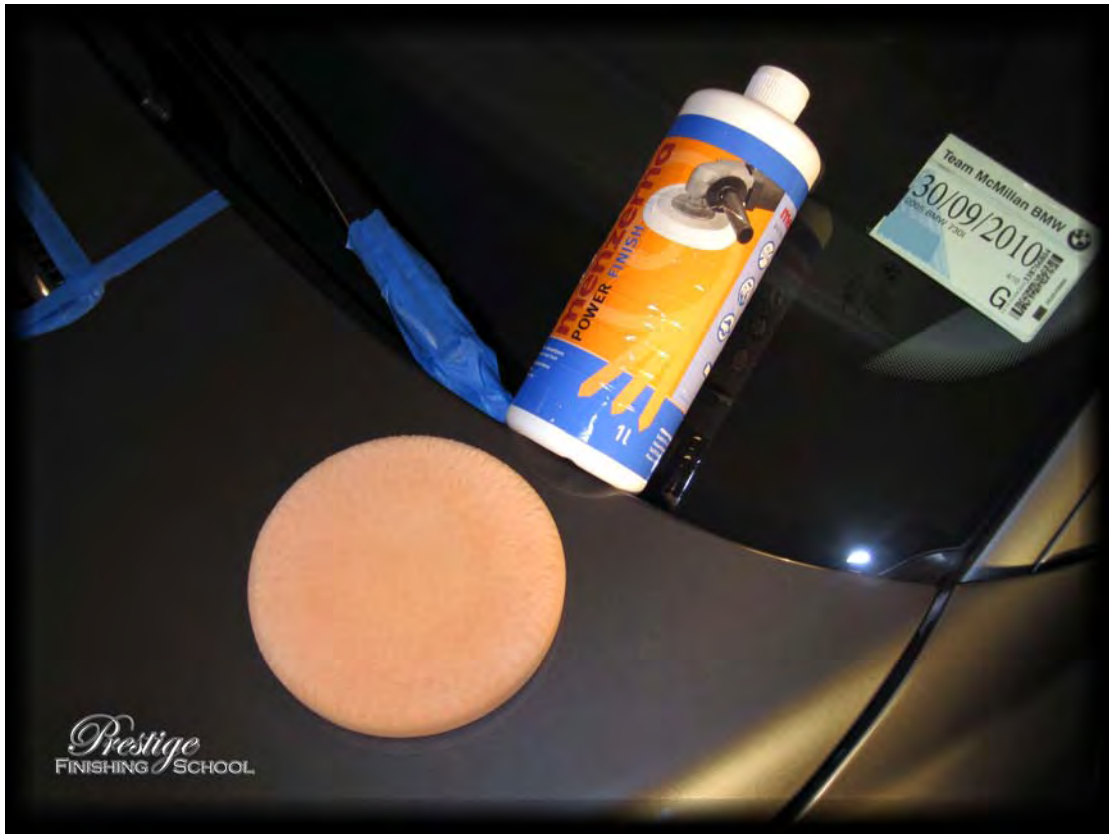
PO 85 RD 3.02 was initially developed for removing more severe paint defects and 2000 grit sanding marks from the cerami-coat finish of modern Mercedes paints. It is now being widely used on regular clearcoat finishes and is particularly effective on the harder clear coat finishes found on VAG and BMW paints.

Once again, we reached for Menzerna “Power Finish” PO85 RD 3.02 on a 3M compounding pad.

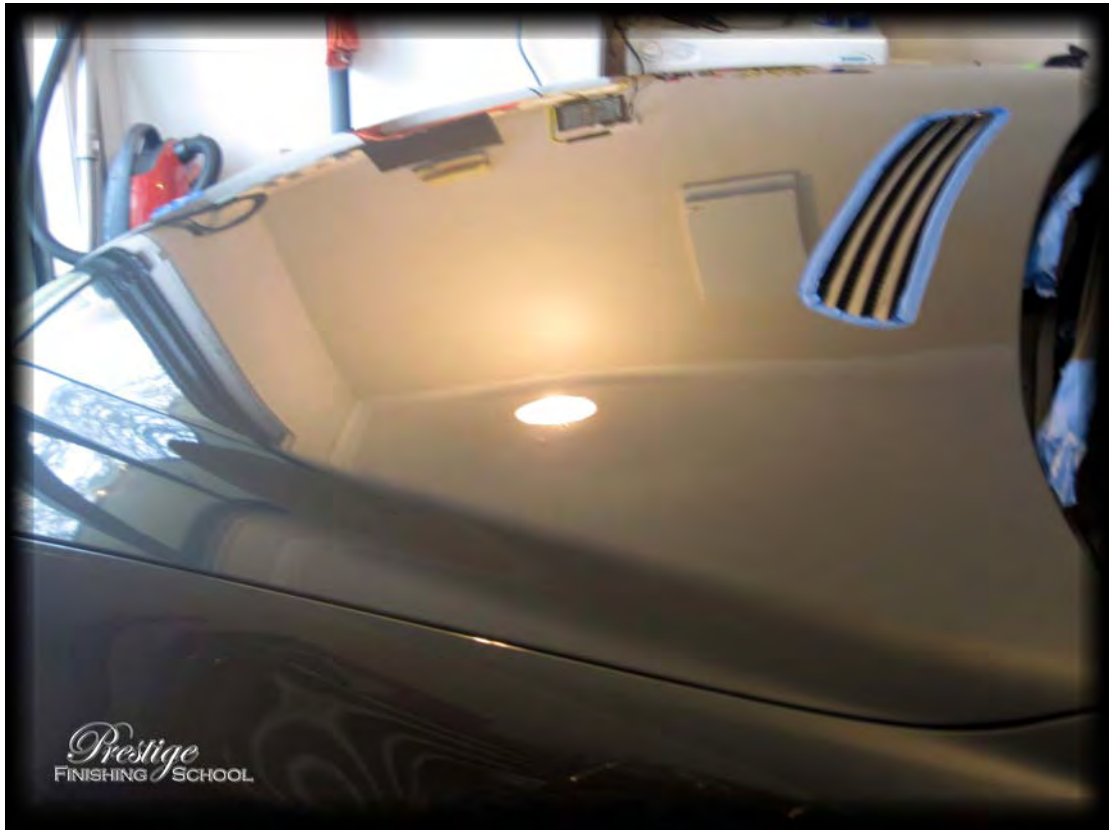
...leaving a crisp, glossy, deeply reflective surface.

...which was subsequently refined with Menzerna RD85 on a 3M finishing pad.

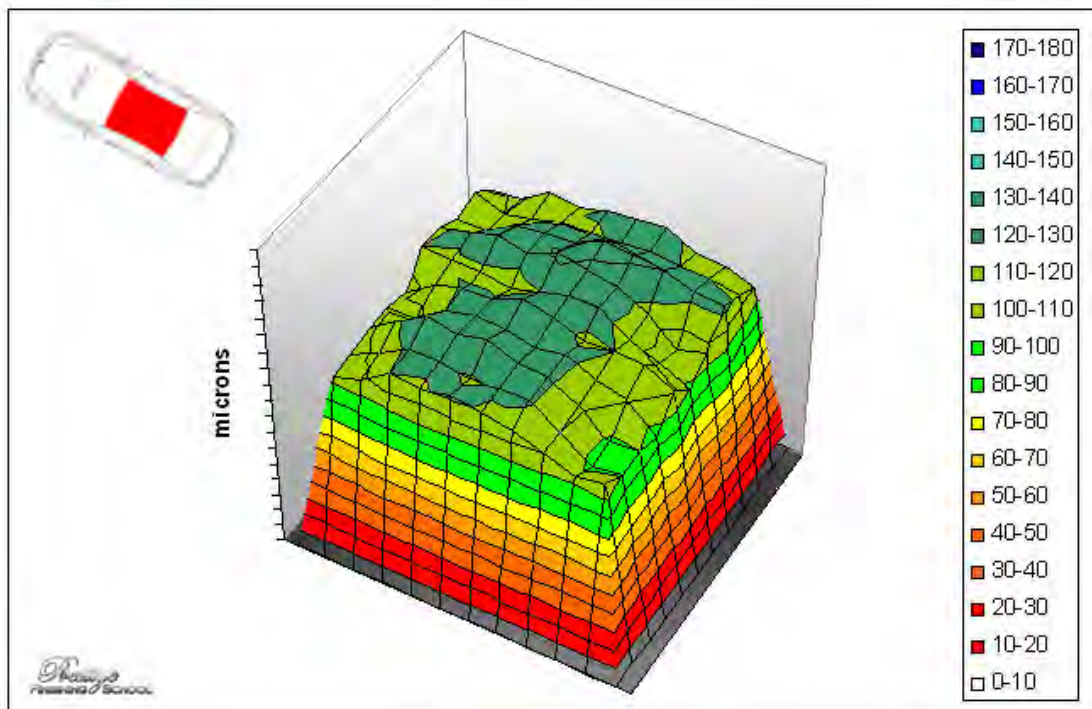
## Roof

The roof was also showing healthy paint levels...

...with slight marring on the surface of the panel.

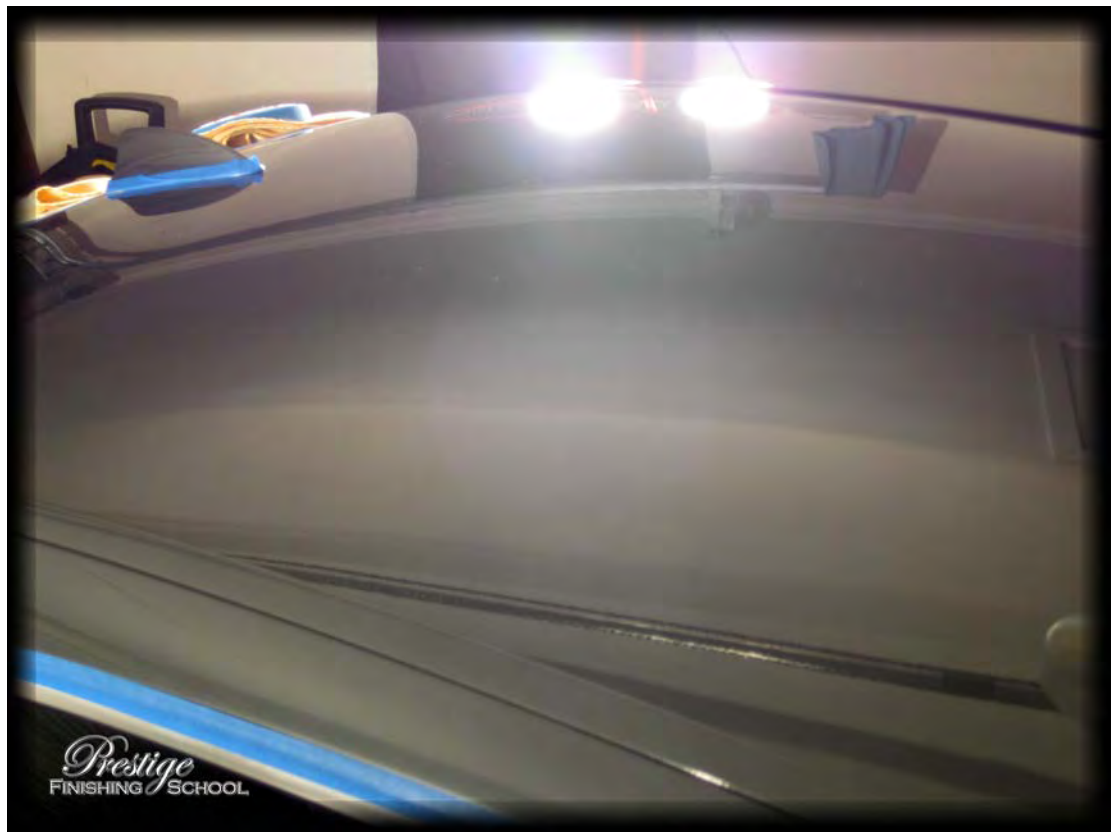
The finished panel:

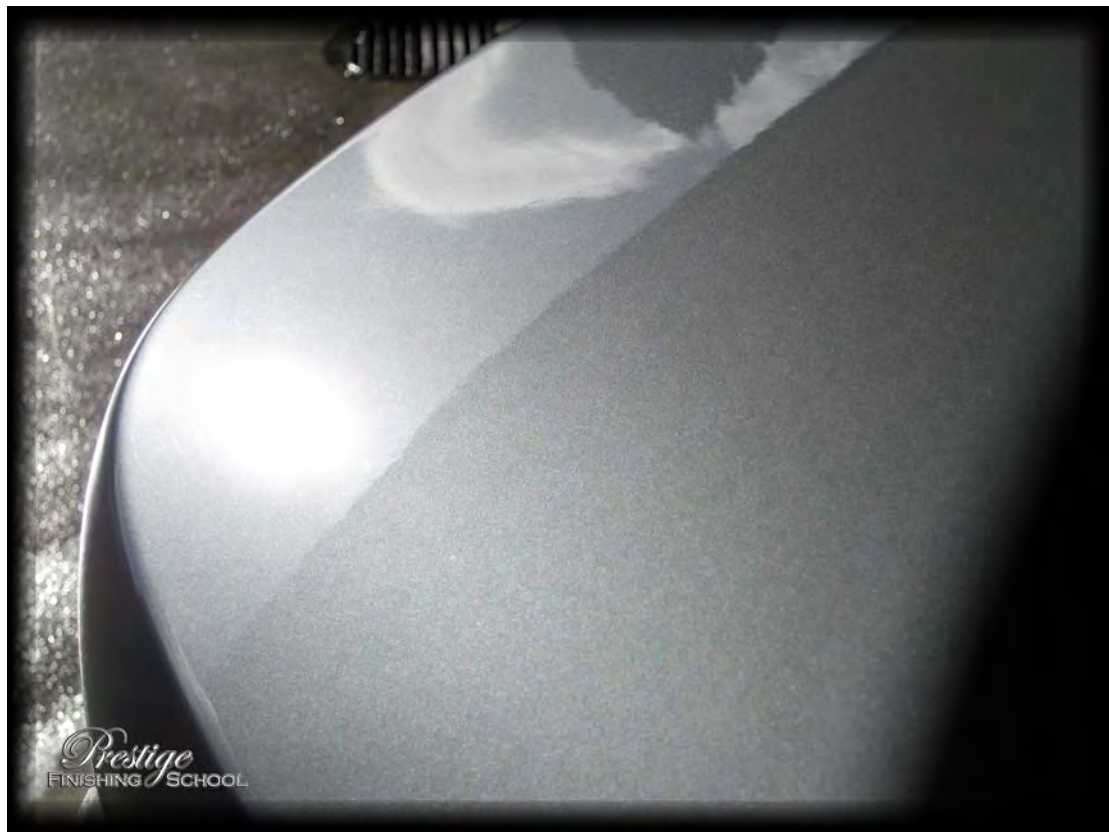
...resulting in a flawless finish.

(NB. This is not a “half-and-half” photo – the sky is reflected on the left, and the underside of the eaves on our roof on the right)

The same corrective process was followed...

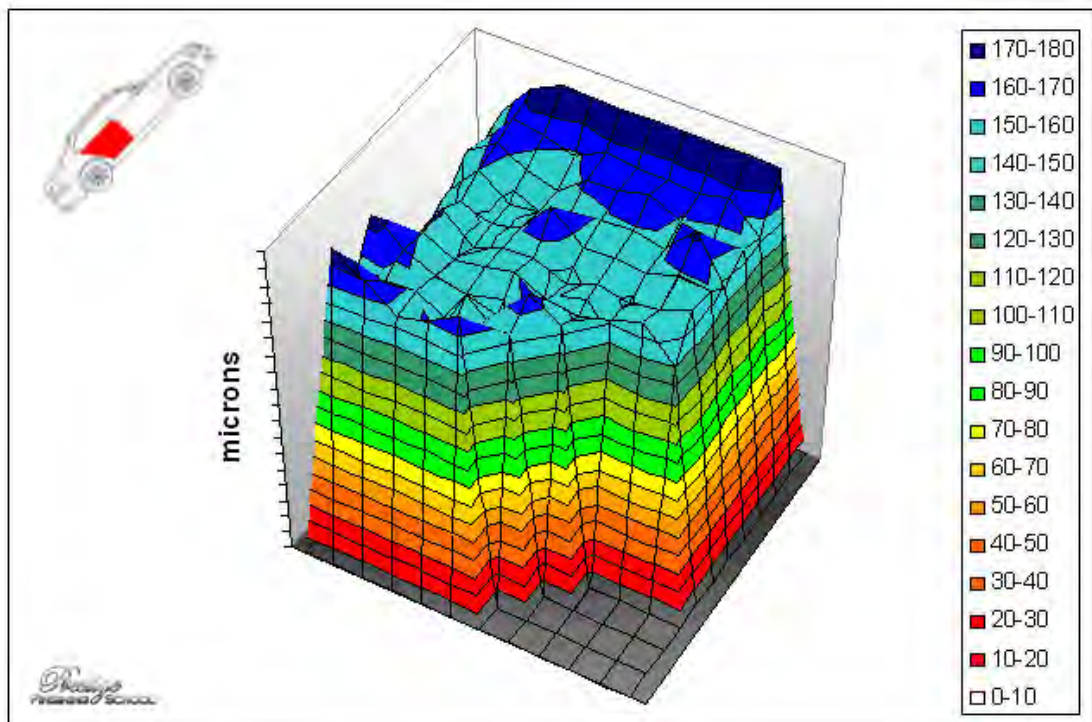
## Right Rear Door

This shot shows the difference between the two right hand doors. The front has been corrected, with the rear showing holograms & buffer trails (likely from previous attempts at machine polishing with poor technique) ...as well as the expected swirls & scratches.

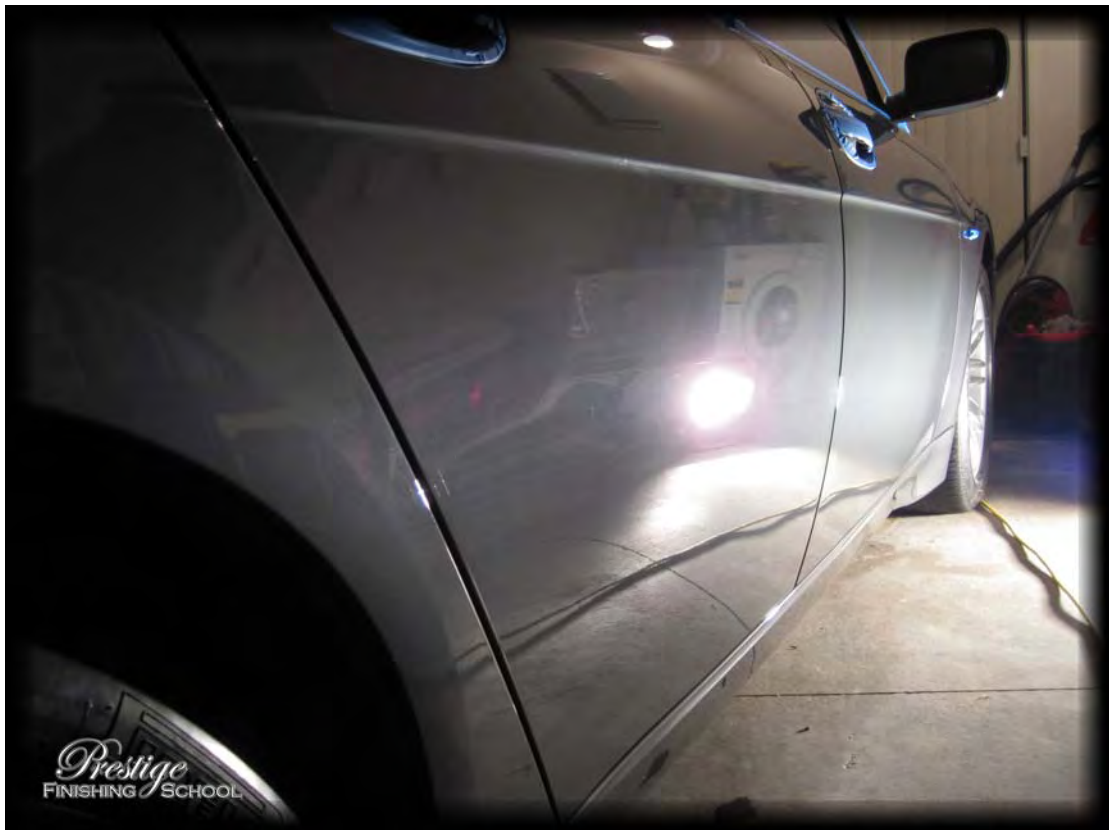
Now with both panels fully corrected:

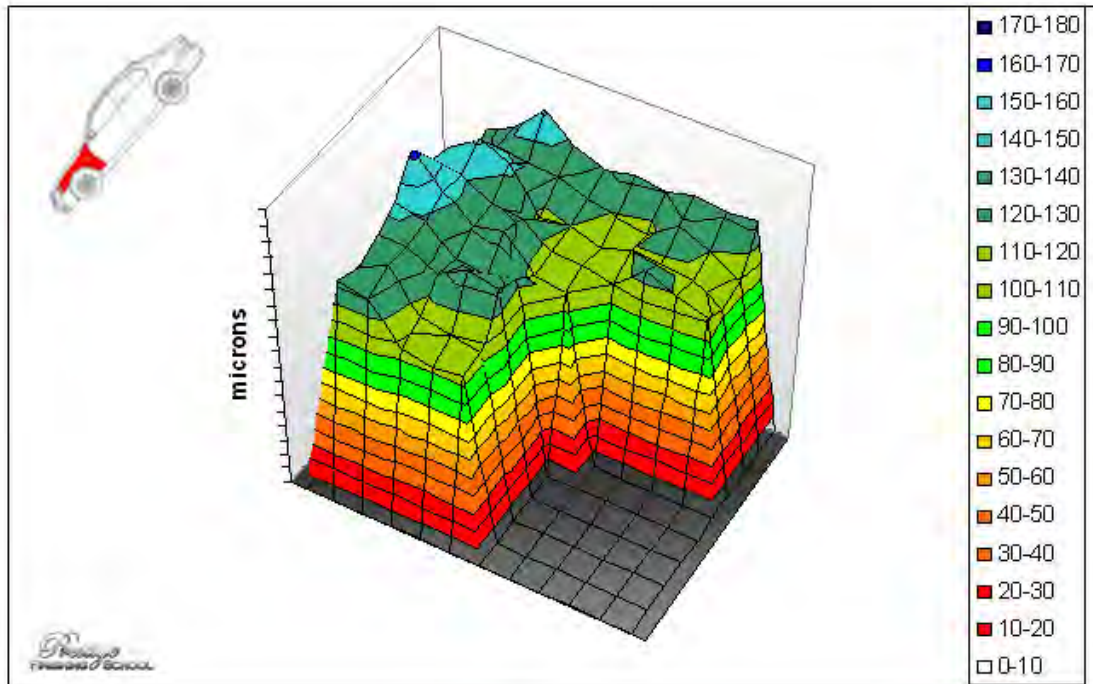
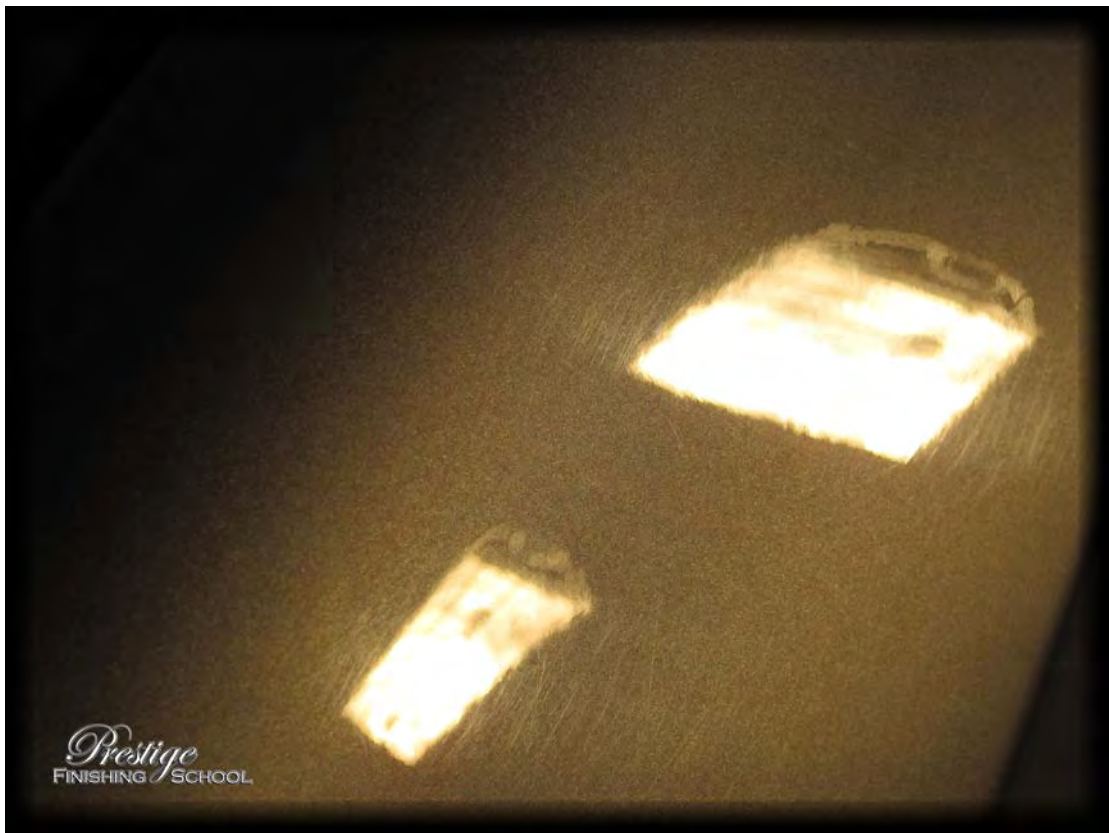
## Left Front Wing

The passenger's side of the vehicle was consistent, hard, uniform factory paint, with varying amounts of surface defects.

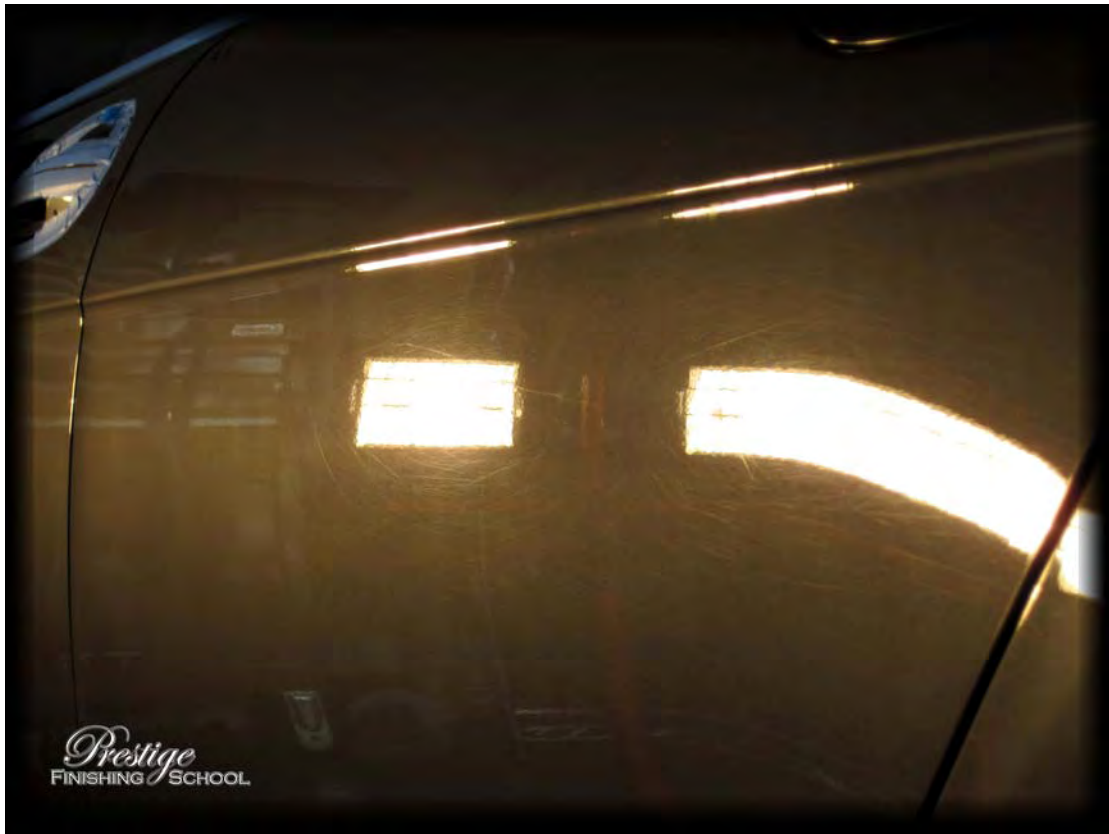
Minor swirl marks clustered around the twin light sources...
